Number	N.84
Section	Body
Page	1 of 2
Date	November, 1971.

BONNET MASCOT

INSTALLATION INSTRUCTIONS FOR BONNET MASCOT BD.29644

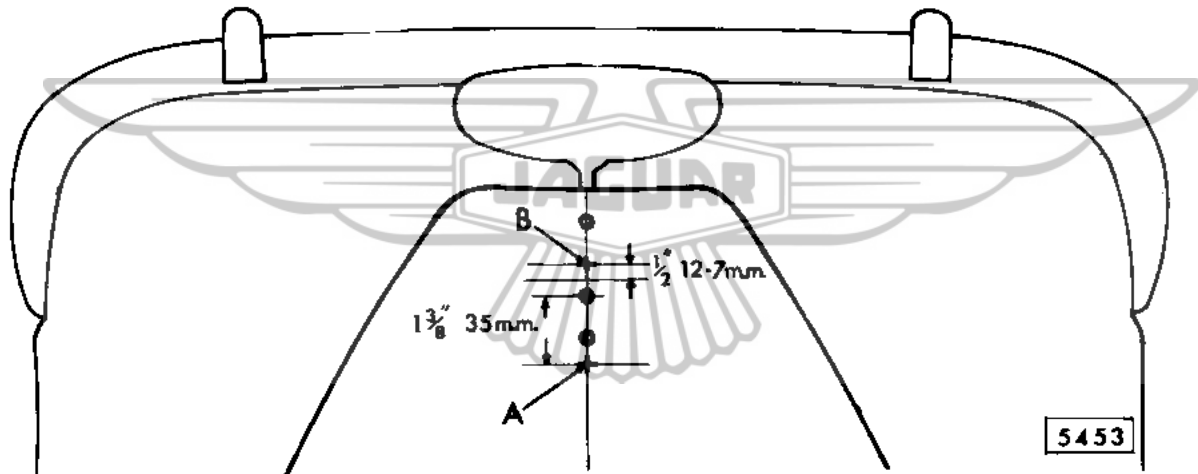
Difficulties in manufacturing Bonnet Mascot BD.10954 have resulted in it being withdrawn and supplies are no longer available. Orders for replacements for the above cars will therefore be executed by Jaguar Spares Division supplying an alternative Bonnet Mascot BD.29644 which varies from the original by the positions of the mounting studs. Instructions for the installation of the new Mascot are therefore detailed below.

1. Remove original Mascot from bonnet
2. Remove front and rear portion of bonnet centre beading
3. Retouch paintwork (if necessary) where bonnet is affected by contact with Mascot or chrome beading.
4. Lightly mark centre line through existing fixing holes, extending line forward by 2 in. (50 mm.).
5. Drill 3/16 in. (4.8 mm.) hole 'A' on centre line, 1 3/8 in. (35 mm.) to rear of front Mascot fixing hole. Locate new Mascot in holes
6. Place rear chrome bead in position, mark against rear of new Mascot base. Remove chrome bead and carefully cut to length. Clean up end of bead.
7. Place front chrome bead in position, mark against front of new Mascot base. Remove chrome bead and carefully cut to length. Clean up end of bead.

8. Lightly mark bonnet across front of new Mascot base.
9. Remove Mascot and centre pop bonnet $\frac{1}{2}$ in. (12.7 mm.) forward of mark. Drill $\frac{1}{8}$ in. (3.17 mm.) diameter hole 'B' in bonnet.
10. Locate clip BD.11719 and secure to bonnet, using pop rivet BD.1814/6
11. Fit Mascot and secure to bonnet, using special cup washer, part number 1744 at front fixing, nuts UCN.119/2 and shake-proof washers C.723/A
12. Fit modified front and rear chrome beads.

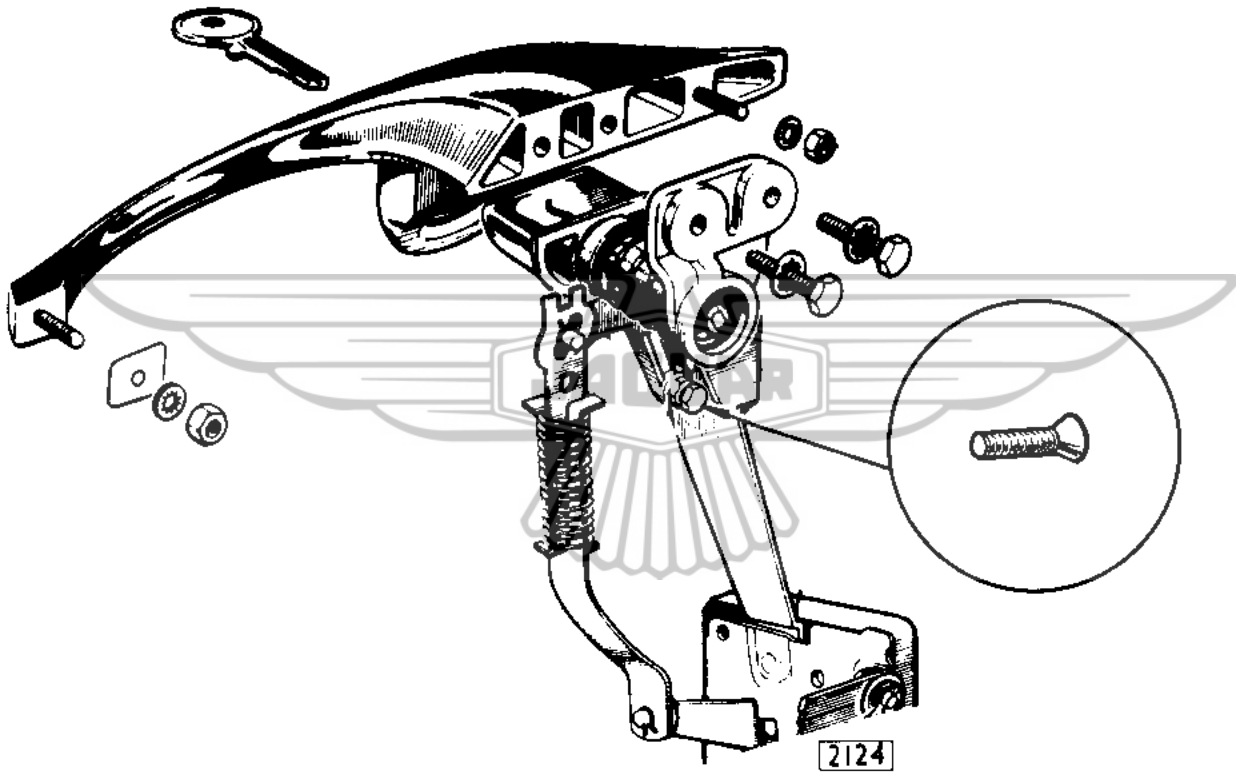
If trouble is experienced with the door locks jamming when the outside button and inside lever are operated at the same time, the following modification should be carried out.

Remove the door casing, wood capping and plastic covering as described in Section N "Body and Exhaust System" of the Mark 2 Service Manual. Move the inner door handle into the locked position. This action moves the plunger operating lever from behind the lock contactor. Slacken the lock nut and unscrew the push button plunger bolt (shown in the illustration overleaf). Discard the hexagon headed bolt and screw the locknut onto the countersunk cross-headed screw (Part Number 8949). Screw the countersunk screw into the plunger operating lever. The clearance between the head of the plunger screw and the lock contactor should be 1/32" (0.8 mm). To adjust, slacken the locknut, screw the plunger screw in or out as required and retighten the locknut.

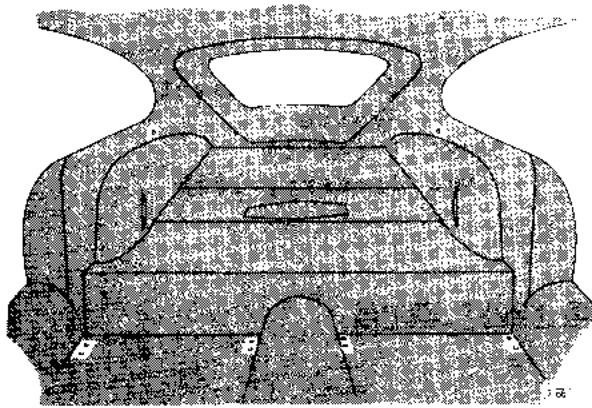
'E' TYPE FIXED HEAD COUPE

On cars with the above chassis numbers and onwards, mounting points for the attachment of seat belt anchor brackets are provided. The mounting points are in the positions shown overleaf and are designed to suit a wide range of seat belt types. The pairs of holes for floor mountings are $2\frac{1}{2}$ " (6.35 cm) between centres, one hole being a $\frac{3}{8}$ " (9.5 mm) plain clearance hole and the other being a $7/16$ " (11.1 mm) UNF tapped hole. The mountings holes behind the seats or on the centre pillars are all tapped $7/16$ " (11.1 mm) UNF. (See illustrations overleaf).

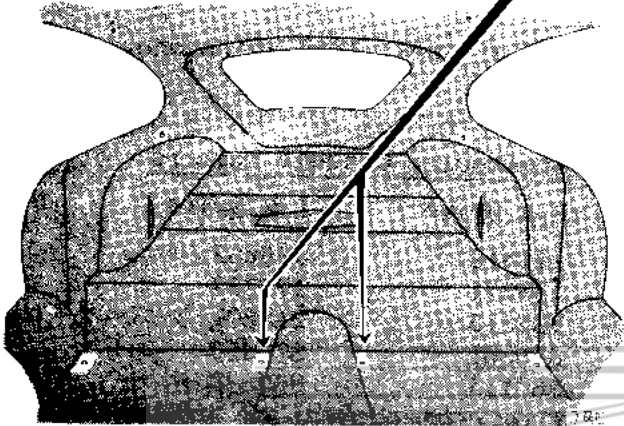
'E' TYPE FIXED HEAD COUPE
EARLY CARS

The positions of the anchorage points are shown overleaf. Earlier cars had two holes, one plain and one tapped, at the floor anchorage positions; later cars have only a single 7/16" (11.1 mm) U.N.F. tapped hole. In either case only the tapped holes will be used for anchorage purposes.

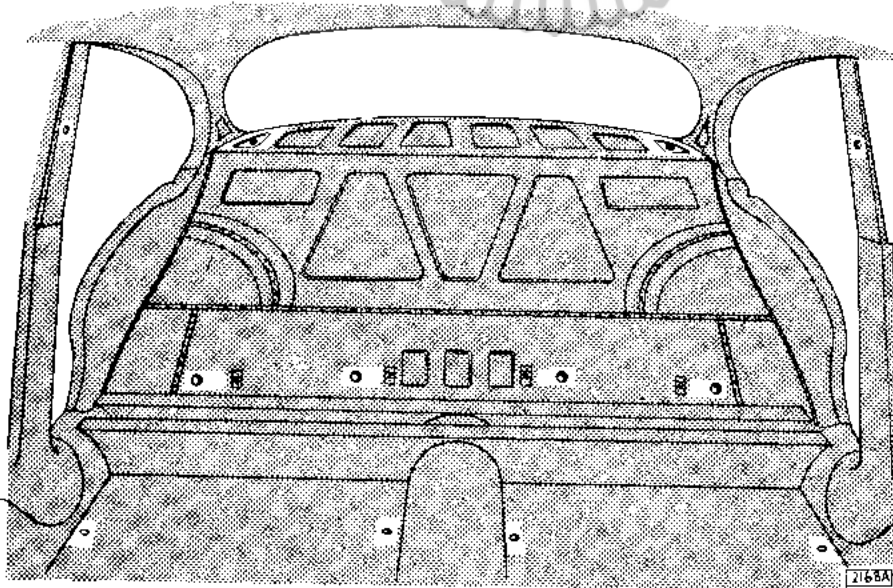
MARK 2 AND MARK 10 MODELS

Note: The tapped holes in the floor are blanked off with plastic cross headed screws. On the Mark 2 and Mark 10 models, the tapped hole in each centre pillar is blanked off with a chrome plated escutcheon.
