Number 0.7.

Section Heating & Windscreen
Washing Equipment.

INTRODUCTION OF THE LUCAS 5SJ SCREEN JET WINDSCREEN WASHER.

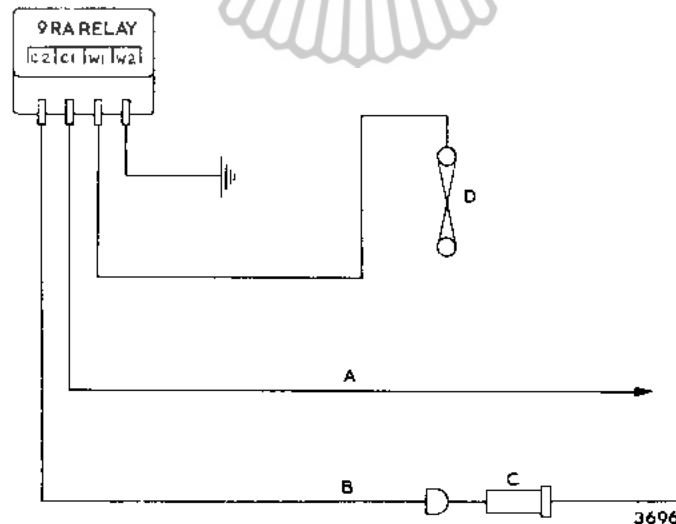
Isolated instances have occurred of ignition switch failure on cars fitted with an Air Conditioning System.

This has been traced to an excessive load being imposed on the two evaporator fan motors when operating under certain adverse conditions conducive to icing up, resulting in an overload on the ignition switch contacts and subsequent breakdown.

To prevent this fault recurring, a Lucas 9 RA Relay (Part No. C.19085) has been introduced into the Air Conditioning Electrical circuit on current production cars, the revised circuit being as illustrated.

If complaints are received of ignition switch failure, it is recommended that the relay is fitted in a convenient position and the circuit modified. The main output terminal (A) should have a 35 amp terminal fitted to connect to the alternator.

- A - To alternator main output terminal (Cable to carry 30 amperes)
- B - To air conditioning line fuse (Cable to carry 30 amperes)
- C - In line fuse
- D - Ignition fuse (No. 3)
