Service Bulletin

REF: JD 05/93

V12 AND AJ6 ENGINES

12 INTRODUCTION OF GRADED CRANKSHAFT BEARINGS

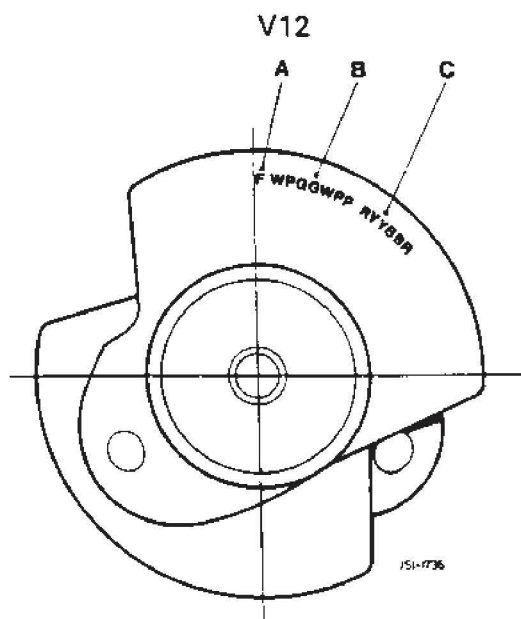
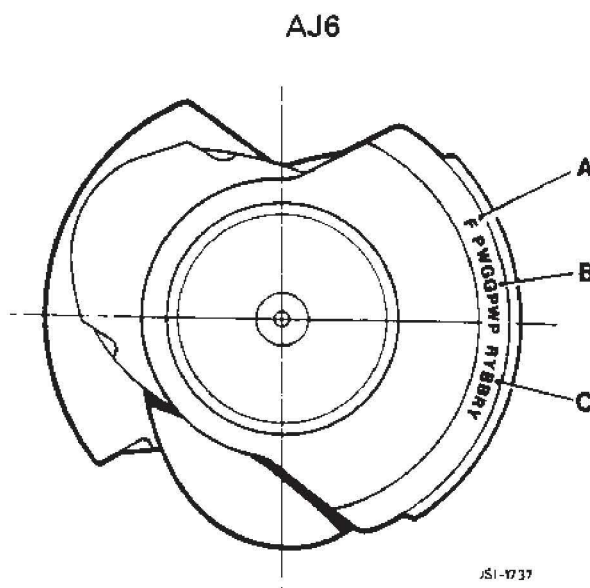
The three different grade diameters of the journals and pins are represented by a letter which corresponds to a colour, i.e. "P" equals Pink, "R" equals Red, etc. The grade of each individual journal and pin on each crankshaft is identified by having the grading diameter colour stamped on the No 1 balance weight, indicating the grade of shell to be fitted, as follows:

A: F Indicates front
B: Journals 1 to 7
C: Pins 1 to 6

The bearing shell is identified by having the colour on one of its edges.

If the bearing shells only have to be replaced, the relevant shells, as noted on the No.1 balance weight (see above), should be ordered.

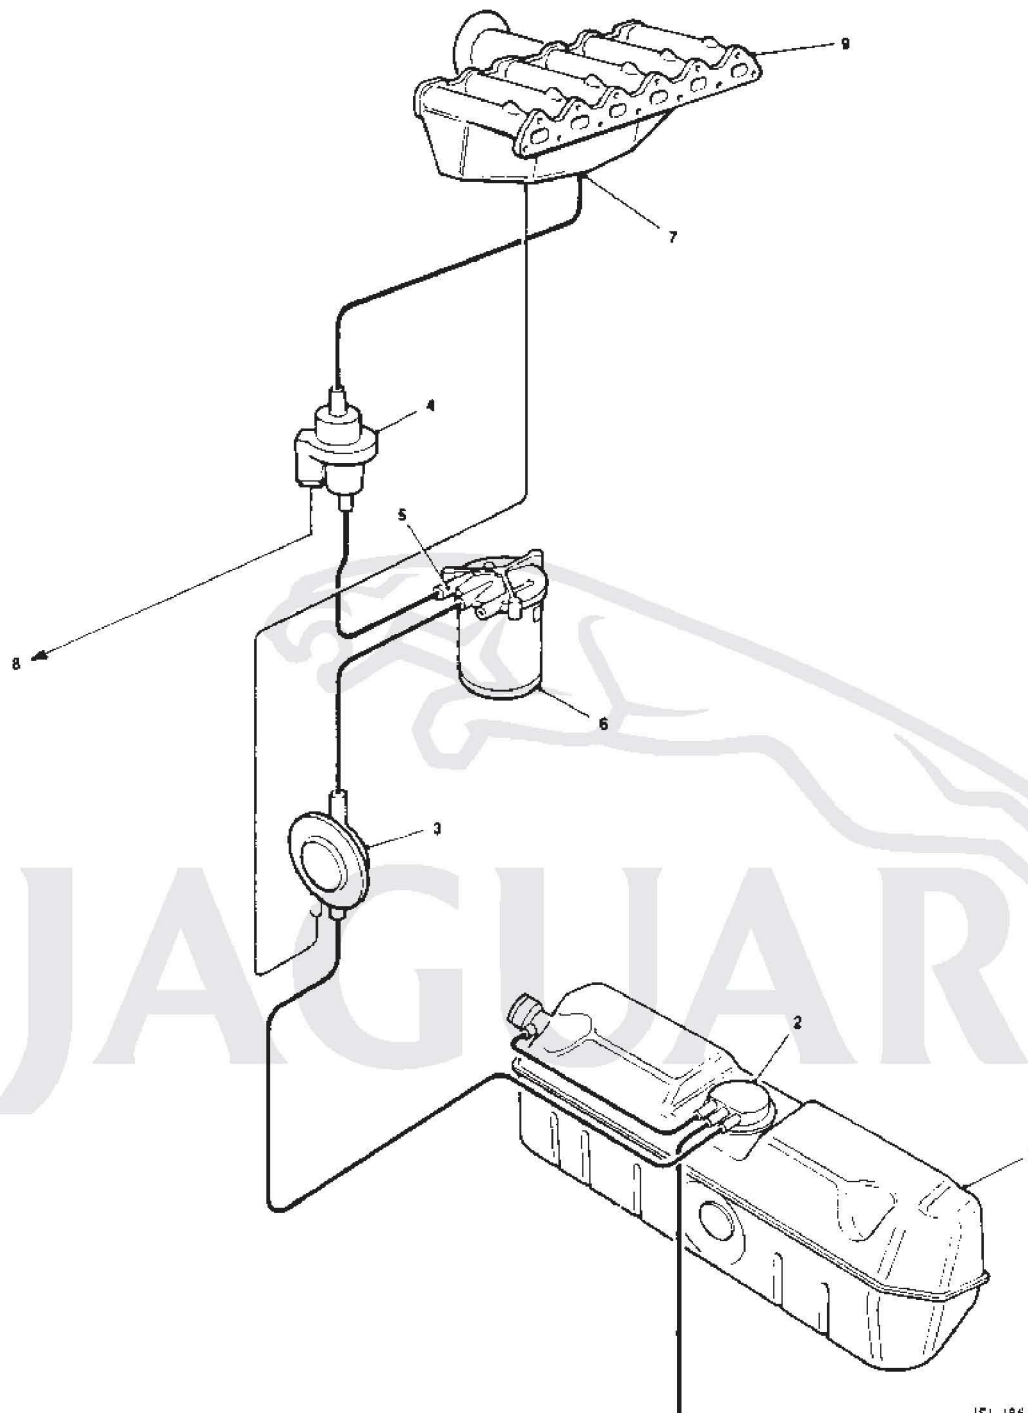
J51-1860

1. Fuel Tank
2. Evaporative loss flange
3. Pressure/Vacuum relief valve with vacuum operated by-pass valve
4. Purge control valve
5. Purge air port (on charcoal canister)
6. Charcoal canister
7. Purge port (on induction manifold)
8. Electrical connection to ECU
9. Induction manifold

When a vehicle is at rest with the engine turned off, the flow of vapour is controlled by a pressure/vacuum relief valve (3, Fig 1), so that a low positive pressure is maintained in the fuel tank. If this pressure exceeds approximately 1.5 psi, the pressure/vacuum relief valve opens, to allow the excess pressure and fuel vapour to bleed into the charcoal canister, thus maintaining the low positive pressure.

The charcoal canister is connected to the vehicle's induction manifold via a purge control valve (Fig 1, item 4), the operation of which is controlled by an electrical signal from the engine management ECU, according to a pre-determined map.

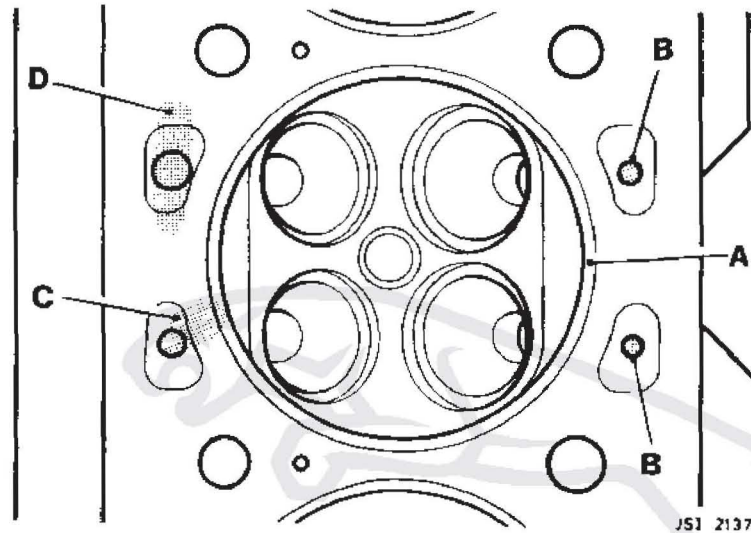
Fig. 1.

Where the cylinder head of an AJ6 engine has been removed in the course of a Service Repair Operation, it may be noticed that a certain amount of erosion to the cylinder head face has occurred around the coolant passages of the cylinder head, forming irregular cavities.

Provided that the eroded area (condition C, Fig.1.) does NOT extend into the area occupied by any firing ring, (Item 'A', Fig 1.), of the head gasket, using a head gasket as a template; a repair can be effected and there is no need to replace the cylinder head.

Where erosion has resulted in the formation of cavities in less critical areas around the coolant passages, (condition D, Fig. 1.), repair of the cylinder head should be undertaken. Careful filling of the cavities to restore the cylinder head face to its original surface profile may be undertaken by means of a proprietary 'Plastic Metal' (eg 'BELZONA'). A suitable product will be available shortly from Jaguar Parts Operations under Part No. JLM 11719.

On engines prior to VIN 677386 (XJ6) and VIN 187554 (XJS) the foundry practices involved in the manufacture of the cylinder head and the cylinder block resulted in elongated cored coolant passages at the upper face of the cylinder block, facing small diameter drilled passages in the cylinder head, separated by the gasket. Coolant flow between cylinder block and cylinder head is controlled by the diameter of the holes in the cylinder head gasket (Item B, Fig. 1.)

In service, the material of the head gasket 'collapses' into the larger cored passage of the cylinder block, leaving a gap between the cylinder head and the gasket, surrounding one or more coolant passages. Coolant in this gap may, in certain circumstances, boil locally and cause erosion of the cylinder head material.

IMPORTANT: CYLINDER HEADS SHOULD NOT BE REMOVED TO LOOK FOR THIS CONDITION. THE ABOVE ACTION SHOULD ONLY BE NECESSARY WHEN THE CONDITION IS NOTICED ON REMOVAL OF A CYLINDER HEAD FOR OTHER REPAIR WORK.

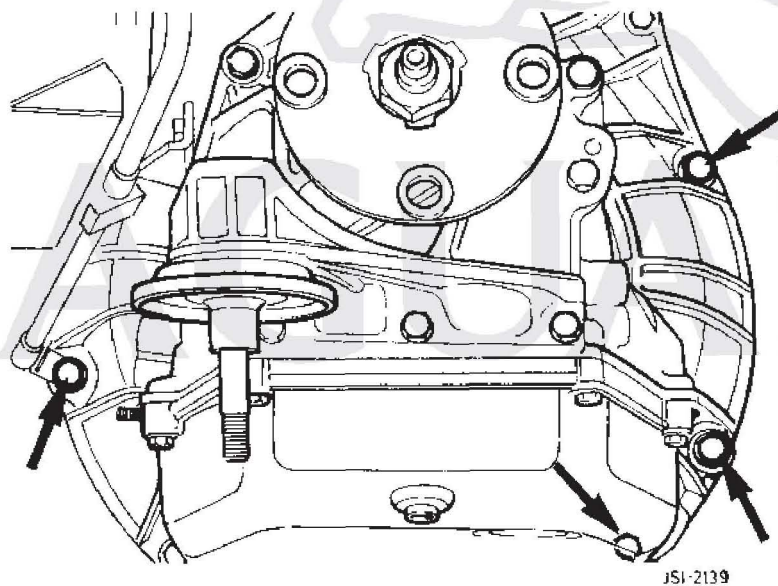
On a number of the above models, manufactured during November and December 1993, four of the ten bolts which fix the automatic transmission convertor housing to the intermediate plate have been found to be of incorrect material specification. The bolts concerned are indicated by arrows in the illustration below.

The suspect bolts are black in colour; if refitted in the course of a service repair operation involving the separation of the transmission from the engine, they would be likely to suffer thread stripping when tightened to the upper limit of recommended torque.

Should the occasion arise to separate the transmission from the engine in the course of a service repair operation, the affected bolts should be replaced by bolts of correct specification. Tests have indicated that there is little likelihood of the affected bolts failing in service.

IMPORTANT: TRANSMISSION UNITS SHOULD NOT BE REMOVED TO LOOK FOR ANY CONCERN. REPLACEMENT OF THE BOLTS CONCERNED IS ONLY REQUIRED AS A PRECAUTION IN THE EVENT OF MAJOR SERVICE REPAIRS.

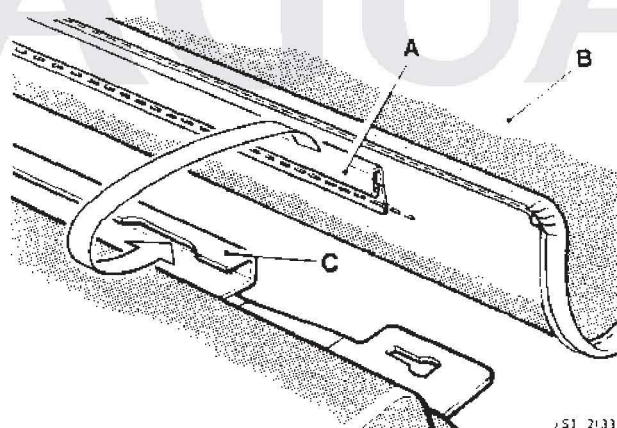
Fig. 1.

The carpet on the Passenger's side of the vehicle is similarly retained at the rear edge. Ensure that on a vehicle being prepared for the customer that the carpet has remained correctly fitted during the delivery cycle. Items 3-5 above should also be observed when refitting a carpet, or when fitting a replacement carpet.

Where the carpet is being refitted to a vehicle in service, or should it be necessary to fit a replacement carpet, items 3-6 above should be observed to ensure correct fitment.

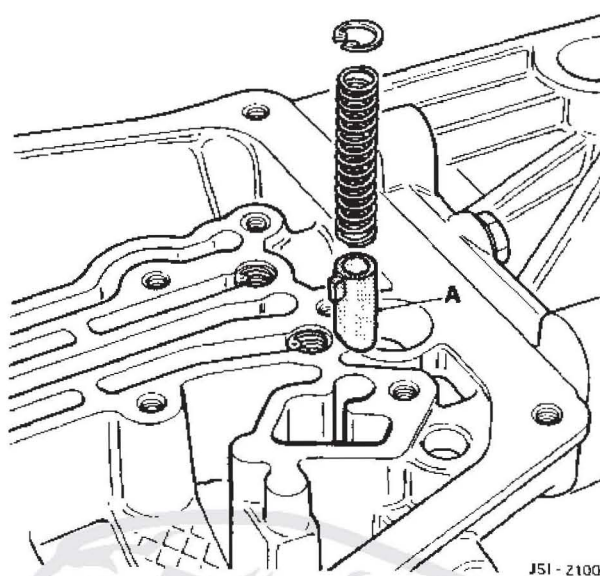
Should this seal be incorrectly fitted or restricted, it may interfere with the transmission fluid pressure so as to cause a partial engagement of the torque converter lock-up clutch; in turn, this may cause the engine to stall at low/idling RPM.

Remove the oil seal (Part No. JLM 863), Item A, Fig. 1.

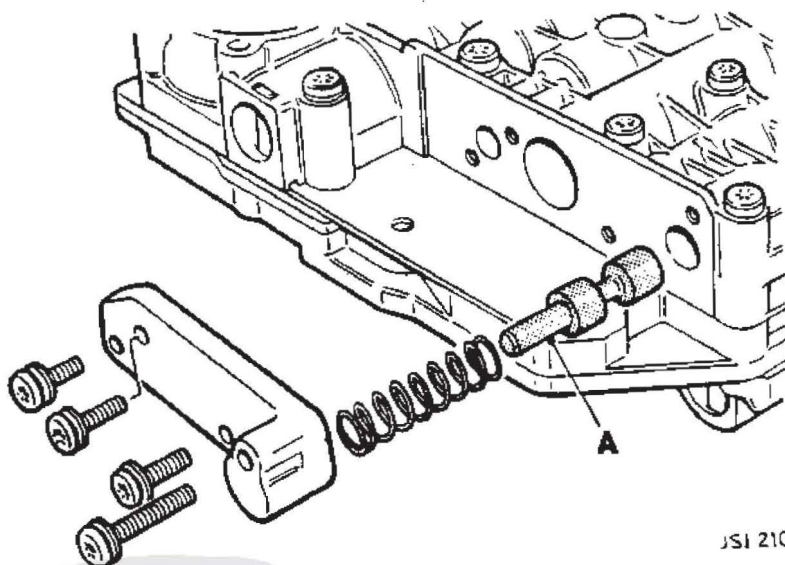
Fig. 2.

This valve controls the flow of fluid to the torque converter lock-up clutch. Should the valve stick, the resultant incorrect fluid flow may lead to the engine stalling at low RPM.

Should there be any tendency of the valve to stick, gently lap the valve until a smooth-running fit is achieved.

Thoroughly clean all parts; re-assemble using a new spring and oil filter.

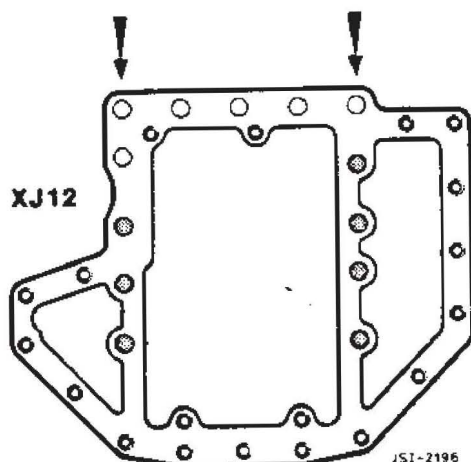
Fig. 1. XJ12 MODELS

In addition to the possibility of oil leakage at either of the above gaskets, oil may also spread upwards along the threads of certain bolts which retain the sandwich plate and baffle tray. The heads of the bolts are in contact with oil, while the tops of the threads in the crankcase are exposed externally. In the event of the oil sump being removed to allow replacement of either gasket, the threads of the bolts concerned should be sealed by the application of 'Loctite 542' sealer.

Torque setting: 21-27 Nm.

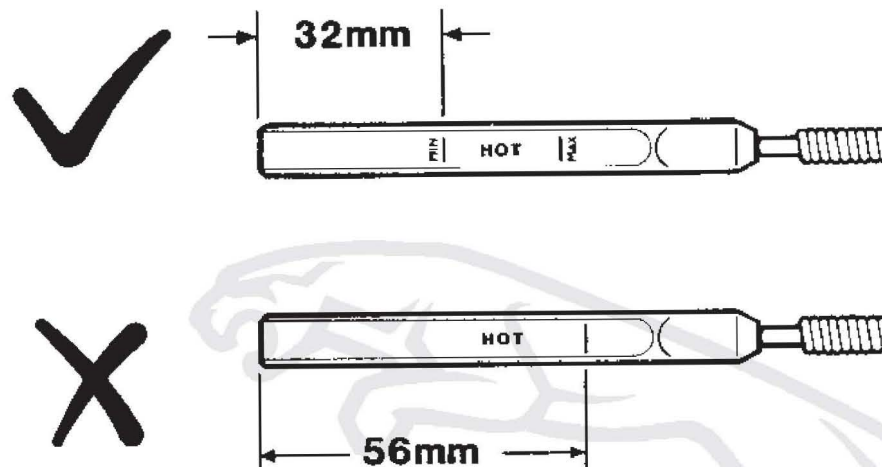
JSI-2207

CORRECT DIPSTICK: Measurement = 32 mm.

INCORRECT DIPSTICK: Measurement = 56 mm.

Where an incorrect dipstick is identified, it should be replaced by one of the correct specification, Part No. EBC 8409, the incorrect item being returned through normal Warranty channels.
