DATE: JULY 1992

REF: JD 08/92

## ERRATA

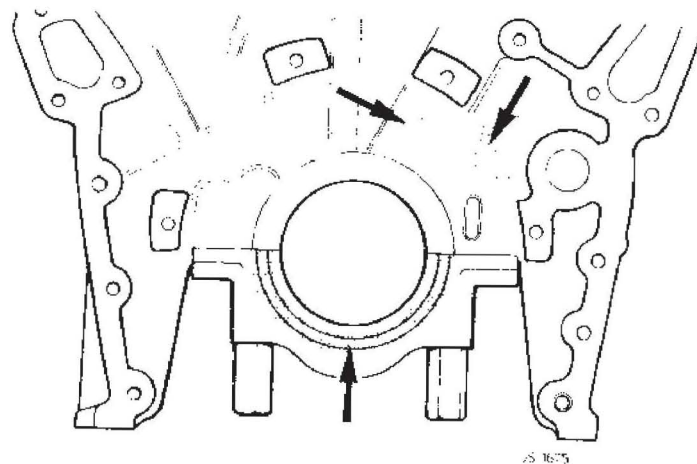
FIG 1

In most cases, the new pump can be used as a direct replacement with no modification to the block; however, in some cases, a foul condition may exist between the pump and certain areas of the old sand-cast block. To check for any foul condition, the pump should be offered in the correct position to the mounting bosses. If it lies flat against the bosses, the condition is correct. If the pump lies proud of the bosses, material should be removed from the foul area of the block (refer to shaded areas in Fig. 1 for possible foul areas) by careful use of a rotary file or similar implement.

Care should be taken when removing material to ensure that swarf produced by the operation is completely cleared from the area and that no other part of the engine, i.e. crank, main bearing, is damaged during the operation.

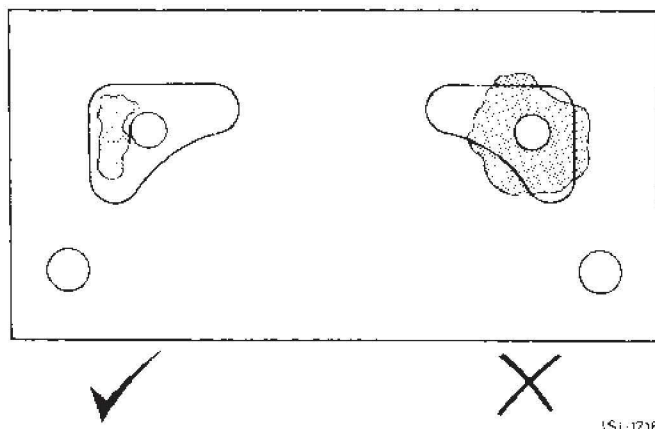
FIG. 2

If the erosion is within the cut-out the cylinder head should be refitted in the normal manner.

Dealers should ensure that Jaguar coolant / anti-freeze / corrosion inhibitor is used in the cooling system at the correct concentration, or, where this is not available, phosphate-free anti-freeze to BS 6580 should be used.

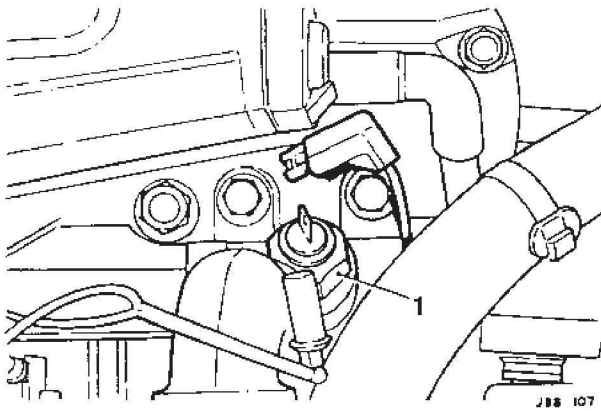
Fig 1

- MODEL** : XJS 4.0L AND V12 FACELIFT MODELS  
VIN RANGE 179737 TO 185038
- SUBJECT** : COOLANT TEMPERATURE GAUGE
- CUSTOMER CONCERN** : There is a tendency for the gauge to indicate a three-quarter or higher reading during normal driving conditions.

- DEALER ACTION** : Yes
- REPAIR METHOD** : COOLANT TEMPERATURE TRANSMITTER - RENEW
- Disconnect the battery negative lead.
- WARNING:** Do not remove the cap at the remote header tank unless the engine is cold.

- Remove and discard the seal / washer.
- Fit the new seal / washer to the replacement transmitter.
- Fit and tighten the transmitter.
- Reconnect the transmitter feed wire. Check / top up the coolant. Refit the pressure cap.

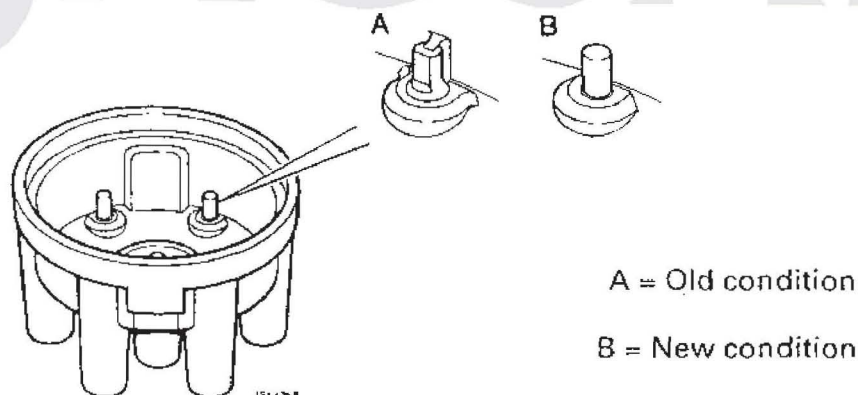
FIG 1

Distributor assemblies incorporating caps to the revised condition were progressively introduced from 1st April 1992 production build, with the following safe engine numbers and VINs provided:

Please note that the part number for the distributor cap, JLM 150, remains unchanged and is fully interchangeable on vehicles with engine numbers prior to those listed above.

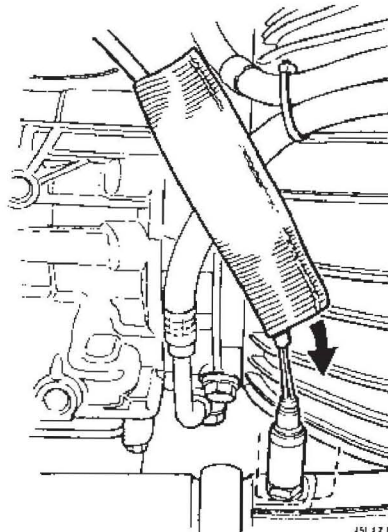
SLEEVE  
C. 33139/4

Following reports of the intermittent display of "Fuel Failure 44" on the instrument pack, it was found that this symptom could be caused by water penetrating the lambda sensor.

A lambda sensor splash-shield has been introduced from VIN 664941, which can be fitted retrospectively and should be installed whenever a lambda sensor is changed. This will reduce the possibility of water ingress.

The six-inch silver heat-proof sleeve is fitted by sliding it over the sensor, prior to its replacement. After the sensor has been fitted, Dealers should ensure that the sleeve is pushed fully back down to cover the whole sensor.

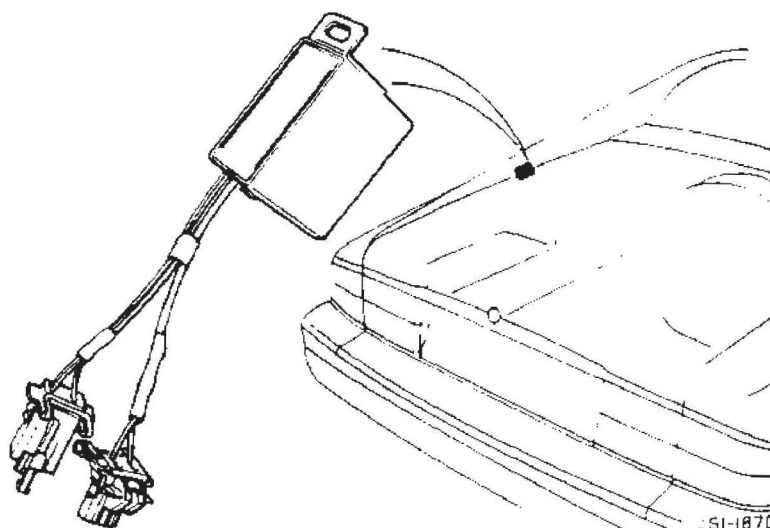
Fig 1

MODEL : XJS 4.0 LITRE MODELS ONLY  
SUBJECT : SPEED INTERFACE MODULE  
CUSTOMER CONCERN : Fuel Fail (FF) Code 68 registering at speeds in excess of 90 mph (144 kph).  
ADVICE TO CUSTOMER : A new interface module is now available and should be fitted to resolve this concern.  
DEALER ACTION : Yes  
REPAIR METHOD : Speed interface module – renew (XJS 4.0 litre only).  
\* Open the boot  
\* Disconnect the battery negative lead  
\* Remove the LH side trim panel  
\* Locate the speed interface module secured to the relay mounting bracket (See Fig. 1.)

- \* Remove the module and replace with new interface module, Part No. DAC 11375
- \* Replace the trim panel
- \* Reconnect the battery negative lead
- \* Close the boot
