Service Bulletin

REF: JD 26/93

SUBJECT : STEERING PULL

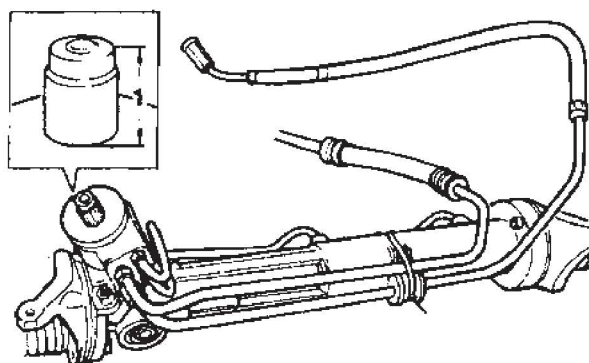
FIG. 1

The ZF Phase 2 Steering Rack (Fig. 1) is added to the 1994 MY specification. The rack body consists of two aluminium pressure diecastings; the rack mounting is unchanged. The pinion height (1, Fig. 1) is increased by 7mm; the steering column is altered to accommodate this change. The fluid pipe union positions in the valve block are also altered, with the fluid pipes being modified accordingly. The steering rack assembly is a non-serviceable item.

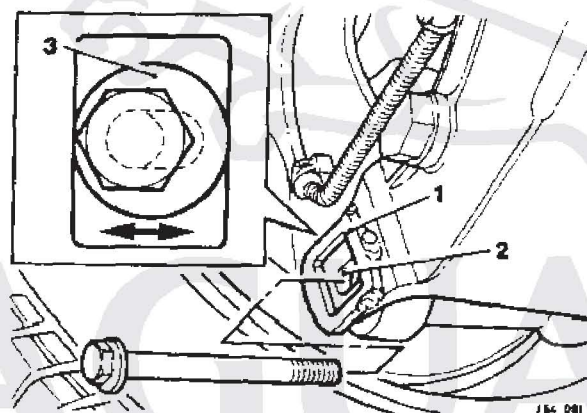
FIG. 2

The lower suspension arm has a plate, with a rectangular recess machined in the centre, added to the rear pivot eye (1, Fig. 2). The suspension arm pivot bolt hole (2, Fig. 2) is elongated, horizontally, at this point.

The pivot bolt has an integral eccentric (3, Fig. 2) below the bolt head, which, when in position in the plate, has a slight clearance at the sides but full clearance at the top and bottom. Rotation of the bolt head, with the eccentric constrained between the vertical faces, causes the bolt shank to be moved in the horizontal plane, thus displacing the hub carrier and effecting wheel alignment adjustment.

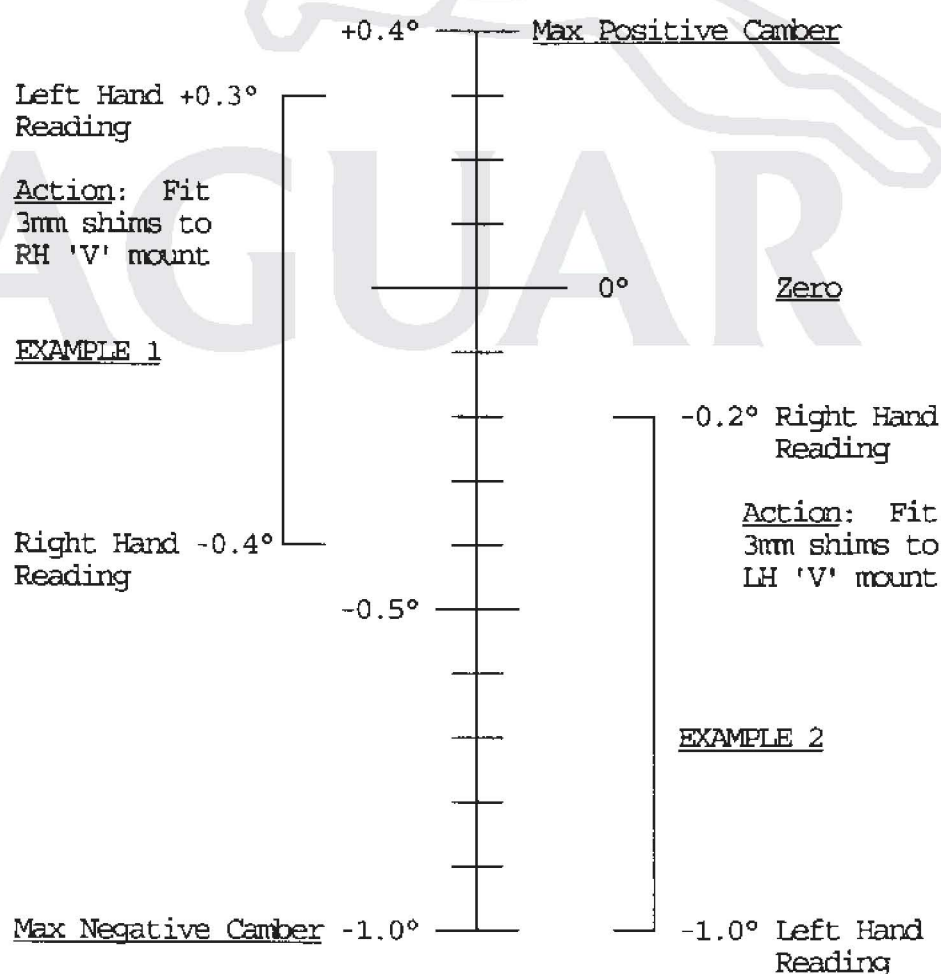
3. Calculate the camber imbalance by subtracting the lower or negative figure from the higher figure obtained.

See Fig. 1 below.

4. ADD shims to the side of the vehicle on which the GREATER NEGATIVE or SMALLER POSITIVE reading was obtained.

The objective is to reduce the measured camber imbalance by fitting a MAXIMUM of 3 adjustment shims. Each shim added corrects 0.1° of camber imbalance.
