Number	FF.1
Section	Automatic Transmission
Sheet	1 (of 1)
Date	May, 1960

TORQUE CONVERTER SETSCREWS

(All Automatic Transmission Models)

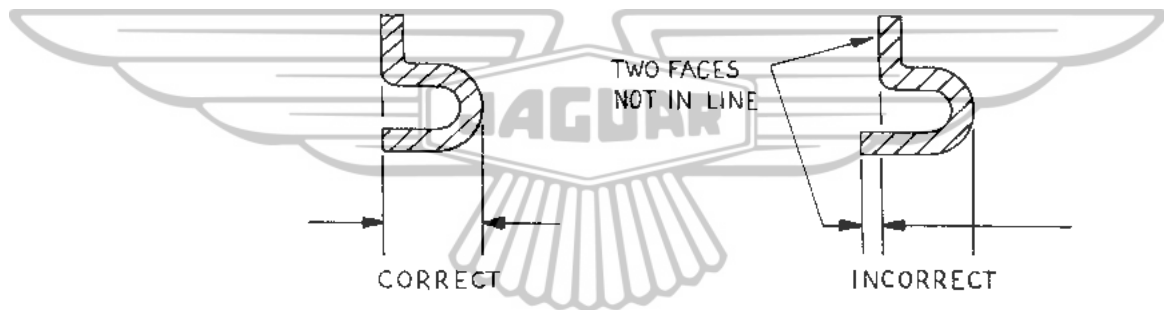
Information has been received from the Manufacturers of the Automatic transmission unit to the effect that some of the above units have been built with a dimensionally faulty rear clutch piston spring seat.

The fault is best described by reference to the sketches below.

The effect of this fault is to reduce the length in which the rear clutch spring has to operate, which, under adverse tolerance conditions of all the rear clutch components, can allow the spring to become solid before the rear clutch is fully engaged.

1. Soft 2 - 3 shift.
2. Breakaway on 3 - 2 shift.
3. Judder or clutch squawk in reverse.

When the rear clutch is stripped, the clutch piston spring seat should be checked and if the two faces are not in line within .020" (.508 mm.) should be discarded and replaced with a part that is correct to drawing.

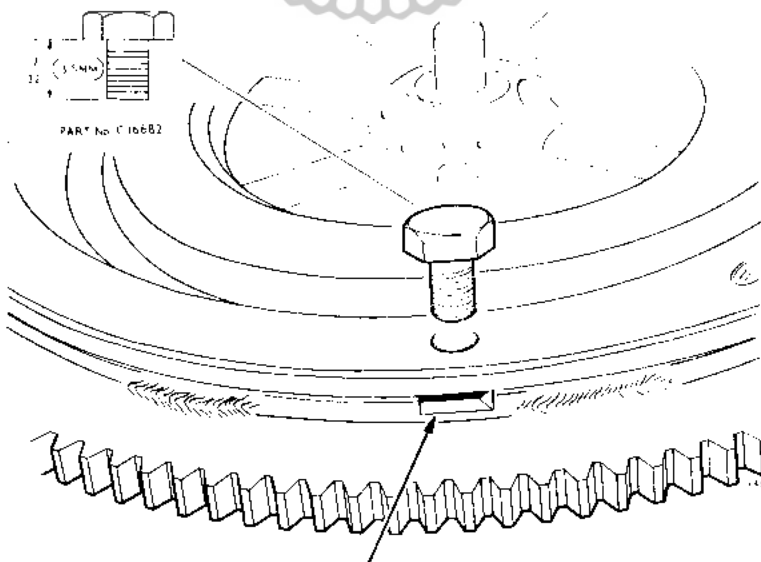
FIG 2

Torque converters are now secured to the drive plate with longer setscrews (Part number C.16682). To ensure full engagement of the longer thread, a cut-a-way is machined in the torque converter below each threaded hole as indicated by the arrow in Fig.2.

Note that it is ABSOLUTELY ESSENTIAL that the long setscrews which are $17/32''$ (13.5 mm) in length (see inset in Fig.2.) are not fitted to a torque converter which does not have cut-a-ways machined under the setscrew holes, otherwise the setscrews will bottom in the holes. A torque converter without the cut-a-way is illustrated in Fig.1; the $7/16''$ (11.1 mm) long setscrew which MUST be fitted to this type of converter is shown inset.

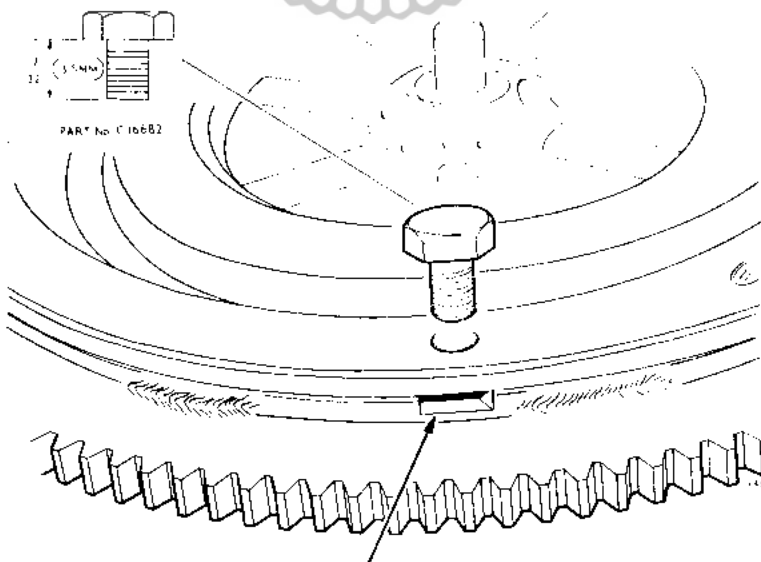
FIG 2

Torque converters are now secured to the drive plate with longer setscrews (Part number C.16682). To ensure full engagement of the longer thread, a cut-a-way is machined in the torque converter below each threaded hole as indicated by the arrow in Fig.2.

Note that it is ABSOLUTELY ESSENTIAL that the long setscrews which are $17/32''$ (13.5 mm) in length (see inset in Fig.2.) are not fitted to a torque converter which does not have cut-a-ways machined under the setscrew holes, otherwise the setscrews will bottom in the holes. A torque converter without the cut-a-way is illustrated in Fig.1; the $7/16''$ (11.1 mm) long setscrew which MUST be fitted to this type of converter is shown inset.
