Number G.2. (2nd issue)
Section Propeller Shaft

PROPELLER SHAFT JOINTS

J A G U A R
 S E R V I C E A N D S P A R E S O R G A N I S A T I O N
 S E R V I C E B U L L E T I N N O . 2 3 2

DIVIDED PROPPELLER SHAFT ALIGNMENT

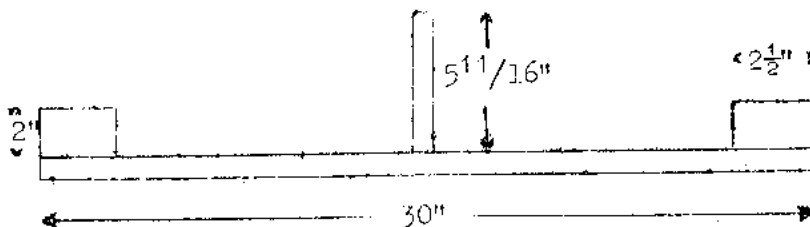
Check 1.

Check the distance from the bottom of the front flange of the front propeller shaft to the bottom faces of the longitudinal chassis side members. This distance should be $3.11/16" \pm 1/16"$ (93.5 mm \pm 1.5 mm). A simple checking jig can be made for checking this distance as shown in the following sketch.

If the propeller shaft flange is too LOW suitable packings can be fitted between the rear engine mounting rubbers and the mounting brackets at the top or bottom of the rubbers.

If the propeller shaft is too HIGH suitable packing can be fitted between the rear engine mounting cradle and the body floor.

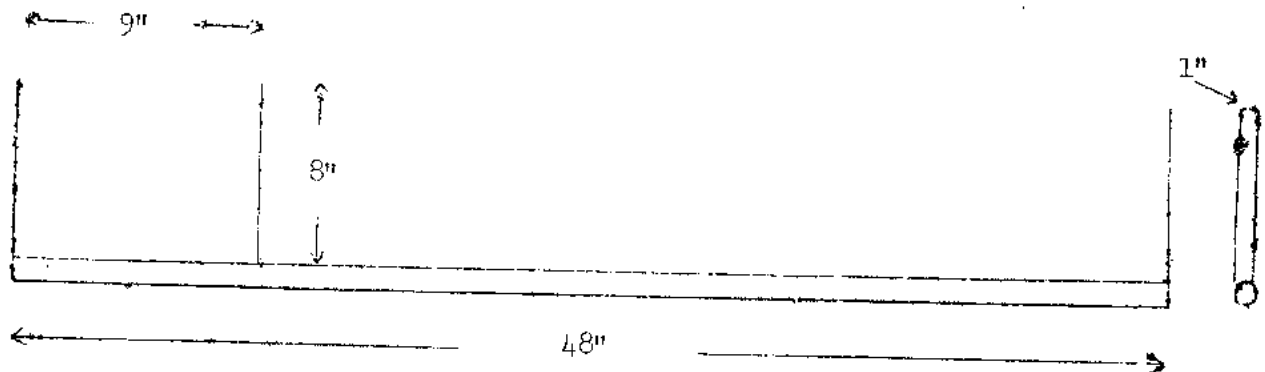
Check 2.

Check that the front and rear propeller shafts are in a straight line in the horizontal plane.

The most convenient way to do this is to make up a simple jig as shown in the following sketch. The jig consists of 3 pieces of flat bar 8" x 1" x 3/16" (20.5 cm x 2.5 cm x 4.75 mm) which are welded exactly in line on to a piece of tube of 1 1/8" (28.5 mm) outer diameter at the distances shown in the sketch. The jig is then held against the front and rear propeller shafts, with the two bars vertical, when any malalignment will be evident.

Alignment of the propeller shafts is carried out at the centre bearing bracket by elongating the two holes through which the setscrews pass to secure the bracket to the body floor. The position of the centre bearing bracket can then be adjusted to allow the propeller shafts to be aligned.
