Number I.1
Section Steering

FITTING TOOL FOR STEERING BOX TOP COVER

MODIFIED RACK AND PINION PRE-LOAD

INTRODUCTION OF MODIFIED UPPER STEERING COLUMN.

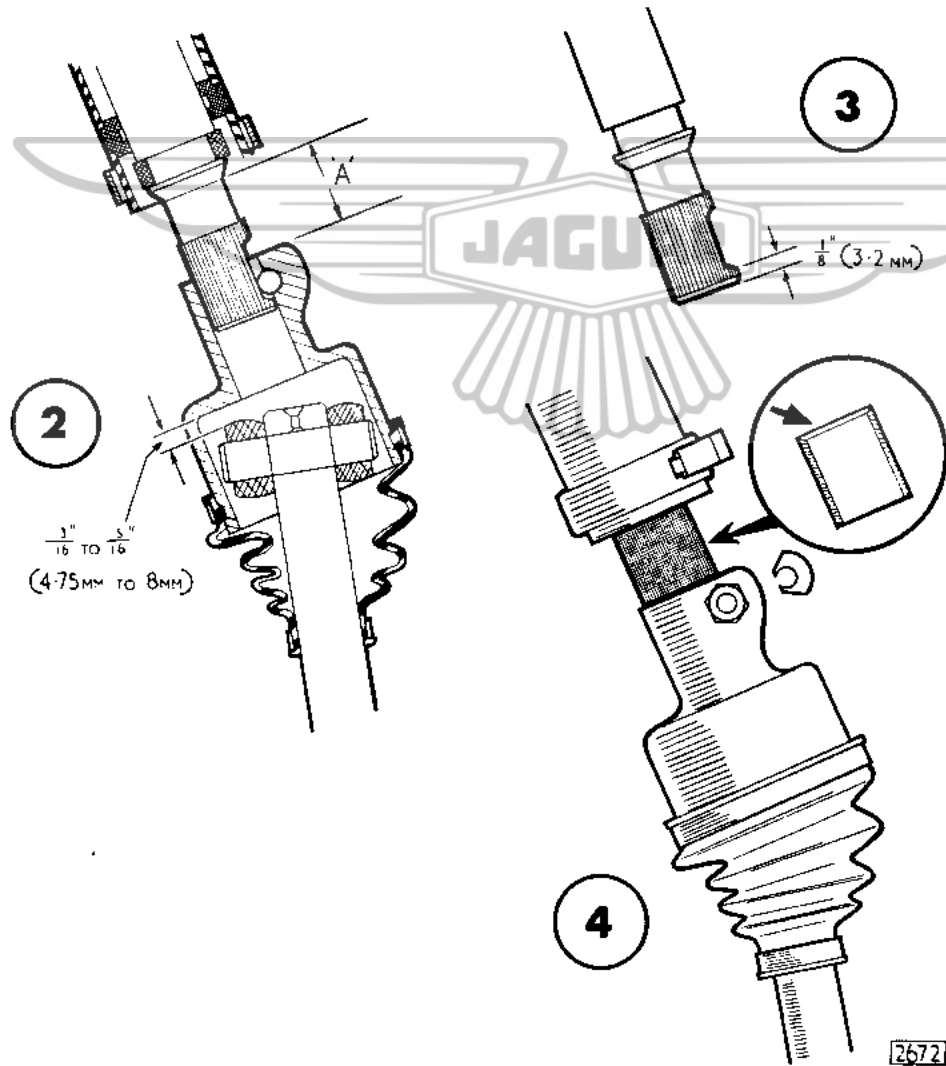
3. Measure the distance from the top machined face to the bottom machined face of the top joint socket on the lower steering column (See Fig.1). If it is less than $2.29/32"$ (7.38 cm) long a new socket (9980) should be fitted. (The socket to be replaced measures $2.21/32"$ (6.75 cm).

4. Press the top joint socket down until it bottoms and then raise towards the upper column until a minimum of $3/16"$ (4.76 mm) or a maximum of $5/16"$ (7.93 mm) movement is achieved. This movement will be controlled by the position of the upper steering outer column which can, if necessary be moved forward to meet the lower steering column by adjustment at the fixing bracket to the dash and loosening the securing clip (C.2905/4) on the scuttle.

Having achieved the condition described in the previous paragraph now measure the distance between the top machined face of the top joint socket and the bottom of the chamfer on the inner column ("A" Fig.2) to ascertain if the spacing collar (C.22698) which is $1.3/32"$ (2.78 cm) long can be fitted. If necessary the spacing collar can be reduced in length by cutting at the unchamfered end.
