| Section | Heating and Windscreen Washing Equipment |

WINDSCREEN WASHING EQUIPMENT - FROST PRECAUTIONS

INADEQUATE HEATING

**SEALING HEATER TO PREVENT FLOW OF HOT AIR WHEN CONTROL IS
IN THE "COLD" POSITION**

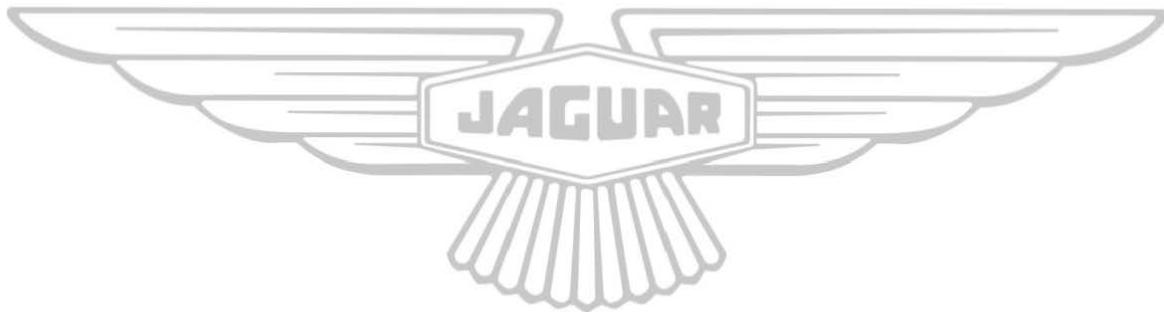
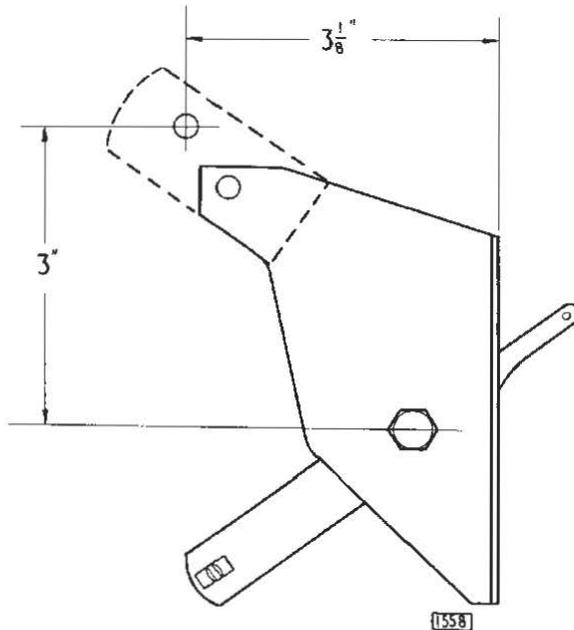
If complaints are received of insufficient heating and demisters blowing cold when the control is in the HOT position, carry out the following rectification procedure:-

- (1) Place the control in the "Hot" position.
- (2) Check the uppermost of the two levers on the engine side of the heater box for further travel. (Note: a small amount of extra travel due to compression of the foam rubber sealing strip is normal).
- (3) If extra travel exists this indicates that the heater flap is not closing fully and it will be necessary to carry out the following modification.
- (4) Remove the casing from the left-hand side of the heater panel by unscrewing the two knurled nuts. Detach the Hot-Cold knob by unscrewing the screw in the side of the knob. Remove the two nuts at the rear of the operating lever bracket and detach the bracket. Disconnect the cable and remove the outer cable clip.

- (5) Make up an extension strip from 16 S.W.G. (.064" - 1.6 mm) steel and weld or bolt it to the control lever bracket in the position shown.
- (6) Refit the outer cable clip to the hole in the extension strip.
- (7) Reconnect the cable and refit the bracket.
- (8) Re-check operation as described in paragraphs 1 and 2.

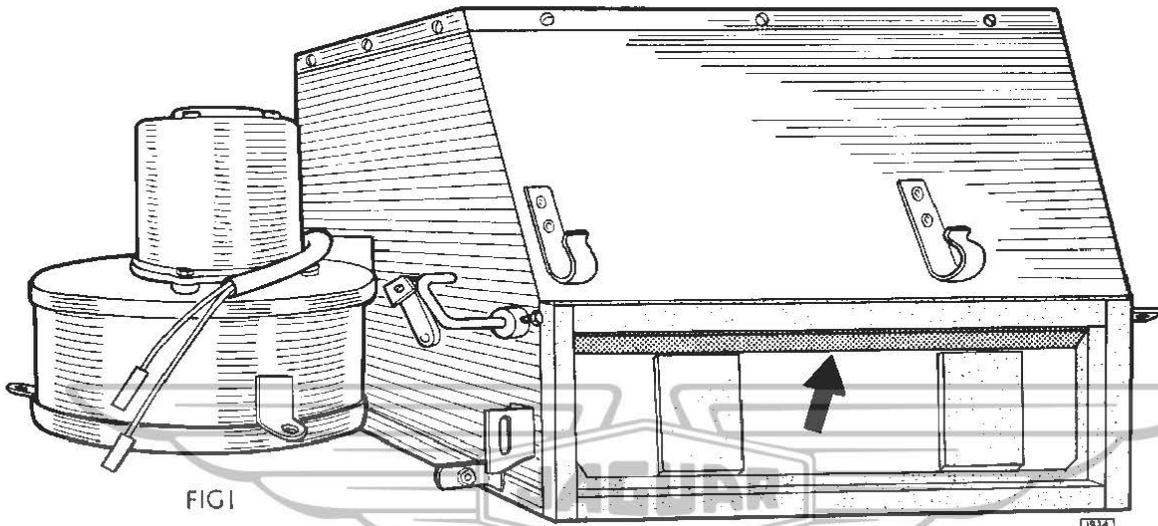
FIG 1

If on early Mark 2 cars not equipped with a water valve (see Service Bulletin number 0.2) trouble is experienced with the heater delivering warm air when the control is in the "cold" position the following procedure should be carried out:-

2. Affix a piece of polyurathene (Part number C.15966) to seal the gap at the hinge of the lower flap as shown in Fig.1.
3. Remove the end cover plate (11 screws) and affix a piece of polyurathene (Part number C.17408) to seal the gap adjacent to the upper flange hinge (see Fig.2.)
4. When replacing the heater matrix in the box ensure that the long strip of black felt affixed to one side of the matrix is uppermost.
