DATE: OCTOBER 1992

REF: JD 16/92

ERRATA

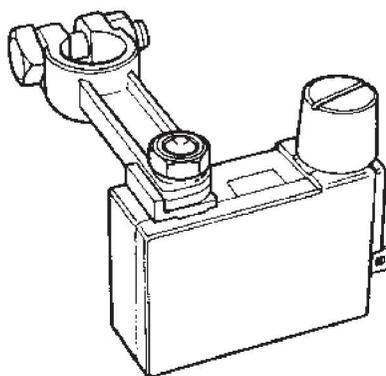
FIG 1

Owing to the relocation of the battery into the boot at 93 MY, a revised battery transit relay has been introduced, (see Fig 1).

The procedure for the removal of this new relay is as follows:

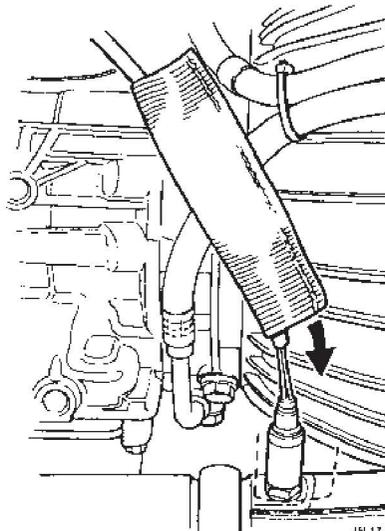
SLEEVE
C. 33139/4

Following reports of the intermittent display of "Fuel Failure 44" on the instrument pack, it was found that this symptom could be caused by water penetrating the lambda sensor.

A lambda sensor splash-shield has been introduced from VIN 664941, which can be fitted retrospectively and should be installed whenever a lambda sensor is changed. This will reduce the possibility of water ingress.

The six-inch silver heat-proof sleeve is fitted by sliding it over the sensor, prior to its replacement. After the sensor has been fitted, Dealers should ensure that the sleeve is pushed fully back down to cover the whole sensor.
