REF: JD 02/91

REF: JD 08/92

ISSUE NO: JD 18/92

- MODEL** : XJS ALL MODELS
- SUBJECT** : WINDOW LIFT MOTOR / REGULATOR ASSEMBLIES
- CUSTOMER CONCERN** : Poor operation / sticking / noisy.
- ADVICE TO CUSTOMER** : Installation of a revised motor or a motor regulator assembly (which incorporates a new motor) will overcome sticking or noisy operation.
- New window lift motors have been introduced in production from VIN 184117.
- DEALER ACTION** : Yes.
- REPAIR METHOD** : Window lift assemblies incorporating the new motor are fully interchangeable with previous assemblies. All motors will be supplied with the necessary additional parts for fitment to vehicles prior to VIN 184117. If the new motor is required to be fitted to vehicles after VIN 184117, the additional parts supplied with the kit should be discarded. For details of part numbers and components relative to VIN, please refer to "Parts Information" below.

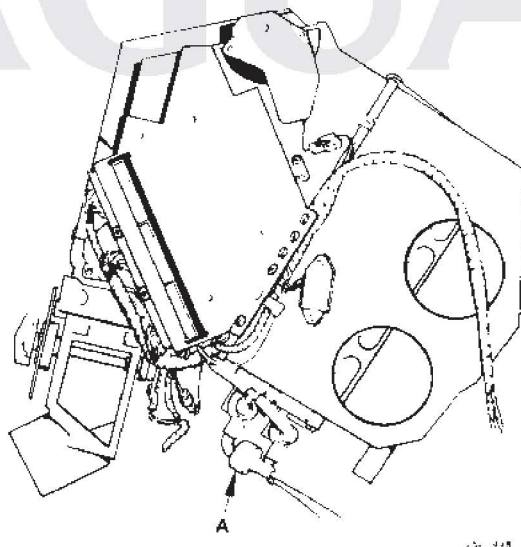
1. Please note that the restrictor valve detailed in kit JLM 2295 reads CCC 3587; this should read CCC 3537.
2. An error has also been noted whereby the installation details for valve CCC 3587 have been omitted.

With the right hand side centre console panel removed, locate the centre vent restrictor valve (blue ident) = (A). See illustration on following page.

Note which direction the blue ident is positioned.

Remove the blue restrictor and replace with the yellow restrictor (CCC 3537), install the restrictor in the same orientation.

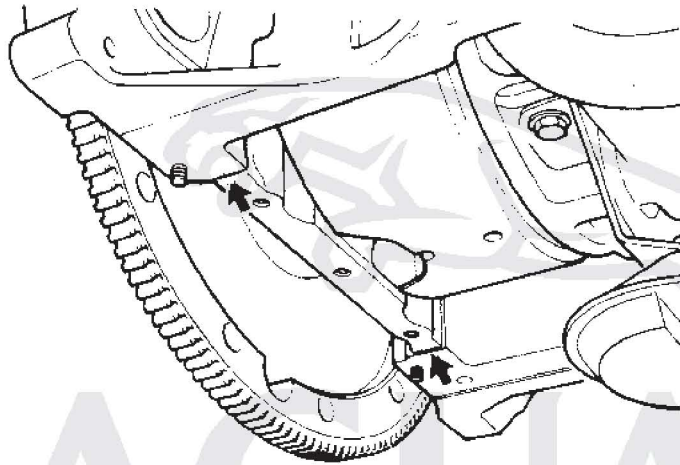
FIG 1

When removing or replacing the sump sandwich plate gasket, would Dealers please note that to help prevent the possibility of oil leaks, additional RTV sealant should be applied as follows:-

A bead of RTV sealant approximately 3 mm wide and 10 mm long should be applied in the middle of the joint line between the cylinder block and the rear main bearing cap in two positions (Fig 1) before the sump sandwich gasket is fitted.

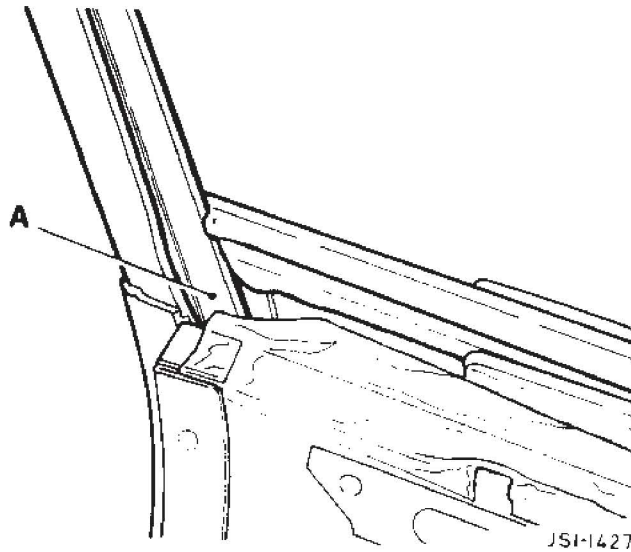
FIG 1

Service reports have identified some incidence of door glass sticking and juddering whilst it is being powered up and down. The reports also point out that the adjustments incorporated within the window lift assembly do not, in all cases, provide an effective means of eliminating the problem.

1. Remove the door trim (refer to S.R.O. 76 34 01) to gain access to the door glass window lift regulator assembly.
2. Disengage the regulator assembly from the door glass and allow it to rest in the lower door panel.
3. Place hands on either side (surface) of the door glass, then move the glass up and down. Refer to Fig 1, Point 'A'. The glass movement becomes restricted at this point as full contact is made between the glass and upper to lower guide channels. Close observation of the glass channel seal at the foul point 'A' will invariably show signs of pressure marking and wear.

Note: When excessive wear is apparent on the inner surface of the seal, it MUST be renewed.

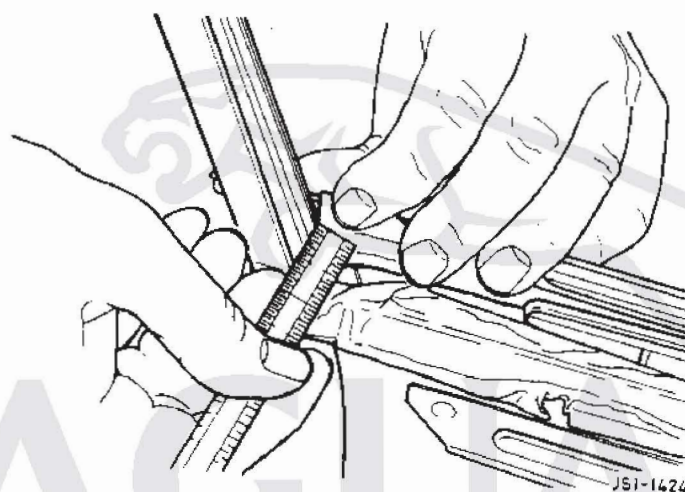
FIG 4

8. If this dimension is less than 19.5 mm, the door glass movement will still be restricted at this point. Should this dimension be correct, items 9 to 11 can be disregarded. When this width is less than 19.5 mm, the door/window frame channel will have to be opened out.
9. To open out this channel, insert a 15 mm thick steel drift approximately 12 cm long x 25 mm wide into the channel as shown in Fig 5.

7. Refer to Fig 4; using an engineer's steel rule, measure the external width of the frame as shown. The correct dimension should be 19.5 to 20.5 mm.

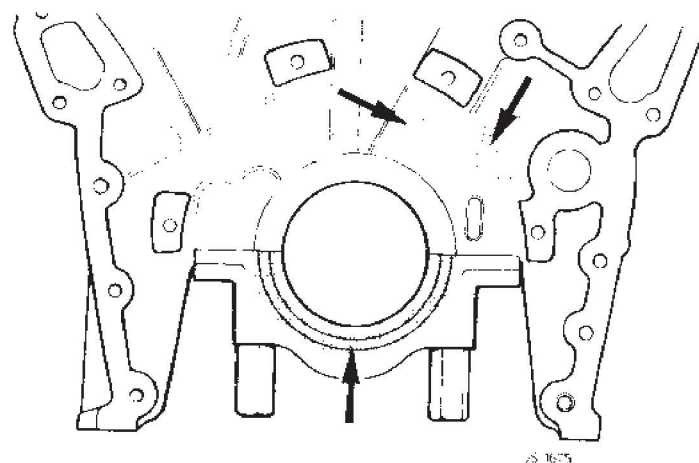
FIG 1

In most cases, the new pump can be used as a direct replacement with no modification to the block; however, in some cases, a foul condition may exist between the pump and certain areas of the old sand-cast block. To check for any foul condition, the pump should be offered in the correct position to the mounting bosses. If it lies flat against the bosses, the condition is correct. If the pump lies proud of the bosses, material should be removed from the foul area of the block (refer to shaded areas in Fig. 1 for possible foul areas) by careful use of a rotary file or similar implement.

Care should be taken when removing material to ensure that swarf produced by the operation is completely cleared from the area and that no other part of the engine, i.e. crank, main bearing, is damaged during the operation.

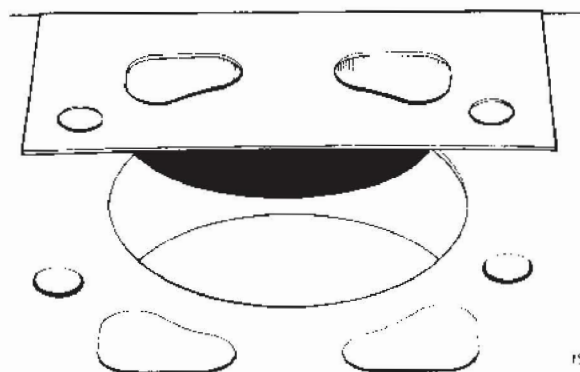
FIG. 1

On removal of AJ6 cylinder heads for service work, it has been reported that in some cases a certain amount of erosion exists on the gasket face around the inlet side water jacket holes.

Make a paper template of the cored holes in the cylinder block that correspond with the affected water holes in the head. To orientate the template to the head water holes, include the cylinder head bolt holes on the template. (See Fig. 1)

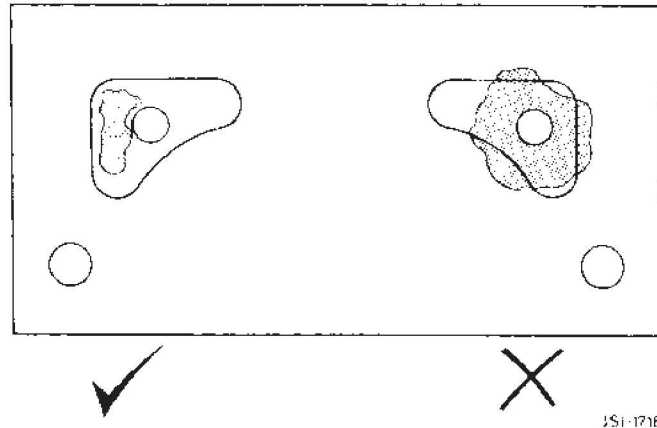
FIG. 2

ONLY IF THE EROSION ON THE HEAD OVERLAPS THE CORED HOLE CUT-OUTS SHOULD THE HEAD BE CHANGED.

If the erosion is within the cut-out the cylinder head should be refitted in the normal manner.
