Service Bulletin

JAGUAR

Date JANUARY 1984
Sheet 1 of 9
Bulletin JD.01/84

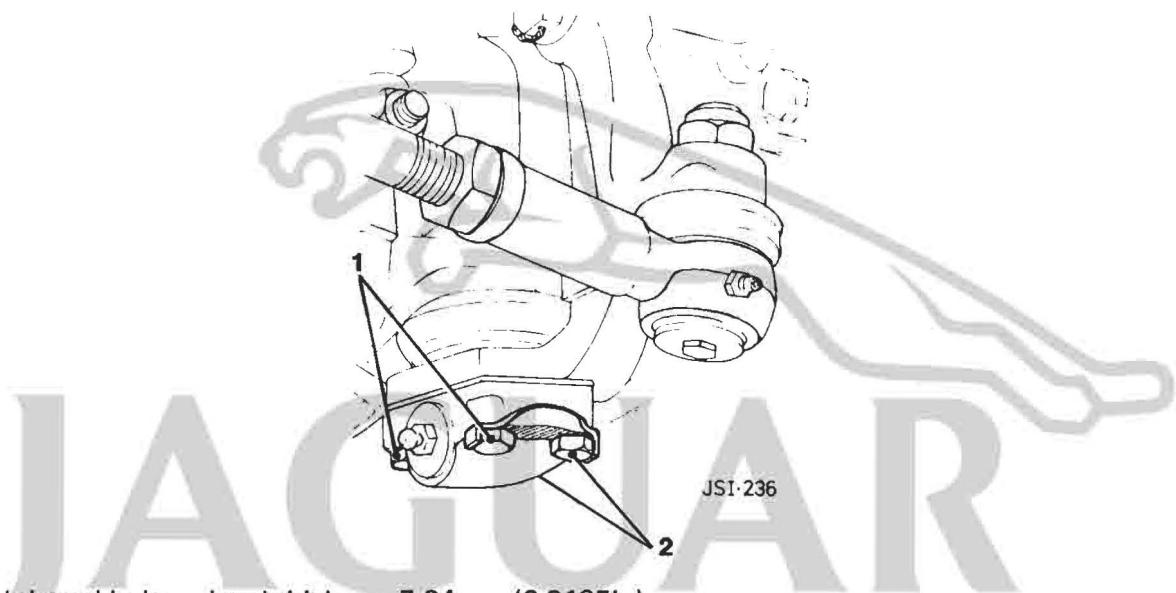
The bolts securing the lower ball pin cap to the stub axle carrier may on some vehicles be in a mixed condition, i.e. the head of the bolts are of different thicknesses 7.94mm (0.3125in) and 4.76mm (0.1875in).

1. Inboard bolts – head thickness 7.94mm (0.3125in)
2. Outboard bolts – head thickness 4.76mm (0.1875in)

It is important that if any of these bolts are removed during service, they should be replaced in the correct position – see diagram.

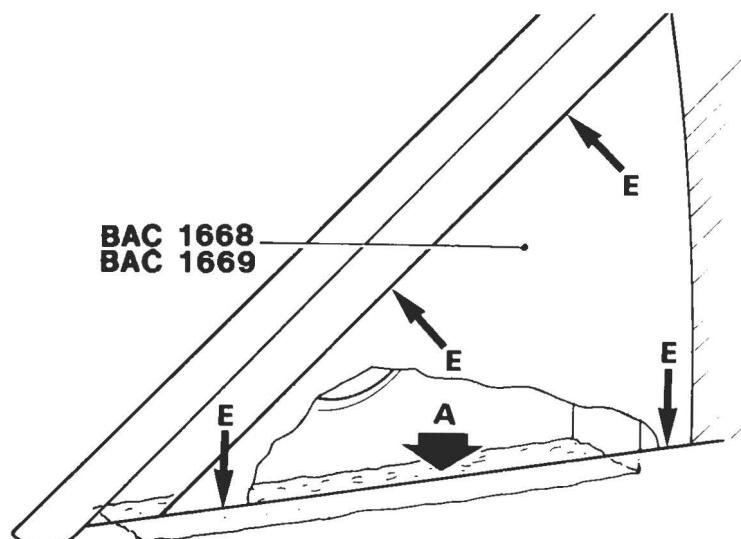
3. Water ingress and wind noise glass channels – All Doors – Series III & XJ-S (Fig. 3)

In most instances this is caused by gaps behind the window seals (BAC 1562 Series III, BD 46041 XJ-S), particularly at top corners.

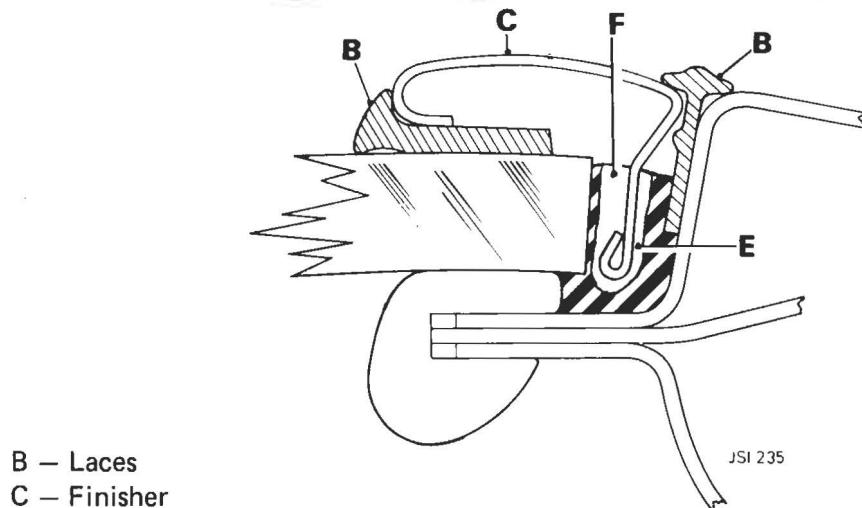
B — Laces
C — Finisher

This complaint is caused by poor adhesion of Betaseal to screen and/or aperture.

Major repair of this fault is detailed in Service Bulletin JD 05/81 Item 35. However, local rectification of small leaks may be carried out using the following method:

- A Identify area of leakage
- B Remove inner and outer lace.
- C Remove the relevant bright finisher.
- D Carefully cut a section of Betaseal from the suspected leak area, prime and apply new Betaseal.

- E A further section of Betaseal will have to be cut out to allow re-fitment of the bright finisher.
- F Apply new Betaseal. Refit finisher. Re-fit laces.

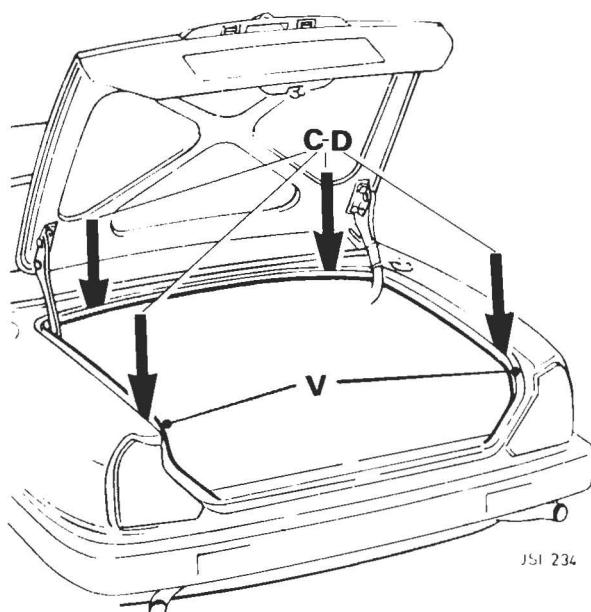
JSI 234

This problem is caused by porosity in the channel seams or a badly fitted boot seal.

- A Apply sealant "C" or "D" to all seams around the boot channels. Allow to dry and paint as necessary (Fig. 13).
- B If a leak is apparent between the seal and boot lid at point "V", this is due to overstretching the seal when fitting. The old seal should be discarded and a new seal fitted, taking care to avoid stretching on curves.

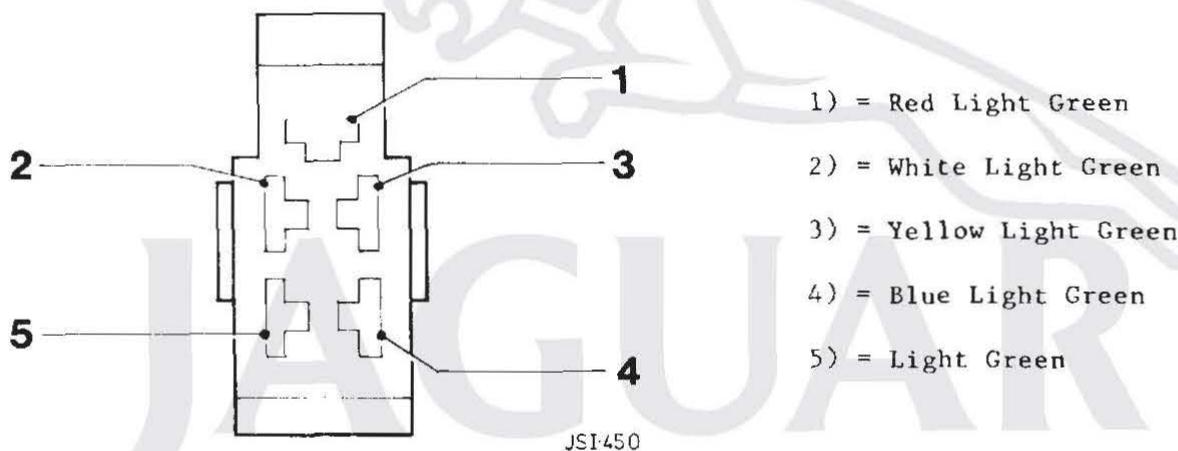
Correct Condition

Investigations have identified that certain AEU 1731 kits were equipped with an incorrect adaptor harness which caused a short circuit to occur when fitted.
