Service Bulletin

Date MAY 1984
Sheet 1 of 2
Bulletin JD.05/84

XJ-S/XJ-SC

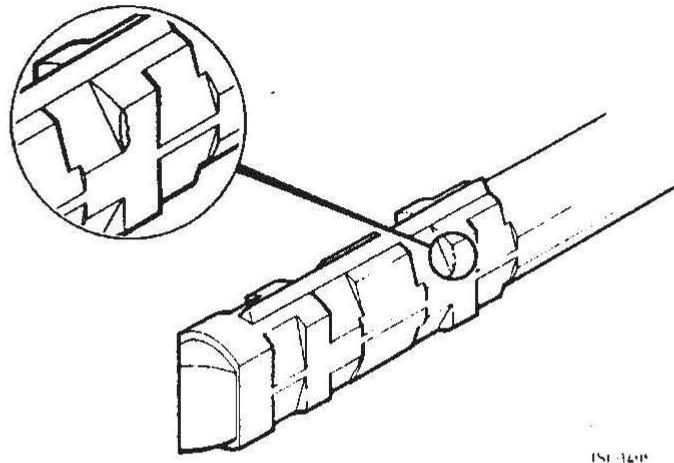
FIG 1

Reports have been received of keys sticking, baulking or not turning in the lock, as a result of key damage, in particular to the edge of the No.1 key cut – see Fig 1:-

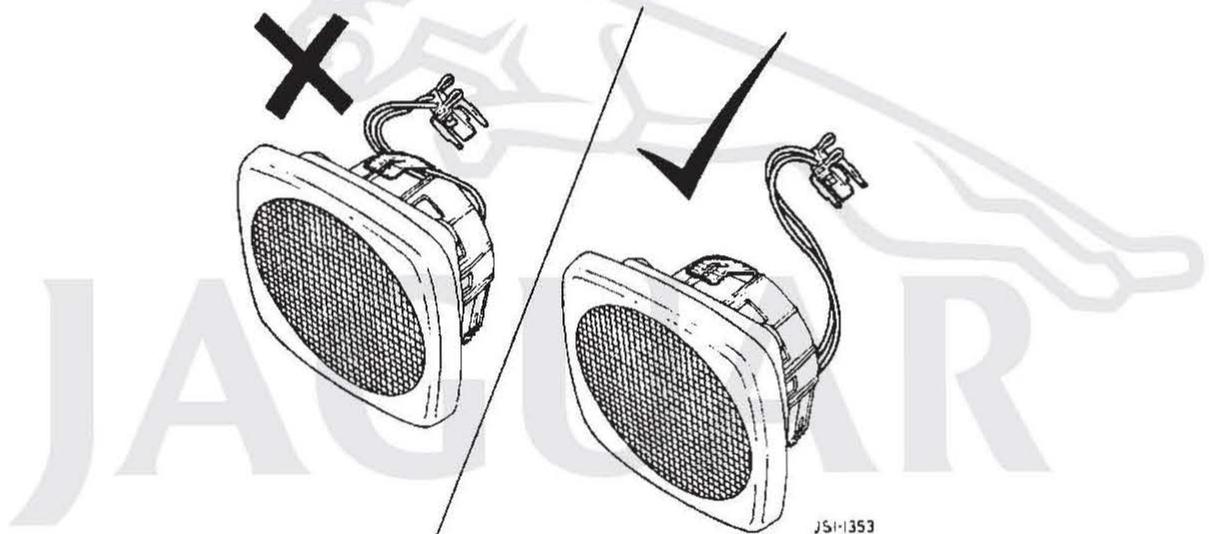
FIG 1

If the wiring is trapped between the speaker housing retaining clips (Fig 1) and the steel heelboard panel, the insulation may wear away, allowing the wire to ground.

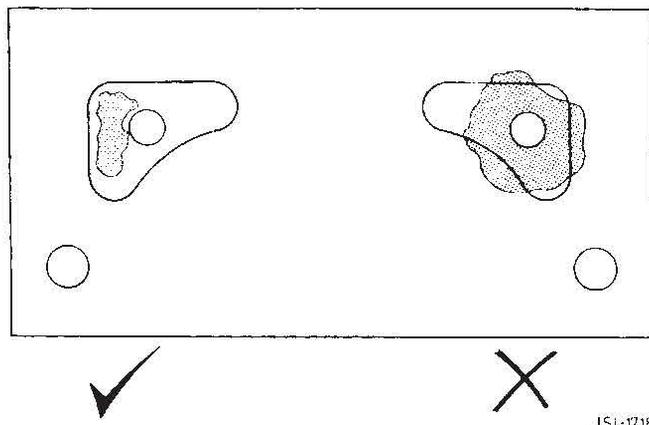
FIG. 2

If the erosion is within the cut-out the cylinder head should be refitted in the normal manner.

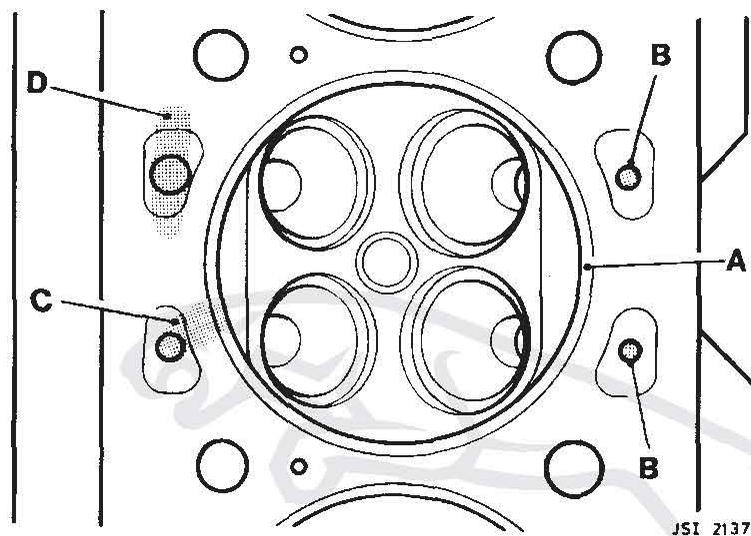
Fig. 1.

On engines prior to VIN 677386 (XJ6) and VIN 187554 (XJS) the foundry practices involved in the manufacture of the cylinder head and the cylinder block resulted in elongated cored coolant passages at the upper face of the cylinder block, facing small diameter drilled passages in the cylinder head, separated by the gasket. Coolant flow between cylinder block and cylinder head is controlled by the diameter of the holes in the cylinder head gasket (Item B, Fig. 1.)

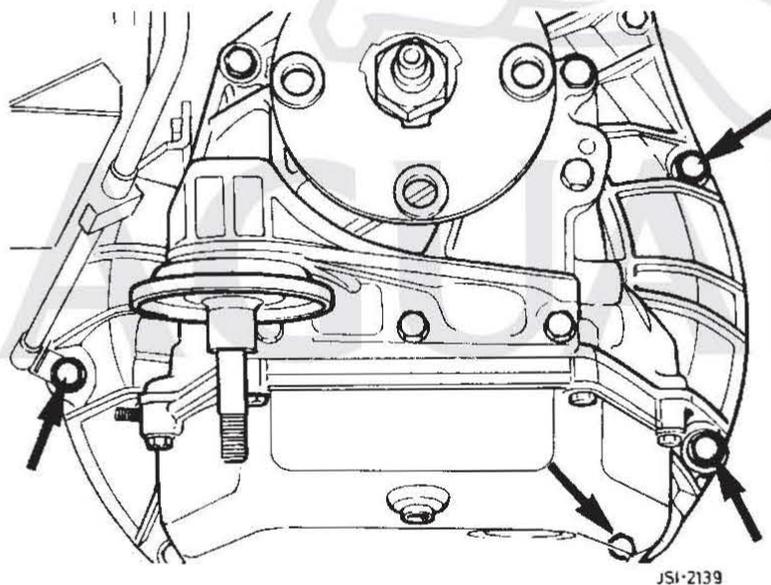
On a number of the above models, manufactured during November and December 1993, four of the ten bolts which fix the automatic transmission convertor housing to the intermediate plate have been found to be of incorrect material specification. The bolts concerned are indicated by arrows in the illustration below.

The suspect bolts are black in colour; if refitted in the course of a service repair operation involving the separation of the transmission from the engine, they would be likely to suffer thread stripping when tightened to the upper limit of recommended torque.
