Service Bulletin

Date JANUARY 1984
Sheet 1 of 9
Bulletin JD.01/84

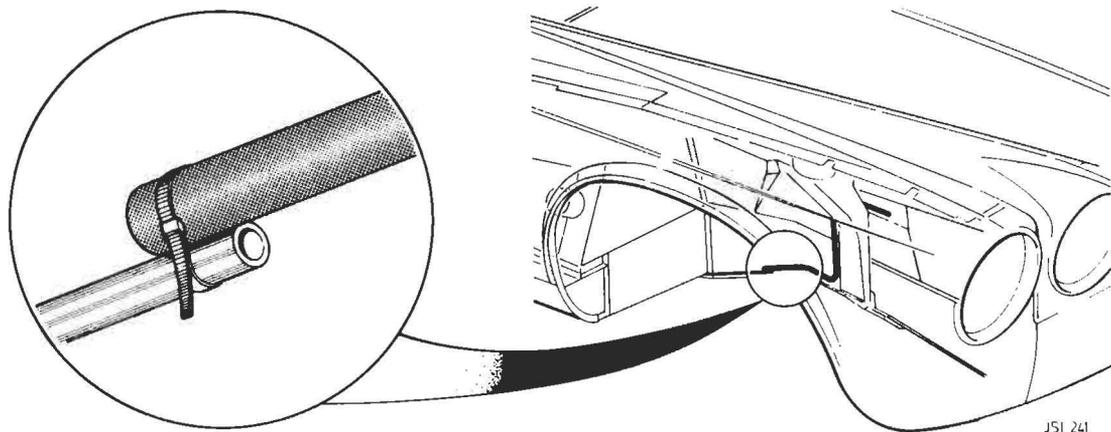
For saloon models only, the breather pipe from the fuel tanks to the carbon canister will be disconnected for transit purposes.

The flexible breather pipe situated to the rear of the right hand wheel arch must be connected to the steel bundy pipe at P.D.I.

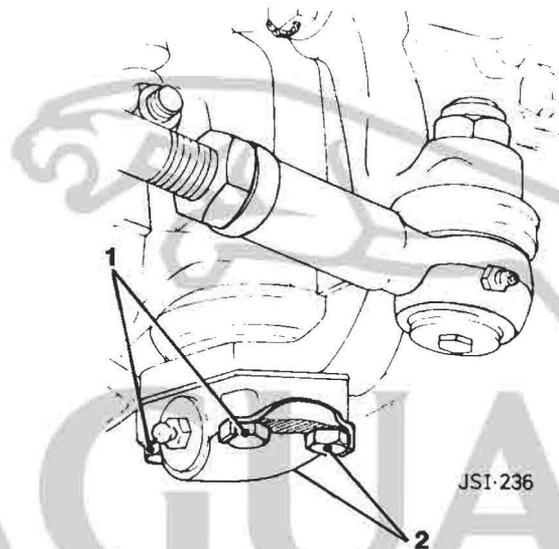
The bolts securing the lower ball pin cap to the stub axle carrier may on some vehicles be in a mixed condition, i.e. the head of the bolts are of different thicknesses 7.94mm (0.3125in) and 4.76mm (0.1875in).

1. Inboard bolts – head thickness 7.94mm (0.3125in)
2. Outboard bolts – head thickness 4.76mm (0.1875in)

It is important that if any of these bolts are removed during service, they should be replaced in the correct position – see diagram.

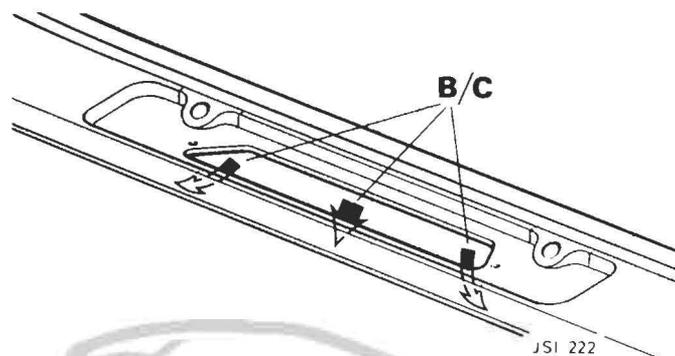
If the seams in this chamber are inadequately sealed, water can enter the vehicle footwells whenever the vehicle is exposed to heavy rainfall.

1. Remove plenum grille (Series III Workshop Manual Operation 80-15-29, XJ-S Workshop Manual Operation 84-15-12 – Items 1–7).
2. Apply sealant B or C by brush into all seams inside the chamber (Fig. 1).
3. Replace grille.

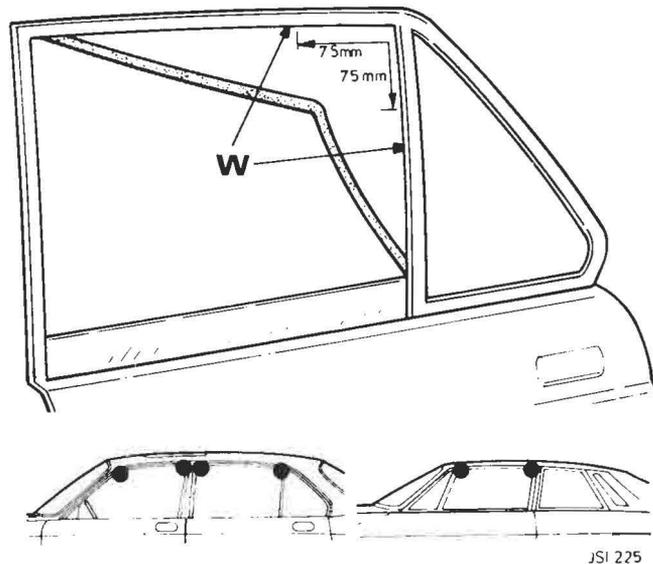
3. Water ingress and wind noise glass channels – All Doors – Series III & XJ-S (Fig. 3)

In most instances this is caused by gaps behind the window seals (BAC 1562 Series III, BD 46041 XJ-S), particularly at top corners.

- A Remove glass seal at points marked "W" (Fig. 3).
- B Apply sealant "E" into the channel corner and spread a bead 75mm (3in) from the corner in sufficient quantities to allow extrusion when the seal is refitted. Carefully clean off any surplus sealant.

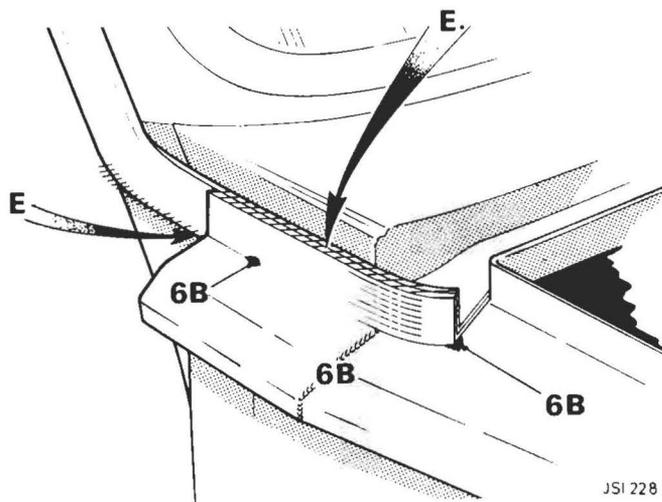
7. Water ingress via seams at "A" post waist — XJ-S (Fig. 7)

Identification and rectification of water leaks in this area have been detailed in Service Bulletin JD 07/82 Item 53.

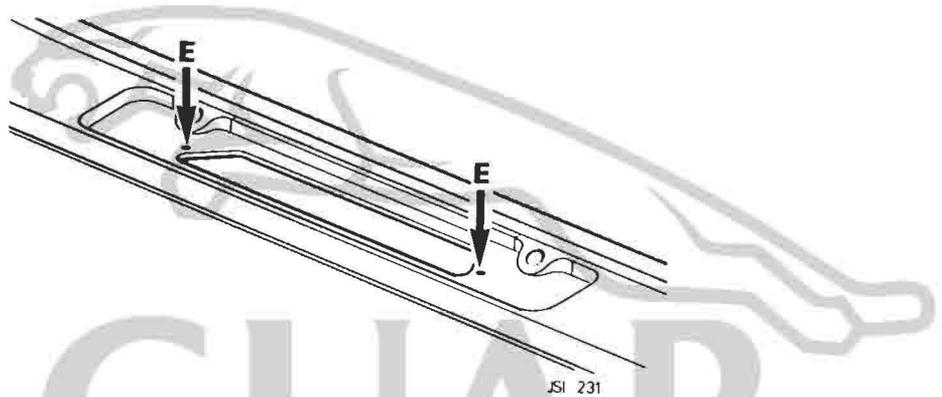
8. Water ingress via plenum grille mounting pin holes – Series III only (Fig. 8)

This may arise due to inadequate sealing around the two mounting pin holes, allowing water to enter the vehicle via the double skin.

- A Remove plenum grille (Workshop Manual Operation 80-15-29).
- B Remove two plastic inserts BD 26989.
- C Apply sealant "E" by brush to seal around the holes.
- D Allow ten minutes to dry and reassemble.

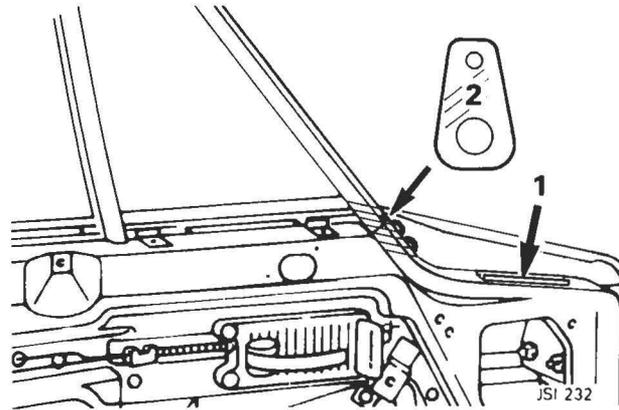
9. Water ingress and/or wind noise between door and "A" post at waist – XJ-S only (Fig. 9)

- A Remove and discard the door drain channel and plug the three redundant holes in the door, and paint as necessary (1 Fig. 9).
- B Test the vehicle to establish if the fault has been rectified.
- C If the fault is still apparent, remove the peardrop seal (2 Fig. 9).
- D Apply a proprietary body filler to the joint, DRESS OFF WHEN HARD TO ENSURE A GOOD PROFILE, refit screw and paint as necessary. This action, if properly carried out, will eliminate water leaks in this area.

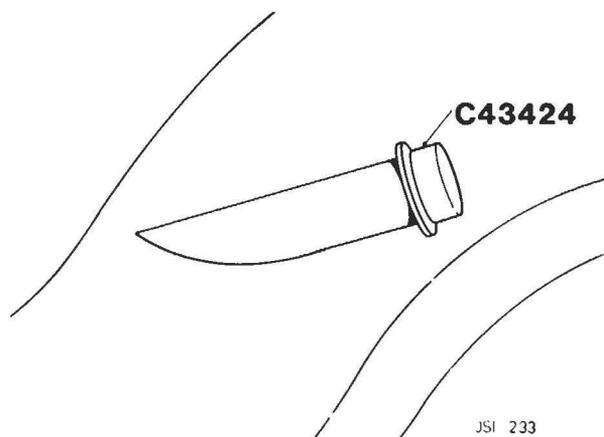
10. Water ingress via handbrake cable tube – XJ-S only (Fig. 10)

This complaint is caused by inadequate sealing of the cable exit, and/or blanking cap not being fitted. This area should be examined if water ingress is apparent in rear footwells only.

- A Check the sealing cap of the tube from which the cable exits, and rectify any leaks.
- B Check the plug C43424 for security over the blanking hole and rectify as necessary to ensure complete sealing.

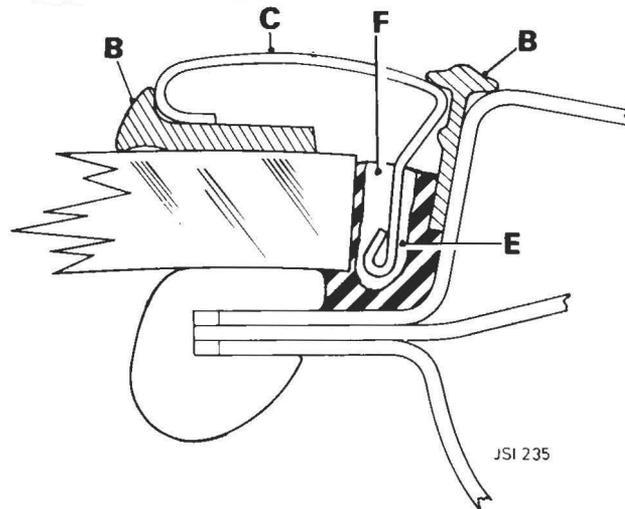
11. Water ingress via windscreens – Series III only (Fig. 11)

This complaint is caused by poor adhesion of Betaseal to screen and/or aperture.

Major repair of this fault is detailed in Service Bulletin JD 05/81 Item 35. However, local rectification of small leaks may be carried out using the following method:

- A Identify area of leakage
- B Remove inner and outer lace.
- C Remove the relevant bright finisher.
- D Carefully cut a section of Betaseal from the suspected leak area, prime and apply new Betaseal.

- E A further section of Betaseal will have to be cut out to allow re-fitment of the bright finisher.
- F Apply new Betaseal. Refit finisher. Re-fit laces.

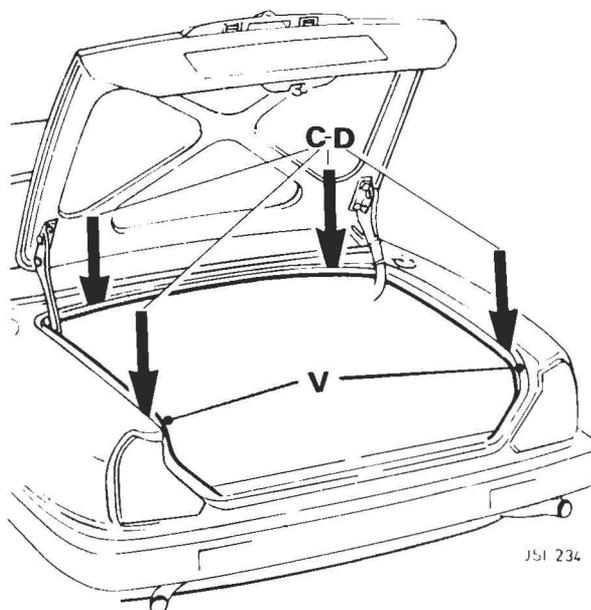
This problem is caused by porosity in the channel seams or a badly fitted boot seal.

- A Apply sealant "C" or "D" to all seams around the boot channels. Allow to dry and paint as necessary (Fig. 13).
- B If a leak is apparent between the seal and boot lid at point "V", this is due to overstretching the seal when fitting. The old seal should be discarded and a new seal fitted, taking care to avoid stretching on curves.
