Service Bulletin

Date JANUARY 1984
Sheet 1 of 9
Bulletin JD.01/84

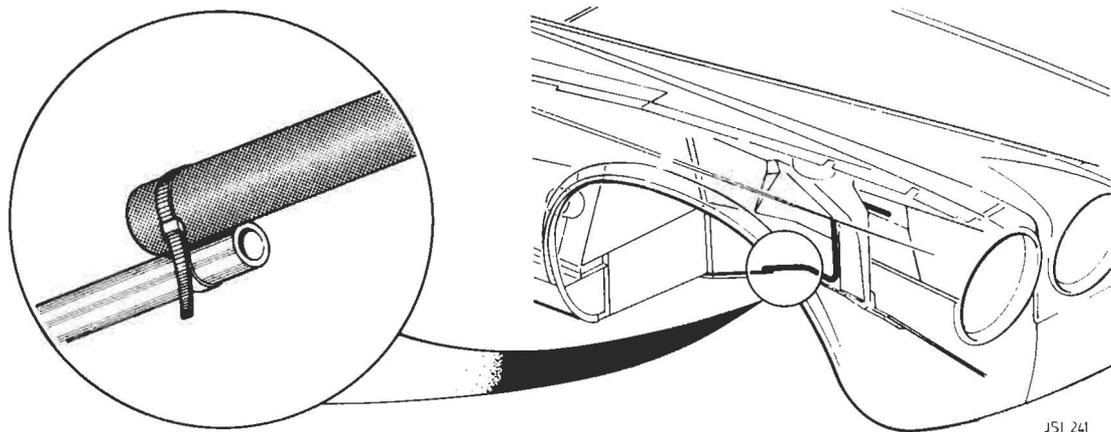
For saloon models only, the breather pipe from the fuel tanks to the carbon canister will be disconnected for transit purposes.

The flexible breather pipe situated to the rear of the right hand wheel arch must be connected to the steel bundy pipe at P.D.I.

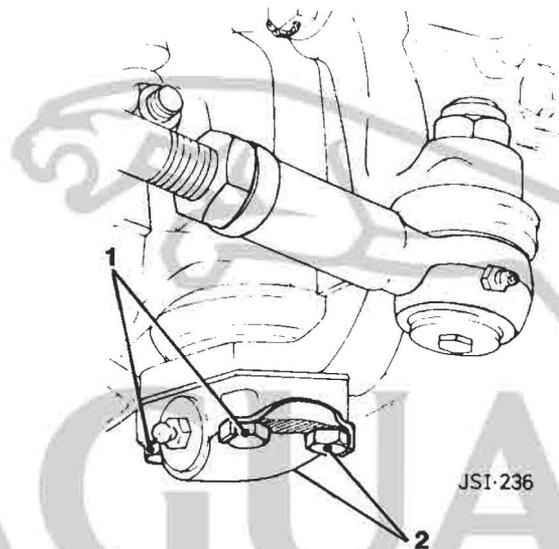
The bolts securing the lower ball pin cap to the stub axle carrier may on some vehicles be in a mixed condition, i.e. the head of the bolts are of different thicknesses 7.94mm (0.3125in) and 4.76mm (0.1875in).

1. Inboard bolts – head thickness 7.94mm (0.3125in)
2. Outboard bolts – head thickness 4.76mm (0.1875in)

It is important that if any of these bolts are removed during service, they should be replaced in the correct position – see diagram.

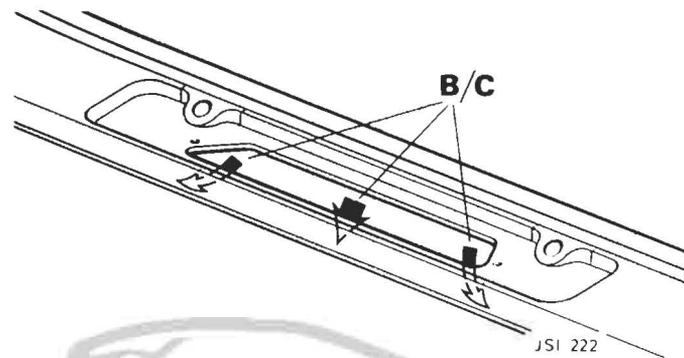
If the seams in this chamber are inadequately sealed, water can enter the vehicle footwells whenever the vehicle is exposed to heavy rainfall.

1. Remove plenum grille (Series III Workshop Manual Operation 80-15-29, XJ-S Workshop Manual Operation 84-15-12 – Items 1–7).
2. Apply sealant B or C by brush into all seams inside the chamber (Fig. 1).
3. Replace grille.

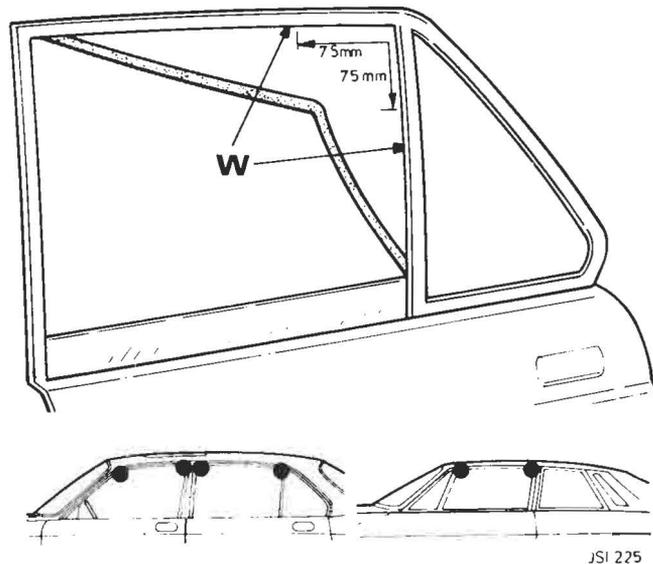
3. Water ingress and wind noise glass channels – All Doors – Series III & XJ-S (Fig. 3)

In most instances this is caused by gaps behind the window seals (BAC 1562 Series III, BD 46041 XJ-S), particularly at top corners.

- A Remove glass seal at points marked "W" (Fig. 3).
- B Apply sealant "E" into the channel corner and spread a bead 75mm (3in) from the corner in sufficient quantities to allow extrusion when the seal is refitted. Carefully clean off any surplus sealant.

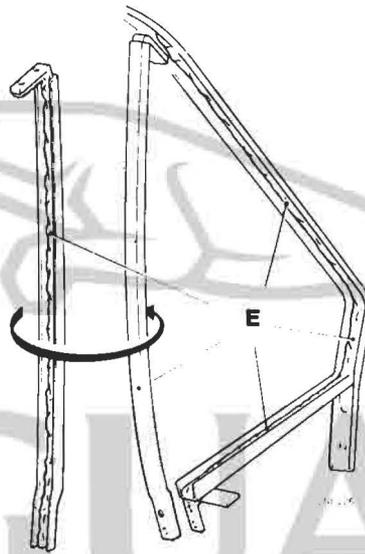
4. Water ingress and wind noise via rear door quarterlight – Series III only (Fig. 4)

- A Refer to previous Bulletin and apply sealant "E" as directed in sufficient quantities to ensure that the excess will extrude when the quarter light is refitted.
- B Following assembly, wipe off all surplus sealant.

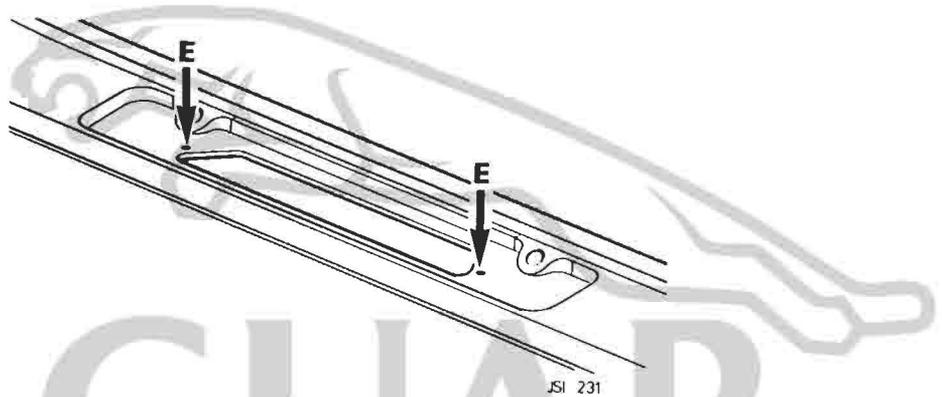
8. Water ingress via plenum grille mounting pin holes – Series III only (Fig. 8)

This may arise due to inadequate sealing around the two mounting pin holes, allowing water to enter the vehicle via the double skin.

- A Remove plenum grille (Workshop Manual Operation 80-15-29).
- B Remove two plastic inserts BD 26989.
- C Apply sealant "E" by brush to seal around the holes.
- D Allow ten minutes to dry and reassemble.

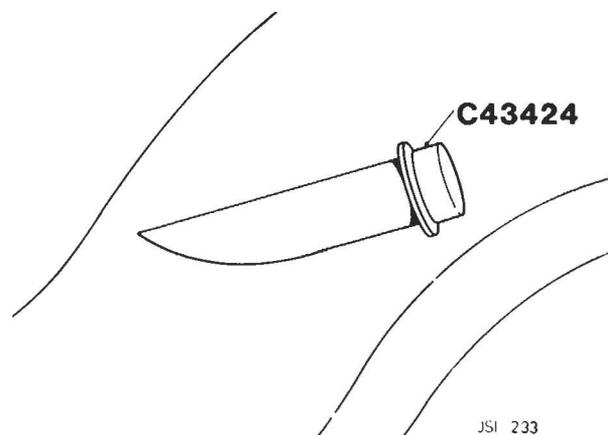
10. Water ingress via handbrake cable tube – XJ-S only (Fig. 10)

This complaint is caused by inadequate sealing of the cable exit, and/or blanking cap not being fitted. This area should be examined if water ingress is apparent in rear footwells only.

- A Check the sealing cap of the tube from which the cable exits, and rectify any leaks.
- B Check the plug C43424 for security over the blanking hole and rectify as necessary to ensure complete sealing.

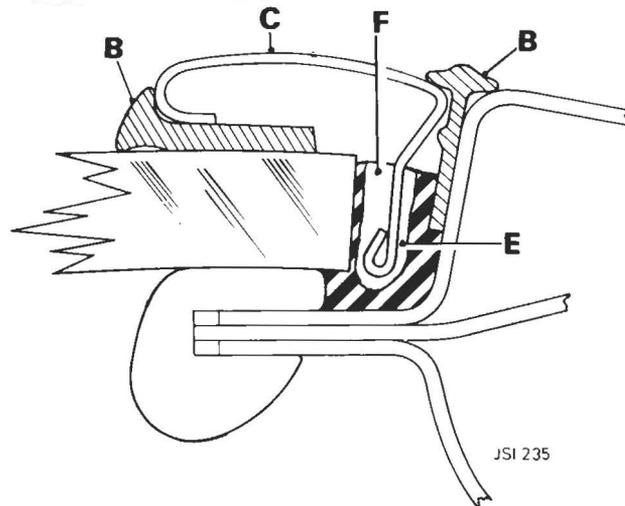
11. Water ingress via windscreens – Series III only (Fig. 11)

This complaint is caused by poor adhesion of Betaseal to screen and/or aperture.

Major repair of this fault is detailed in Service Bulletin JD 05/81 Item 35. However, local rectification of small leaks may be carried out using the following method:

- A Identify area of leakage
- B Remove inner and outer lace.
- C Remove the relevant bright finisher.
- D Carefully cut a section of Betaseal from the suspected leak area, prime and apply new Betaseal.

- E A further section of Betaseal will have to be cut out to allow re-fitment of the bright finisher.
- F Apply new Betaseal. Refit finisher. Re-fit laces.

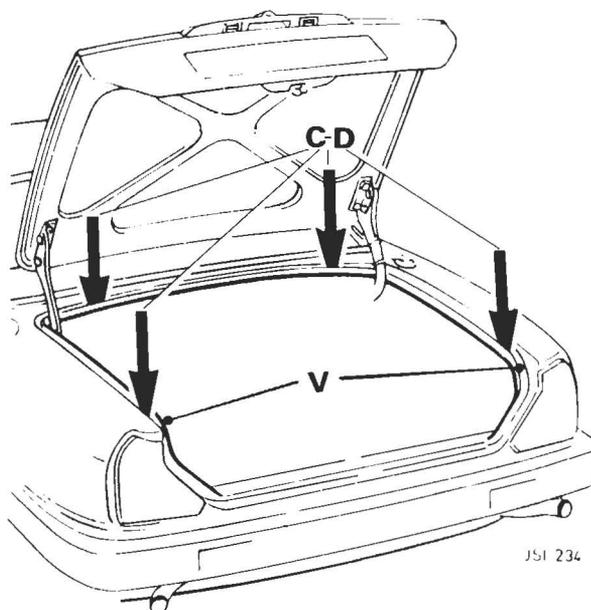
This problem is caused by porosity in the channel seams or a badly fitted boot seal.

- A Apply sealant "C" or "D" to all seams around the boot channels. Allow to dry and paint as necessary (Fig. 13).
- B If a leak is apparent between the seal and boot lid at point "V", this is due to overstretching the seal when fitting. The old seal should be discarded and a new seal fitted, taking care to avoid stretching on curves.

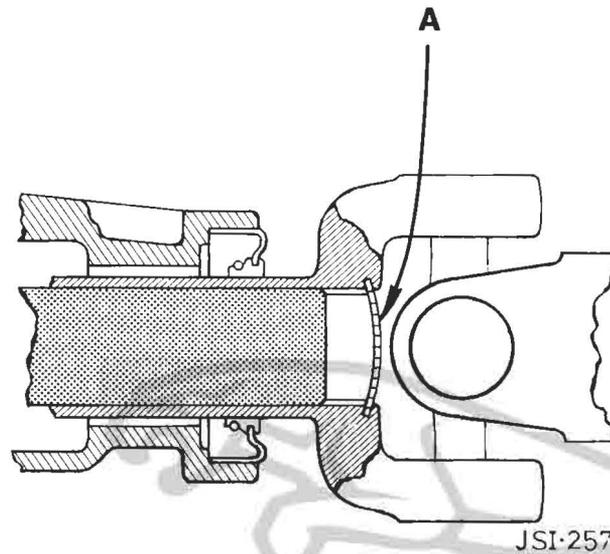
When fitting the propshaft into the Getrag manual gearbox, care must be taken not to disturb the oil sealing plug (A) by pushing the propshaft too far into the gearbox (see diagram). The only stop, when sliding the propshaft into the gearbox, is the sealing plug at the bottom of the propshaft reverse spline and if any force is used the plug can be disturbed and allow oil to leak out from the gearbox.
