DATE: OCTOBER 1991

REF: JD 08/91

**XJS**

# Service Bulletin

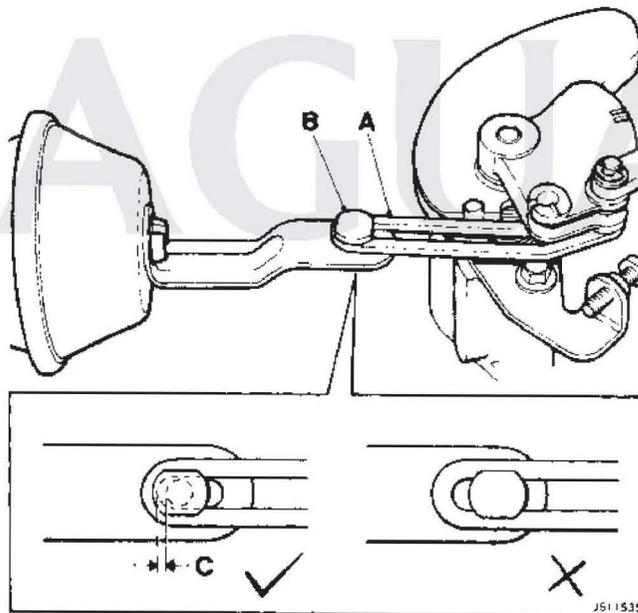
FIG 1

Should customer complaints be received of an increase in the cruise control response time and a degree of hunting of the set speed, the cruise control actuator linkage adjustment should be checked in accordance with the following procedure, before taking any further action.

Dealers should ensure that the clearance between the end of the actuator to throttle link slot (A Fig 1) and the shoulder bolt (B Fig 1) is 0.5mm to 1mm (C Fig 1).

S.R.O.	19.75.11
Allowance	0.10 hrs
Complaint Code	7VCP

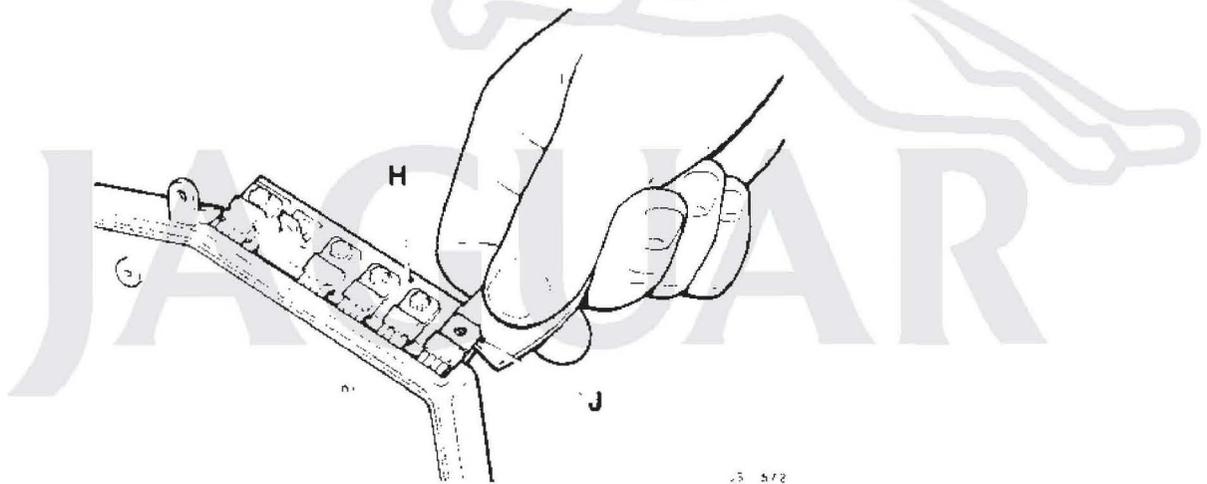
FIG 2

**IMPORTANT:** Do not bend the power transistor away from the heatsink as permanent damage may be caused to the PCB connections. Slide the abrasive paper between the heatsink and the transistor bracket.

Replace the bolt, re-tighten, switch-on the ignition and re-check the voltage reading. If the voltage reading indicates '0' volts, the fault should be corrected. Re-check the system operation.

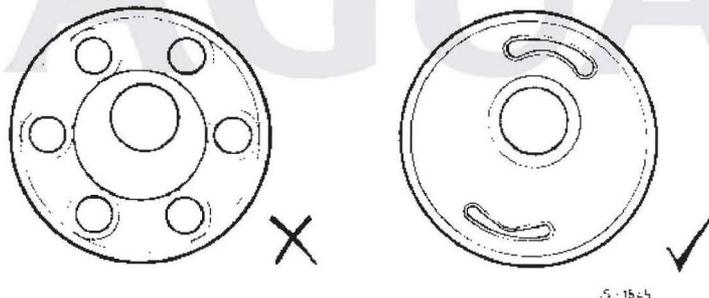
FIG 1

**Note:** The bushes originally used were termed as 'six-shooter' bushes. These have now been redesigned / replaced by the 'smiley-faced' bushes currently being used, see Fig. 1 for identification.

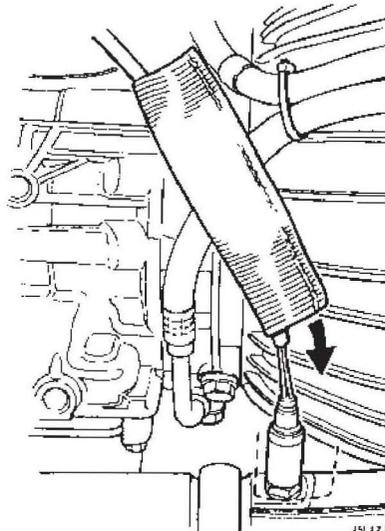
A lambda sensor splash-shield has been introduced from VIN 664941, which can be fitted retrospectively and should be installed whenever a lambda sensor is changed. This will reduce the possibility of water ingress.
