DATE: NOVEMBER 1991

REF: JD 09/91

ERRATA

REF: JD 26/93

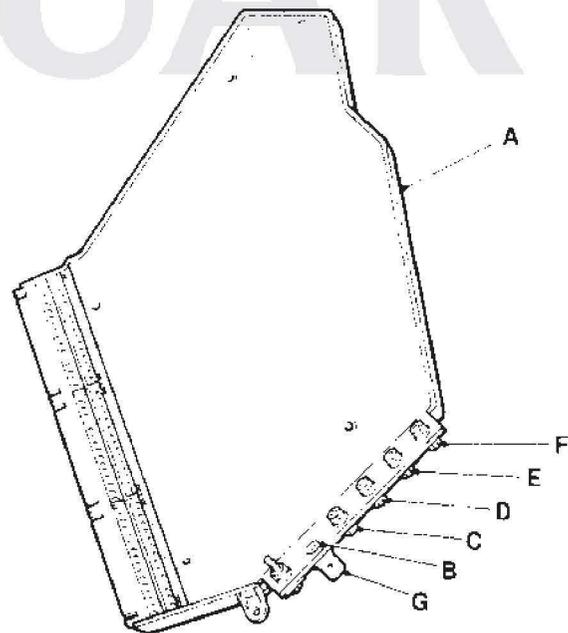
FIG 1

Following investigations into the cause of air conditioning/heater unit rotary flaps 'sticking', a concern has been identified with the servo motor drive ICs retained to the heatsink on the microprocessor unit. On a number of ECUs, the earth points have been found to be electrically poor, causing permanent or intermittent failure of the servo drives. The effect of this, in vehicle, is the 'sticking flaps' problem where the flaps appear to be jammed, although it is the ECU which is at fault.

4. Using a digital voltmeter, touch one lead on to the earth rivet Fig 1 (B). Then, in turn, probe each of the four earth connection bolts, Fig 1 (C, D, E and F); if the earth connections are satisfactory, '0' volts will be indicated. If, during probing, any one of the four readings is abnormally higher, this will indicate a poor earth track.

5. If a higher reading is identified, check the tightness of the earth bolt affected. Tighten if necessary and re-check the voltage. (The Dealer may also check the tightness of the other earth bolts as a precaution).

6. If the voltage reading returns to '0' volts, re-check the system operation. (If the fault persists, proceed to point 8).
7. If the voltage reading remains high, turn-off the ignition. Release and remove the earth bolt and check for any signs of contamination, oxidization, etc. Using a very fine abrasive paper (P1000 or above), clean the earth track as shown in Fig 2. Ensure that both the microprocessor heat sink surface (H) and the power transistor bracket surface (J) are cleaned.

IMPORTANT: Do not bend the power transistor away from the heatsink as permanent damage may be caused to the PCB connections. Slide the abrasive paper between the heatsink and the transistor bracket.

Replace the bolt, re-tighten, switch-on the ignition and re-check the voltage reading. If the voltage reading indicates '0' volts, the fault should be corrected. Re-check the system operation.

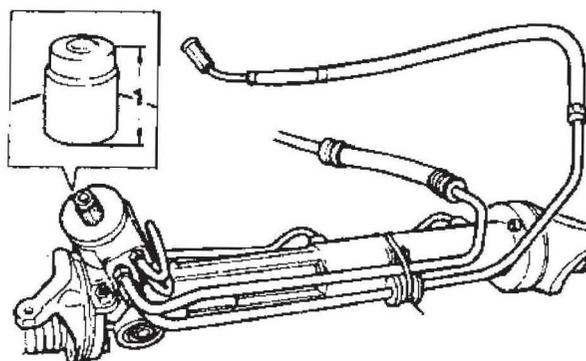
FIG. 1

The ZF Phase 2 Steering Rack (Fig. 1) is added to the 1994 MY specification. The rack body consists of two aluminium pressure diecastings; the rack mounting is unchanged. The pinion height (1, Fig. 1) is increased by 7mm; the steering column is altered to accommodate this change. The fluid pipe union positions in the valve block are also altered, with the fluid pipes being modified accordingly. The steering rack assembly is a non-serviceable item.

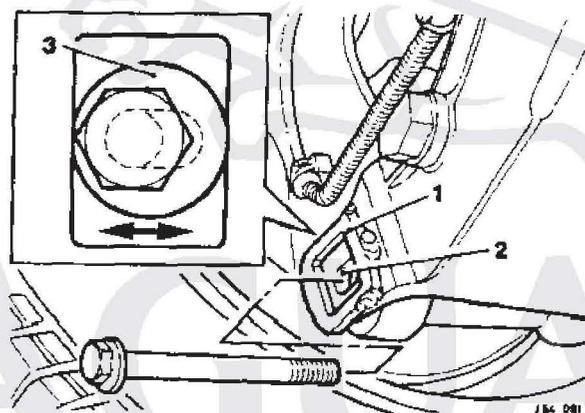
FIG. 2

The lower suspension arm has a plate, with a rectangular recess machined in the centre, added to the rear pivot eye (1, Fig. 2). The suspension arm pivot bolt hole (2, Fig. 2) is elongated, horizontally, at this point.

The pivot bolt has an integral eccentric (3, Fig. 2) below the bolt head, which, when in position in the plate, has a slight clearance at the sides but full clearance at the top and bottom. Rotation of the bolt head, with the eccentric constrained between the vertical faces, causes the bolt shank to be moved in the horizontal plane, thus displacing the hub carrier and effecting wheel alignment adjustment.
