Service Bulletin

DATE: JANUARY 1992

REF: JD 02/92

XJ-S FACELIFT

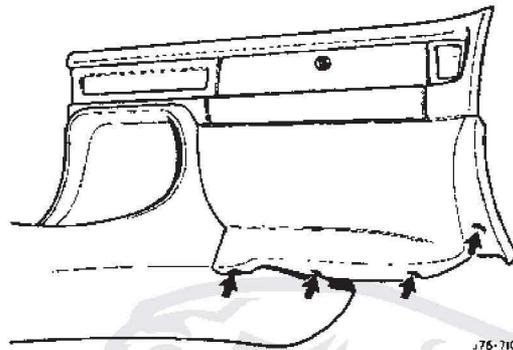
FIG 1

A quantity of dash liners has been replaced due to damage caused by their removal. A Service Tool (JD 188) has now been developed to assist with this procedure. To remove a dash liner, driver's or passenger's side of vehicle, proceed as follows:

Open the appropriate door to gain access to the dash liner.
Undo and remove the dash liner securing screws (Fig.1).

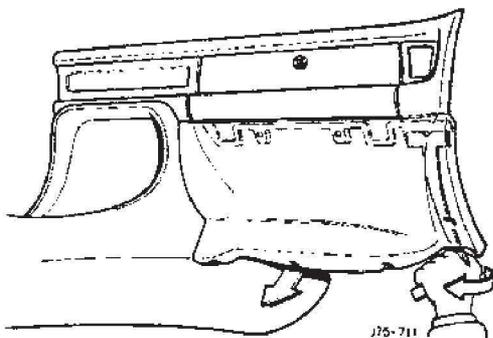
FIG 2

The number of dash liner retainers is different between Federal and U.K. vehicles. To avoid any damage to the dash liner, always ensure all retainers have been carefully displaced before removal.

Insert Service Tool JD 188 behind the dash liner. Locate onto the upper flange with the 'V' cut-out in the tool either side of the first fir tree retainer (Fig. 2). Displace the fir tree retainer from the plastic retainer socket by gently twisting the tool handle (Fig. 2). Remove the remaining retainers in the same manner.

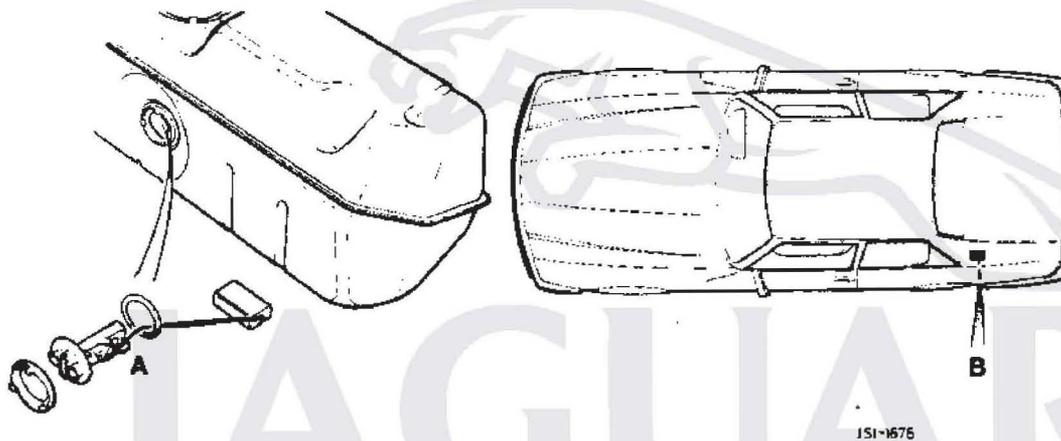
Following isolated concerns with this circuit, some Dealer confusion has arisen during fault diagnosis, which has resulted in the unnecessary replacement of components.

POSSIBLE FAULT CONDITIONS**Loss of damping**

Disconnect the upper wire of the sender from ground and check that the fuel gauge starts to fall. If the low fuel warning light illuminates within 12 seconds of this operation, replace the anti-slosh module.

If the warning lamp fails to illuminate, check the voltage on the warning lamp output of the anti-slosh module (pin 2). If the voltage is less than 0.9 volts, the fault does not lie in the anti-slosh module; therefore, check the lamp and harness. If the voltage is more than 0.9 volts, change the anti-slosh module.

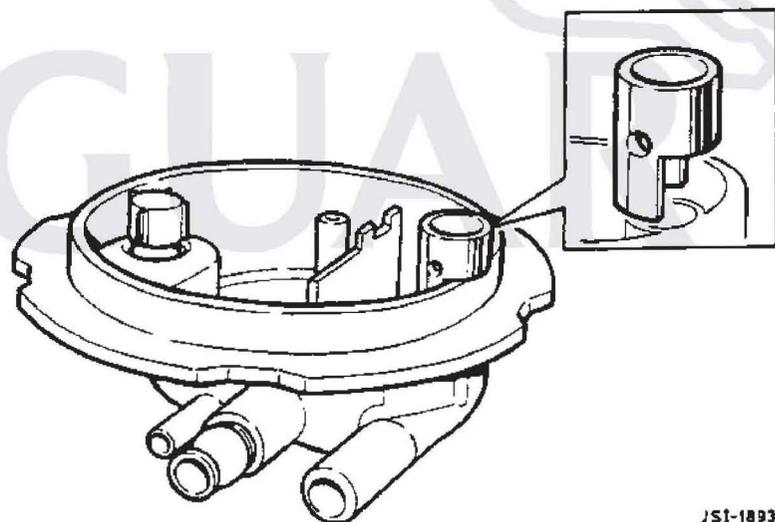
Fig 1

On Facelift vehicles, commencing at VIN 179737, it is necessary to fit a breather tube extension in addition to the revised pattern of fuel filler neck and associated seals and gaiter. This involves removal and refitting of the fuel tank, and replacement of additional seals.

Carefully press the breather tube extension, Part No. EBC 10976, onto the breather stub on the underside of the evaporative loss flange, ensuring that the extension is pushed fully home. See Fig. 1.
