Service Bulletin

JAGUAR

Date: DECEMBER 1985/JANUARY 1986

Bulletin: JD 01/86

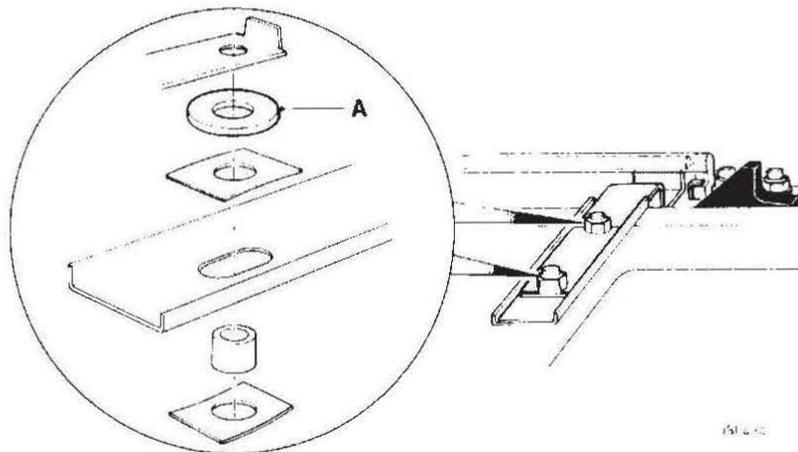
FIG. 1

- 1) Rattles emanating from the rack cable mounting brackets on the sliding roof underpanel.
- 2) Creaks from contact between the roof headlining and the sunroof assembly.

- 1) Remove sliding roof panel.
- 2) Fully close underpanel, de-tab and remove the nuts and tab washers securing the rack cable brackets (Fig. 1).

- 3) Position one 10 mm I.D. plain washer over the distance collar of each stud "A" Fig. 1, to increase tension on the bracket. Refit tab washer and nuts, tighten and re-tab.

NOTE: When the nuts are tight the brackets must be able to slide on the mountings to allow cable movement during operation.

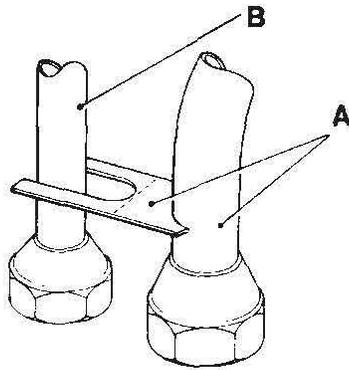
FIG. 1

Following the introduction of the large bore low pressure refrigerant hose at VIN 424475, ref. Service Bulletin 05/85 Item 40, vibration problems have been experienced with the location bracket welded to the low pressure hose, See Fig. I (A).

To prevent a possible foul condition occurring between the bracket and the high pressure hose Fig. 1 (B), which can cause vibration and a metallic rattling noise being detected within the car, this location bracket is now being deflected upwards 90° after hose assembly (See Fig. 2).

Should problems be encountered in service then the above modification should be carried out.

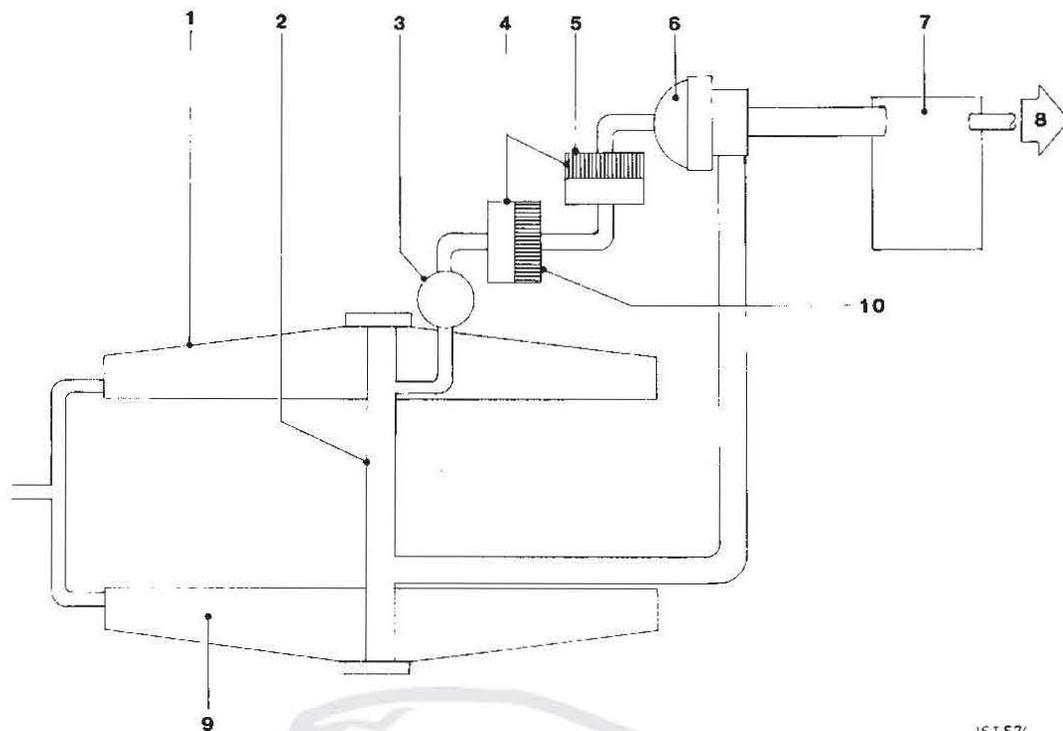
FIG.1

A revised purge control system with vacuum operated switching replacing electrical switching has been introduced on XJS V12 models providing a more stable idle condition when manouvering at low speeds (see Fig.1 on next page for schematic layout). This modification effectively delays carbon canister purging for a few seconds as engine speed increases just off idle, preventing a possible over-rich mixture.
