Service Bulletin

DATE: OCTOBER 1991

REF: JD 08/91

XJS

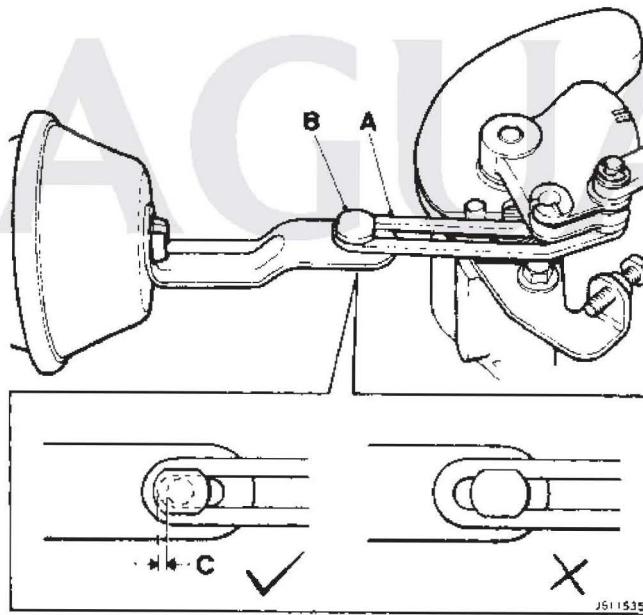
FIG 1

Should customer complaints be received of an increase in the cruise control response time and a degree of hunting of the set speed, the cruise control actuator linkage adjustment should be checked in accordance with the following procedure, before taking any further action.

Dealers should ensure that the clearance between the end of the actuator to throttle link slot (A Fig 1) and the shoulder bolt (B Fig 1) is 0.5mm to 1mm (C Fig 1).

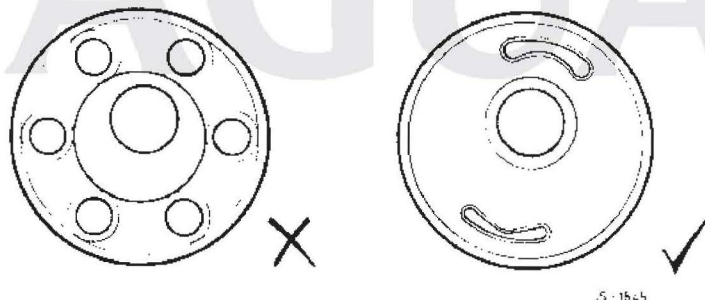
FIG 1

Note: The bushes originally used were termed as 'six-shooter' bushes. These have now been redesigned / replaced by the 'smiley-faced' bushes currently being used, see Fig. 1 for identification.

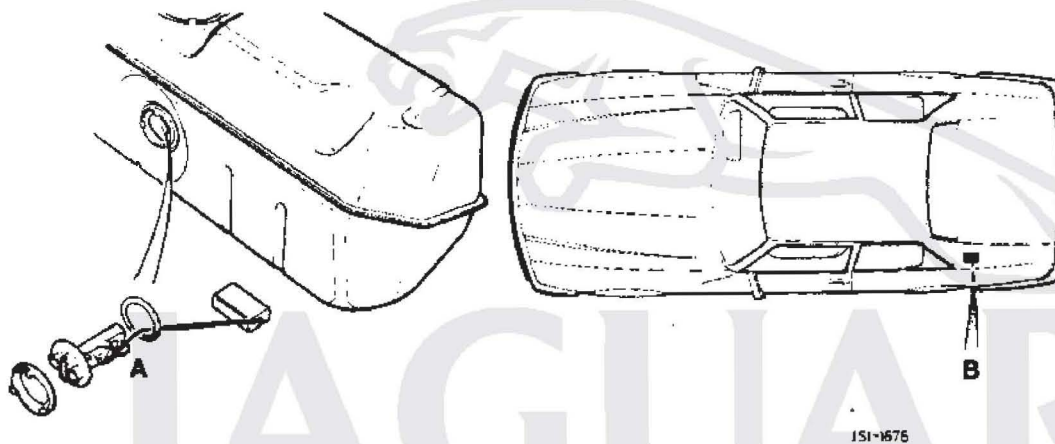
COMPONENT LOCATION

Following isolated concerns with this circuit, some Dealer confusion has arisen during fault diagnosis, which has resulted in the unnecessary replacement of components.
