Service Bulletin

REF: JD 03/92

REF: JD 14/92

REF: JD 16/92

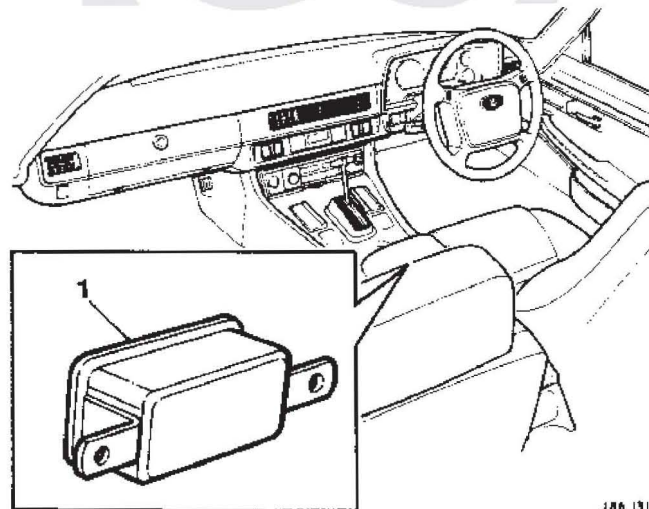
FIG. 2

Prior to VIN 179737 (90MY XJS), the module is located beneath the centre console veneer finisher, attached to a bracket in front of the stowage compartment (Fig. 2).

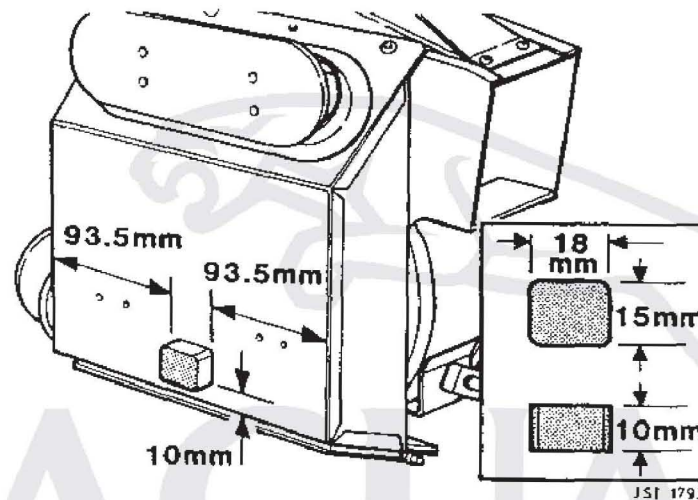
FIG 1

Isolated reports have been received concerning the driver's side blower motor recirculation flap being held partially open, due to the flap fouling the brake pedal switch mounting bracket.

Fig 1 shows the right-hand blower motor assembly for RHD vehicles. The blower motor assembly for LHD vehicles is symmetrically opposite.

To provide adequate clearance, the blower motor assembly is now positioned slightly forward by the introduction of a rubber spacer mounted on the rear face of the blower

In the event that a driver's side blower motor assembly requires replacement on a vehicle after the above VIN, Dealers should ensure that the spacer is removed and re-fitted to the new blower motor assembly.

Please note the "Butyl" tape remains flexible and may be re-used to secure the spacer to the new motor. (Refer to Fig 1 for position and dimension references).

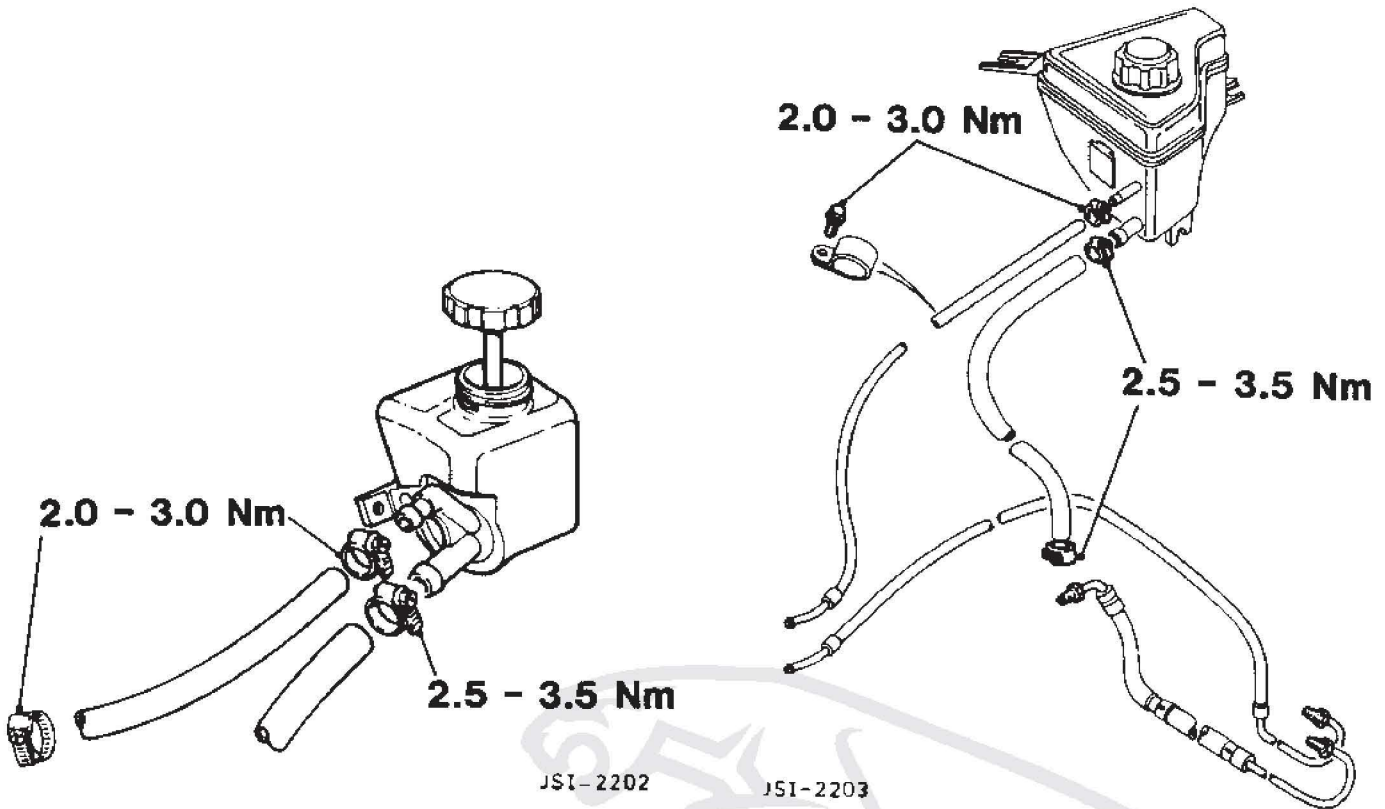
Fig. 1.

The joints at which this pattern of clip are fitted are illustrated in Figs. 1, 2, and 3 overleaf, together with the torque wrench setting applicable to each clip.

- slacken off the clip concerned, just sufficient to allow a check that the hose concerned is fully home on the pipe stub.
- with the worm-drive hose clip in its original location on the hose, tighten the worm-drive clip to the designated torque wrench setting.
- **IMPORTANT:** WAIT 30 MINUTES. THEN RE-TORQUE THE WORM-DRIVE CLIP TO THE DESIGNATED SETTING. (DO NOT SLACKEN OFF THE WORM-DRIVE BETWEEN THE FIRST AND SECOND TORQUE CHECKS).

This re-tightening procedure takes up the relaxation which occurs in the rubber hose after the initial clamping, which otherwise may lead to a leak at the joint concerned if only a single tightening procedure were to be followed.
