Service Bulletin

ISSUE NO: JD 04/92

- MODEL : XJ6 / XJS / S.III V12 (AIR CONDITIONED MODELS)
- SUBJECT : BLOWER MOTOR ASSEMBLIES
- CUSTOMER CONCERN : Brush gear noisy operation, ie: low speed ticking / squeak.

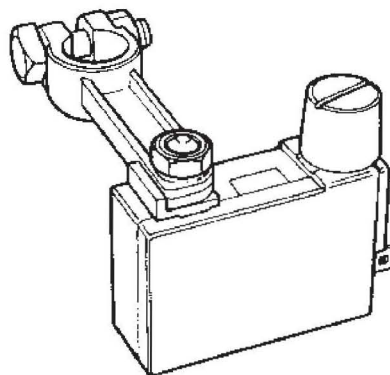
FIG 1

Owing to the relocation of the battery into the boot at 93 MY, a revised battery transit relay has been introduced, (see Fig 1).

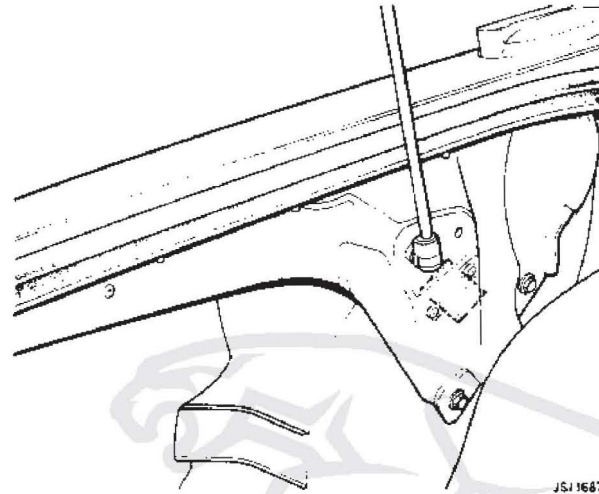
FIG. 1

From VIN 179737 (92MY Facelift XJS), the stop light failure sensor module is located in the boot of the vehicle, attached to the inside of the boot side reinforcement panel (drainage channel) L.H. (Fig. 1).

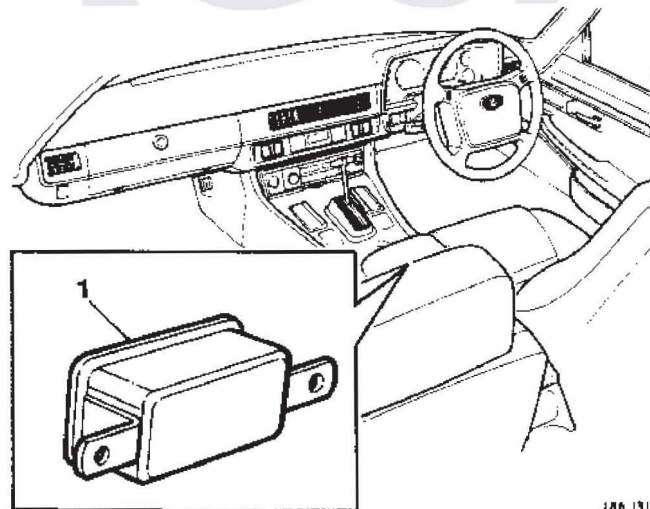
FIG. 2

Prior to VIN 179737 (90MY XJS), the module is located beneath the centre console veneer finisher, attached to a bracket in front of the stowage compartment (Fig. 2).

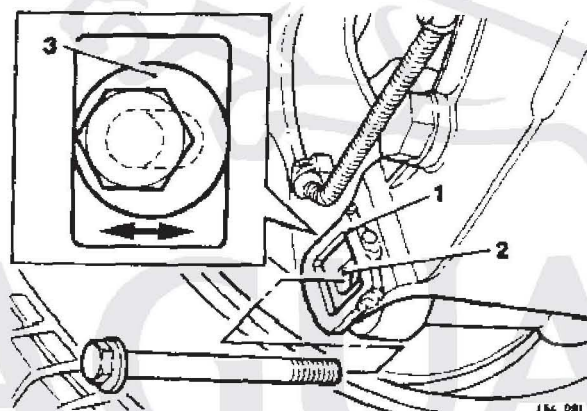
FIG. 2

The lower suspension arm has a plate, with a rectangular recess machined in the centre, added to the rear pivot eye (1, Fig. 2). The suspension arm pivot bolt hole (2, Fig. 2) is elongated, horizontally, at this point.

The pivot bolt has an integral eccentric (3, Fig. 2) below the bolt head, which, when in position in the plate, has a slight clearance at the sides but full clearance at the top and bottom. Rotation of the bolt head, with the eccentric constrained between the vertical faces, causes the bolt shank to be moved in the horizontal plane, thus displacing the hub carrier and effecting wheel alignment adjustment.

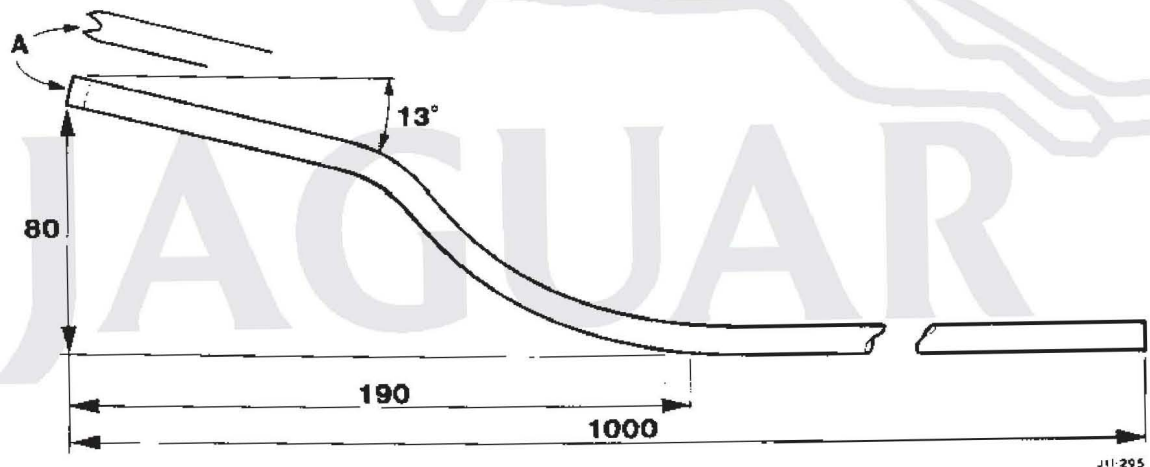
Coinciding approximately with the introduction of XJS 1993.5 Model Year vehicles, a revised pattern of bonnet release catch has been introduced as a running change. In the course of development of the new type of catch, a method of gaining access to the engine compartment has been established to overcome the problem which would arise in the rare event of release cable failure.

7. Release the RHS catch by operating the latch arm directly by hand.
8. Using the locally-made release tool illustrated in Fig. 1. below, the LHS catch may be released after passing the release tool across the top of the engine. The notch on the end face of the tool prevents slippage from the catch.
9. Remove the bonnet by lifting it up and away from the engine compartment aperture.
10. Trace and rectify the release problem.
11. Refit and adjust the bonnet to the aperture.
12. Refit the front grille.
13. Reconnect the battery and refit the battery cover.
14. Re-code the radio; re-set the clock.

The tool illustrated above should be locally manufactured from a length of steel rod, 6.00mm diameter, approximately 1000mm long. The overall length, however, is not critical, provided that the tool is sufficiently long to provide access across the engine compartment.
