Service Bulletin

DATE: OCTOBER 1991

REF: JD 08/91

XJS

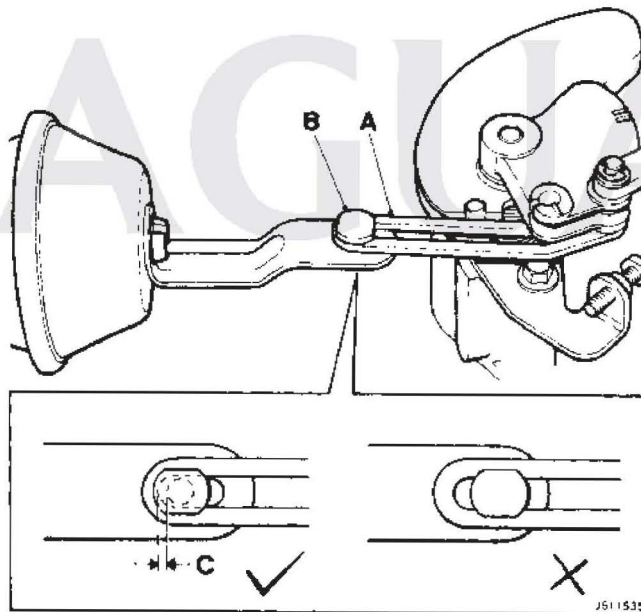
FIG 1

Should customer complaints be received of an increase in the cruise control response time and a degree of hunting of the set speed, the cruise control actuator linkage adjustment should be checked in accordance with the following procedure, before taking any further action.

Dealers should ensure that the clearance between the end of the actuator to throttle link slot (A Fig 1) and the shoulder bolt (B Fig 1) is 0.5mm to 1mm (C Fig 1).

S.R.O.	19.75.11
Allowance	0.10 hrs
Complaint Code	7VCP

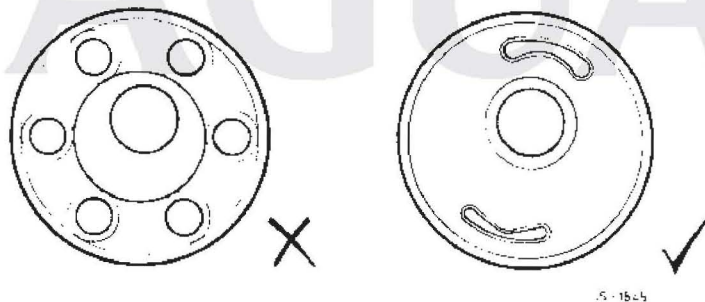
FIG 1

Note: The bushes originally used were termed as 'six-shooter' bushes. These have now been redesigned / replaced by the 'smiley-faced' bushes currently being used, see Fig. 1 for identification.

To aid assembly, prior to fitting new bushes, it is **important** they are correctly aligned with the crossmember.

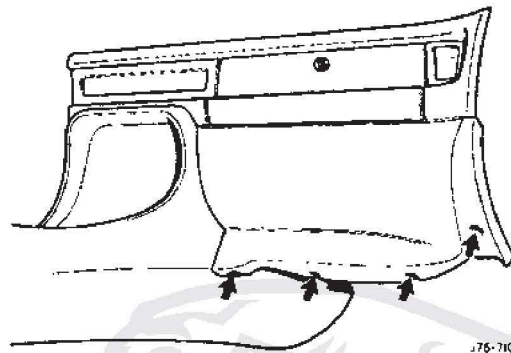
FIG 1

A quantity of dash liners has been replaced due to damage caused by their removal. A Service Tool (JD 188) has now been developed to assist with this procedure. To remove a dash liner, driver's or passenger's side of vehicle, proceed as follows:

Open the appropriate door to gain access to the dash liner.
Undo and remove the dash liner securing screws (Fig.1).
