Number	N.84
Section	Body
Page	1 of 2
Date	November, 1971.

BONNET MASCOT

INSTALLATION INSTRUCTIONS FOR BONNET MASCOT BD.29644

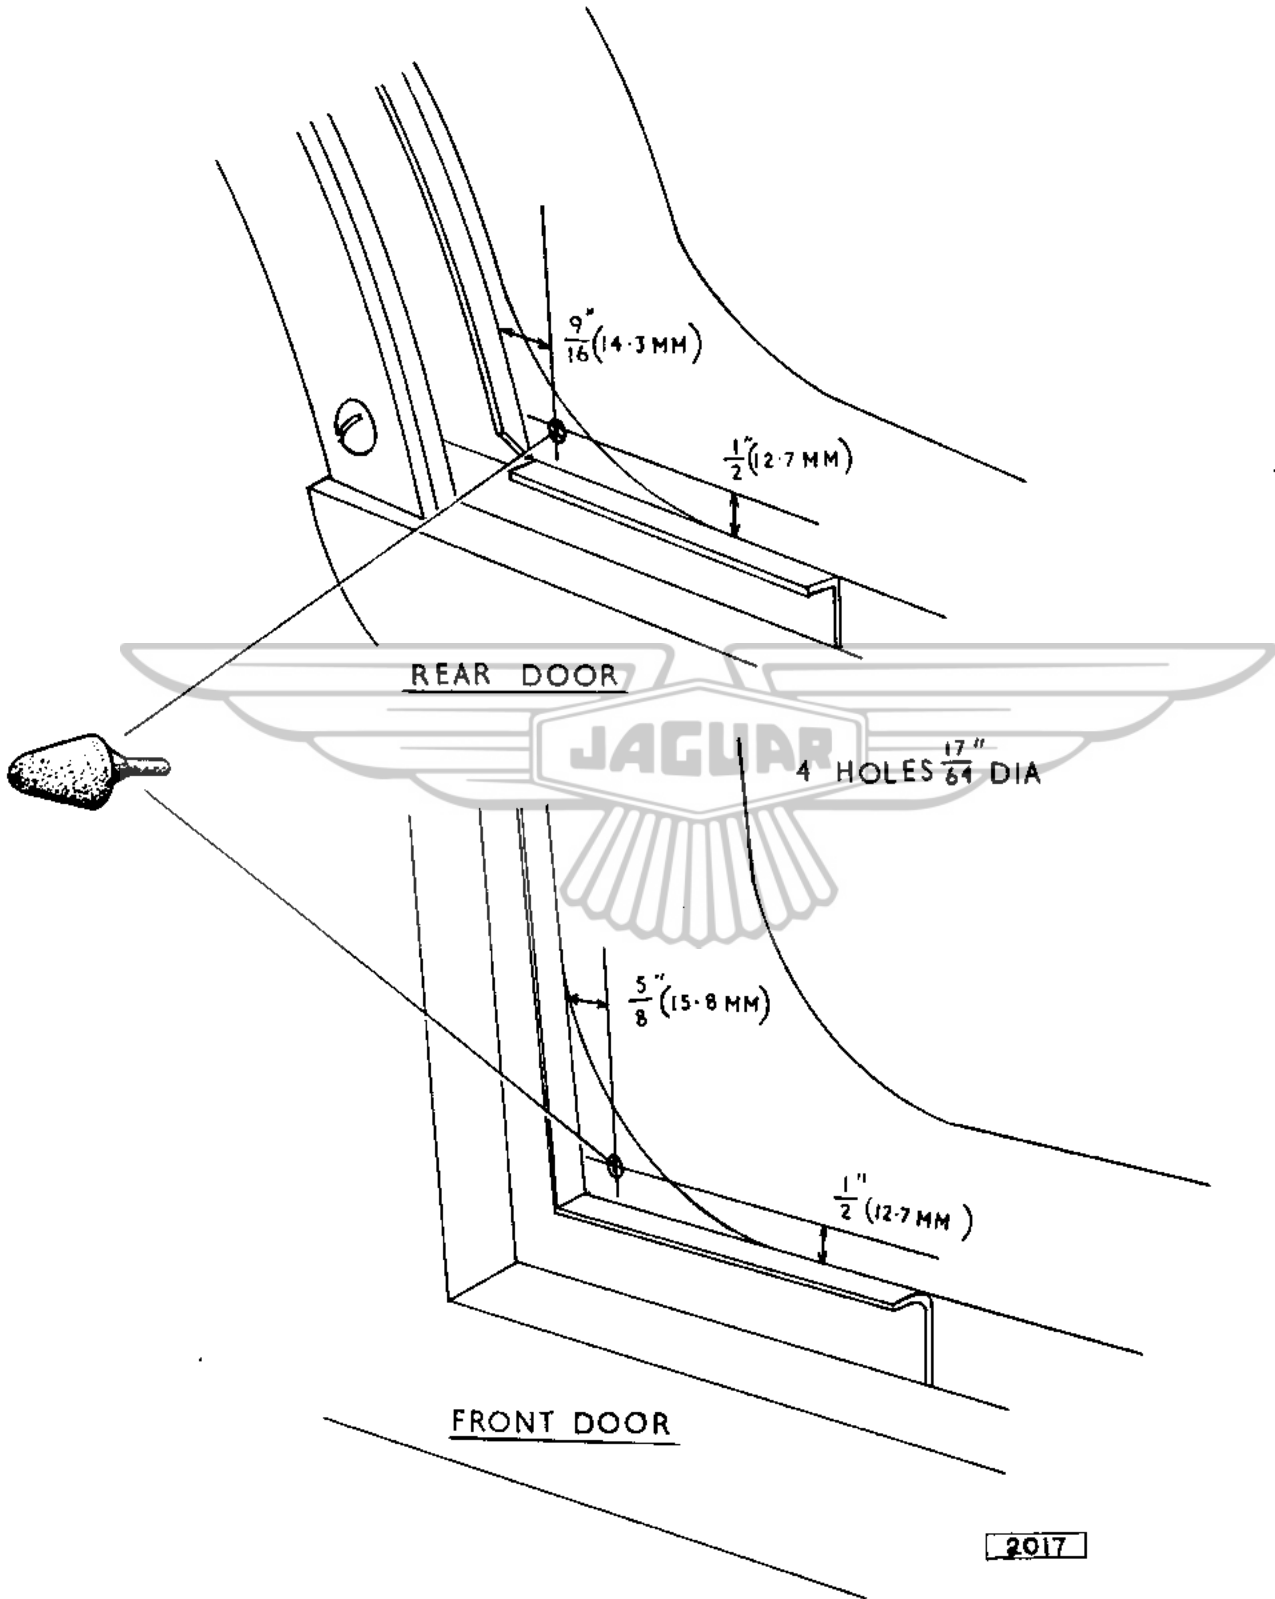
On cars with the above chassis numbers and onwards, a rubber buffer (Part number BD.4951) is fitted to the outer rear corner of the front and rear door sills to eliminate movement of the doors when shut.

On cars with the above chassis numbers and onwards, toughened glass windcreens have a special built-in "zone". This special "zone" is to ensure vision in the event of the windscreen being shattered.

Interchangeability is not affected by the introduction of the buffer which may also be fitted to cars prior to the above chassis numbers if desired. To incorporate this modification on such cars, it is necessary to drill a 17/64" (6.74 mm) hole in the door sills as shown in the illustration overleaf. It may be necessary to reduce the height of the buffer to ensure a perfect fit.

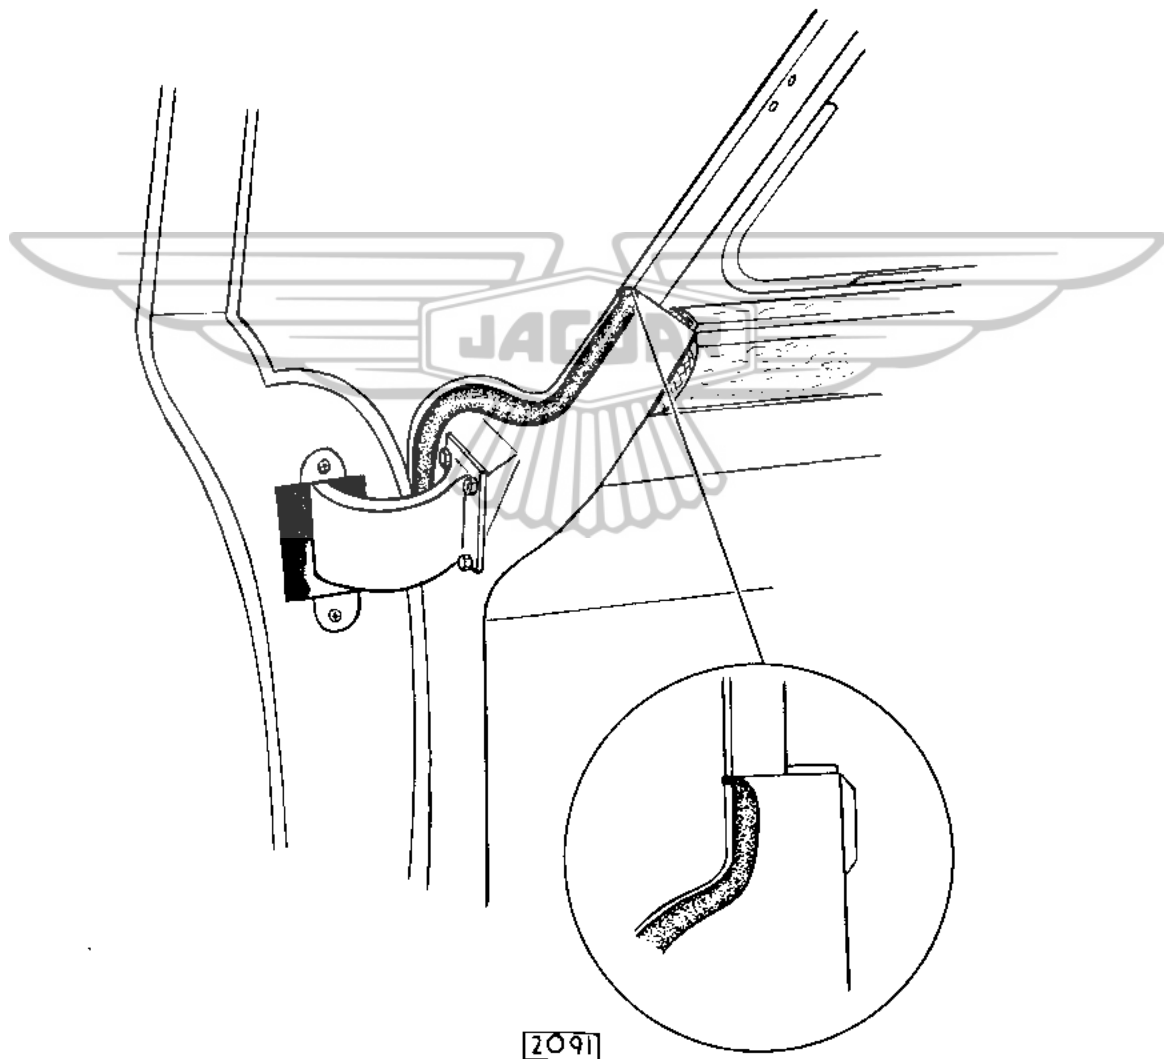
In cases of complaint of wind noise from the front edges of the front doors on Mark 2 models, it is recommended that a rubber sealing strip is fitted to the forward edge of the doors adjacent to the top hinge.

To fit the strip (Part Number BD.21361 (L.H.), BD.21362 (R.H.)) remove the front door capping and waist rail and pull the top of the door trim casing away from below the window aperture. Slacken the two screws below the no draught ventilator and pull the frame away from the door. Using a suitable adhesive, stick the sealing strip to the forward edge of the door so that the upper end is trapped by the no draught ventilator frame (see illustration overleaf). Tighten the securing screws, restick the door casing trim and refit the waist rail and door capping.

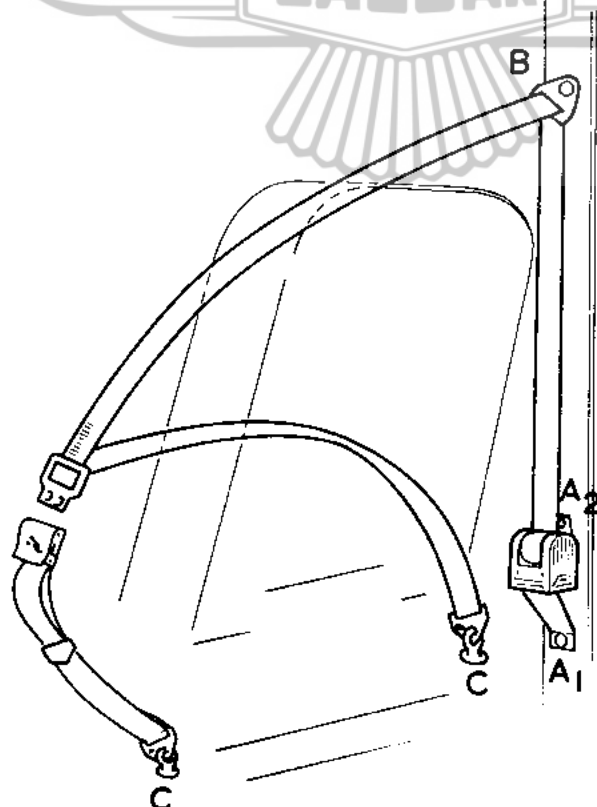
FIG. 1 THE SEAT BELT FITTED

- (13) Attach the main belt to the outer eyebolt and the short (buckle) belt to the inner eyebolt. Re-adjust the seat position. (Fig. 1, reference C).

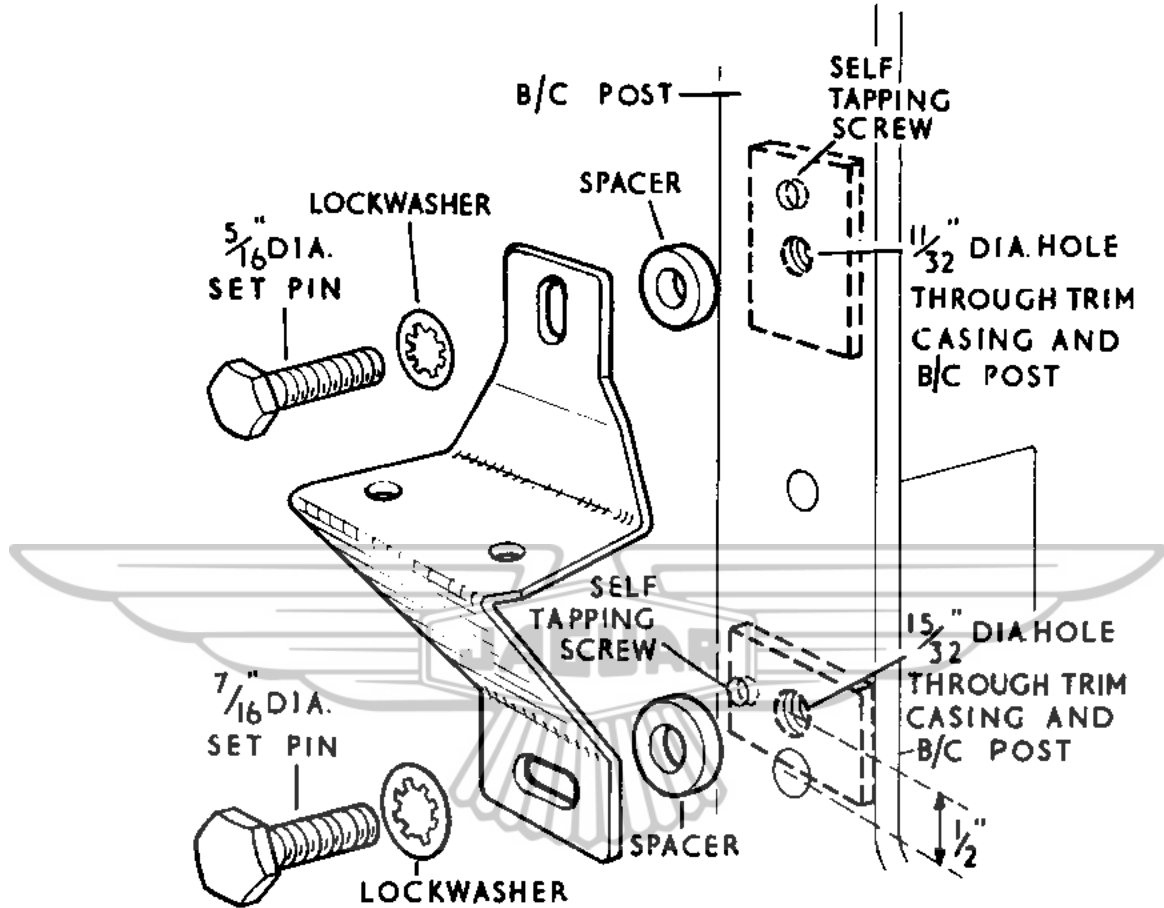
FIG.2 MOUNTING POINTS A₁ & A₂

- (9) Attach the reel to the bracket with the two 5/16" setscrews, nuts and lockwashers. Note that the unit must be fitted so that the strap unreels against the back of the bracket. Attach the mounting bracket to the 'B/C' Post with the 5/16" and 7/16" setscrews, plain and lockwashers; the two distance pieces supplied in the kit should be interposed between the bracket and the trimming (Fig. 2). Tighten the setscrews fully.
