DATE: JULY 1992

REF: JD 08/92

## ERRATA

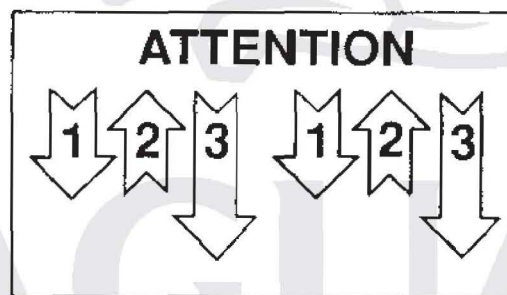
FIG 3

Note: This strut has a bright red warning label, showing the method of operation – Refer to Fig 3.

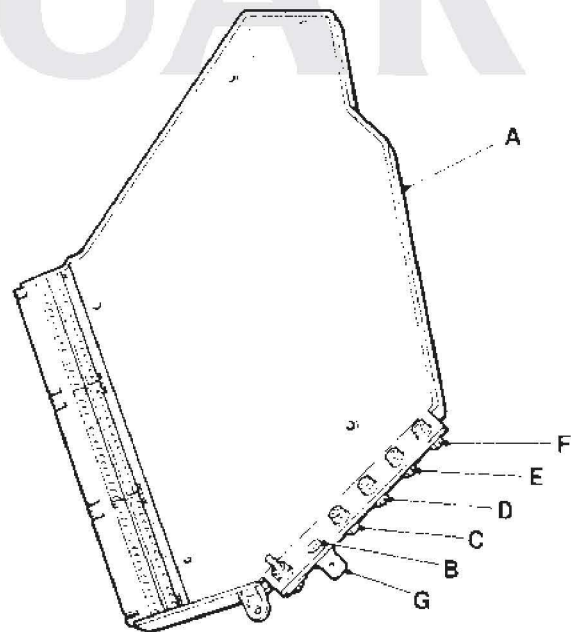
FIG 1

In the event of a vehicle being returned with either an upper or lower rotary flap problem, i.e. intermittent or permanent sticking, the Dealer should carry-out the following procedure before any further action is taken:-

1. Initially determine in what mode the upper or lower rotary flap is jammed, i.e. cooling or heat mode.
2. Remove the necessary trim items from the right-hand side of the unit to gain access to the microprocessor assembly, Fig 1 (A).
3. Switch-on the ignition and air con/heater system. Select manual override. Having already determined in which mode the rotary flap in question is jammed, rotate the temperature demand control in the opposite direction; i.e. if, for instance, the rotary flap is stuck in the cooling mode, turn the

temperature demand control to full heat, or visa versa.

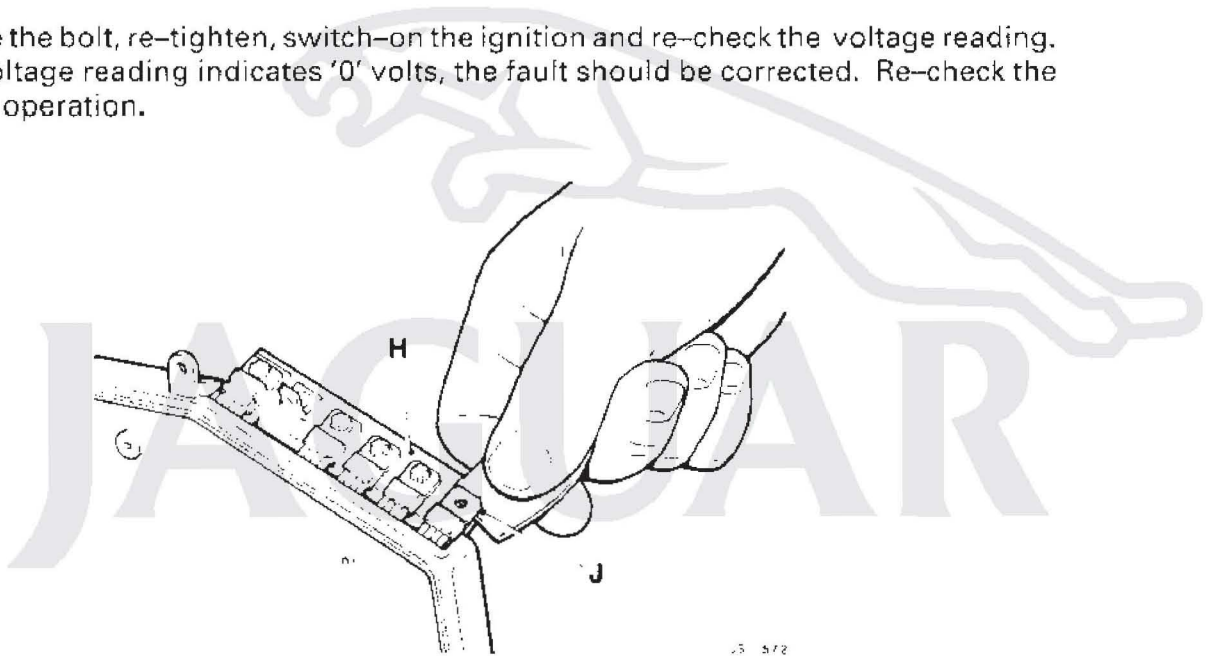
FIG 2

**IMPORTANT:** Do not bend the power transistor away from the heatsink as permanent damage may be caused to the PCB connections. Slide the abrasive paper between the heatsink and the transistor bracket.

Replace the bolt, re-tighten, switch-on the ignition and re-check the voltage reading. If the voltage reading indicates '0' volts, the fault should be corrected. Re-check the system operation.

8. It is unlikely that the fault will persist; however, should this occur, the Dealer should then continue with normal diagnostic procedures to determine the cause.
9. In the event that the fault may not be present at the time the vehicle is returned to the Dealer, the following check should be carried-out to determine if a poor earth connection is present.
10. Switch-off the ignition. Disconnect the earth lead from the Lucar connector on the reverse side of the microprocessor earth rivet, Fig 1 (G).
11. Using a digital meter, measure the resistance (Ohms) between the earth rivet, Fig 1 (B) and the four earth connections, Fig 1 (C, D, E and F).

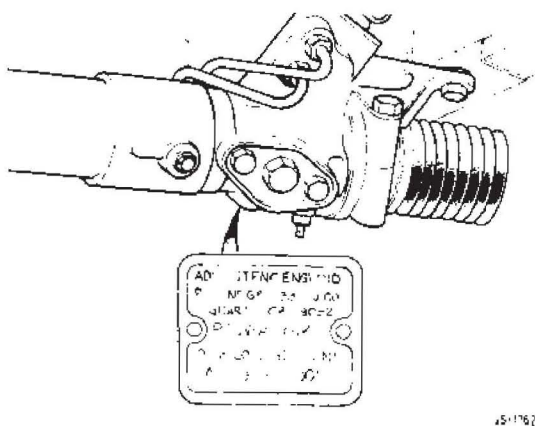
FIG 1

**Note:** Energised pinion seals should only be fitted to steering racks with plated pinion bores. Plated bore racks were fitted from VIN 597940. The plated racks are also identified by the part number stamped on the plate on the underside of the rack (Fig. 1). Part No. CBC 9052 – Right-hand drive vehicles. Part No. CBC 9053 – Left-hand drive vehicles. Energised seals were introduced from Part No. CCC 5650, XJ6 and Part No. CCC 5660, XJS.

A set of Service Tools has been developed (JD 184, JD 185, JD 186 and JD 187) to assist in renewing the steering pinion valve energised seals; Service Tool JD 120, steering rack centralising pin, is also needed to carry out the operation.  
 As a general guide, if lack of steering assistance from cold is experienced, renew the seals. A seal kit is available, Part No. JLM 10839.  
 To renew the seals, proceed as follows:

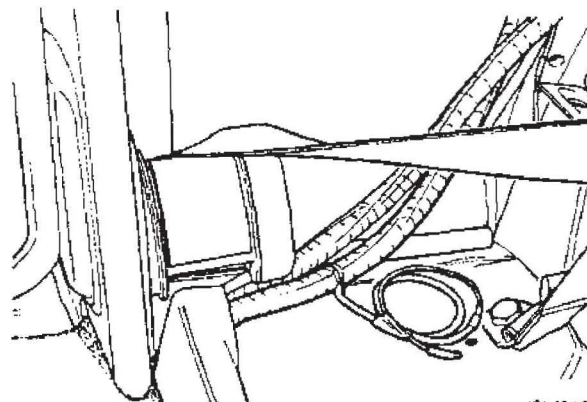
FIG 1

Investigation into Dealer reports of poor operation of the alarm system on XJ-S 92 MY vehicles has shown that a final operation has been omitted from the supplied installation instructions. Therefore, where customer complaints are received, the following action should be taken.

1. Remove the right-hand rear quarter lower trim pad assembly.
2. Identify the alarm antenna coiled in the harness (refer to Fig 1).
