Number I.1
Section Steering

FITTING TOOL FOR STEERING BOX TOP COVER

MODIFIED RACK AND PINION PRE-LOAD

INTRODUCTION OF MODIFIED UPPER STEERING COLUMN.

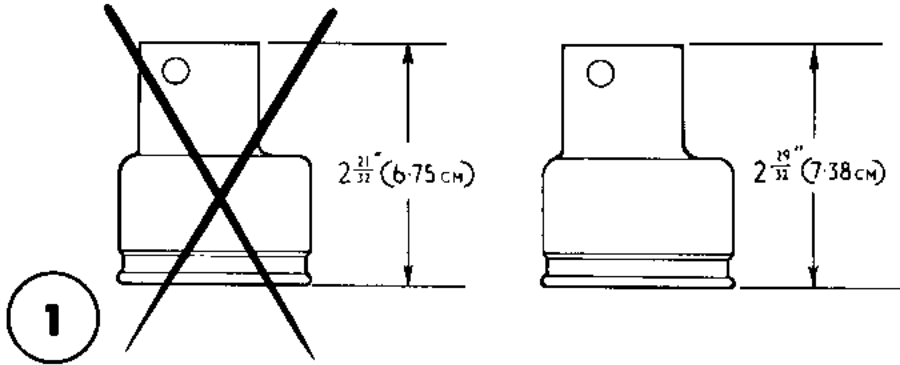
3. Measure the distance from the top machined face to the bottom machined face of the top joint socket on the lower steering column (See Fig.1). If it is less than $2.29/32"$ (7.38 cm) long a new socket (9980) should be fitted. (The socket to be replaced measures $2.21/32"$ (6.75 cm).

Having achieved the condition described in the previous paragraph now measure the distance between the top machined face of the top joint socket and the bottom of the chamfer on the inner column ("A" Fig.2) to ascertain if the spacing collar (C.22698) which is $1.3/32"$ (2.78 cm) long can be fitted. If necessary the spacing collar can be reduced in length by cutting at the unchamfered end.

4. Press the top joint socket down until it bottoms and then raise towards the upper column until a minimum of $3/16"$ (4.76 mm) or a maximum of $5/16"$ (7.93 mm) movement is achieved. This movement will be controlled by the position of the upper steering outer column which can, if necessary be moved forward to meet the lower steering column by adjustment at the fixing bracket to the dash and loosening the securing clip (C.2905/4) on the scuttle.
