REF: JD 02/91

REF: JD 08/92

ISSUE NO: JD 18/92

- MODEL** : XJS ALL MODELS
- SUBJECT** : WINDOW LIFT MOTOR / REGULATOR ASSEMBLIES
- CUSTOMER CONCERN** : Poor operation / sticking / noisy.
- ADVICE TO CUSTOMER** : Installation of a revised motor or a motor regulator assembly (which incorporates a new motor) will overcome sticking or noisy operation.
- New window lift motors have been introduced in production from VIN 184117.
- DEALER ACTION** : Yes.
- REPAIR METHOD** : Window lift assemblies incorporating the new motor are fully interchangeable with previous assemblies. All motors will be supplied with the necessary additional parts for fitment to vehicles prior to VIN 184117. If the new motor is required to be fitted to vehicles after VIN 184117, the additional parts supplied with the kit should be discarded. For details of part numbers and components relative to VIN, please refer to "Parts Information" below.

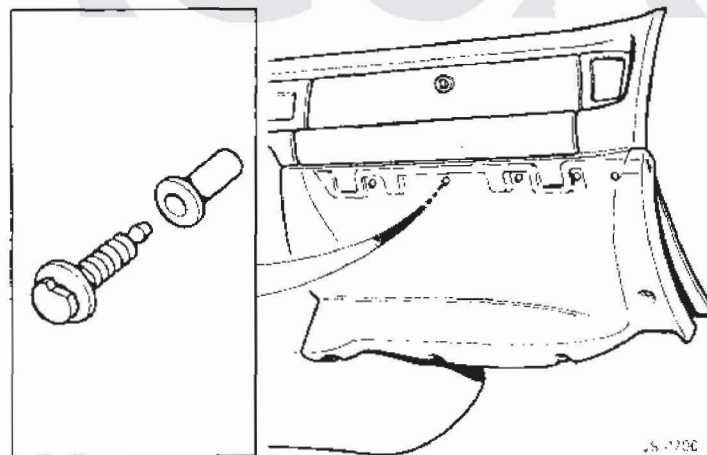
FIG 1

The visual appearance of the facia glovebox lid hinges has been improved on all vehicles built from VIN 658676. Hinges fitted to cars from this VIN are now finished in black.

When renewing / refitting a dash liner, the only fixings that should currently be used are the stud fastener push-in fixings (Part No AGU 1425). These should be used in conjunction with the stud anchor plastic retainers (Part No AJU 1136).
