Service Bulletin

JAGUAR

Date JANUARY 1984
Sheet 1 of 9
Bulletin JD.01/84

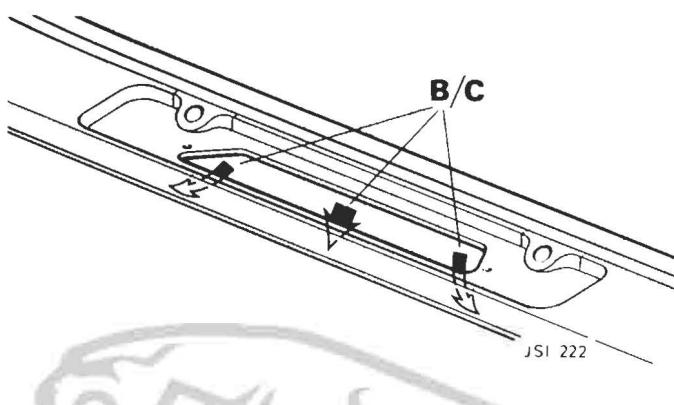
If the seams in this chamber are inadequately sealed, water can enter the vehicle footwells whenever the vehicle is exposed to heavy rainfall.

1. Remove plenum grille (Series III Workshop Manual Operation 80-15-29, XJ-S Workshop Manual Operation 84-15-12 – Items 1–7).
2. Apply sealant B or C by brush into all seams inside the chamber (Fig. 1).
3. Replace grille.

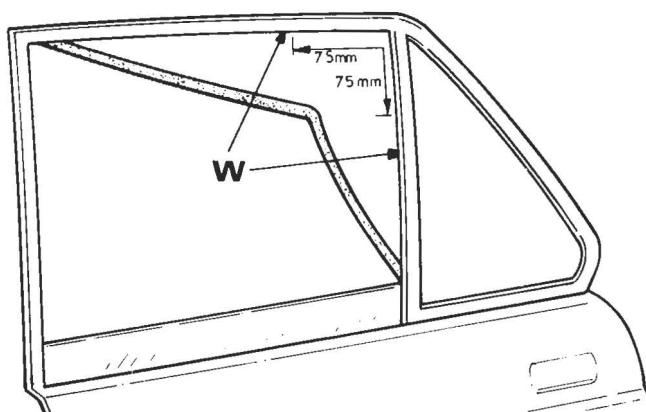
3. Water ingress and wind noise glass channels – All Doors – Series III & XJ-S (Fig. 3)

In most instances this is caused by gaps behind the window seals (BAC 1562 Series III, BD 46041 XJ-S), particularly at top corners.

- A Remove glass seal at points marked "W" (Fig. 3).
- B Apply sealant "E" into the channel corner and spread a bead 75mm (3in) from the corner in sufficient quantities to allow extrusion when the seal is refitted. Carefully clean off any surplus sealant.

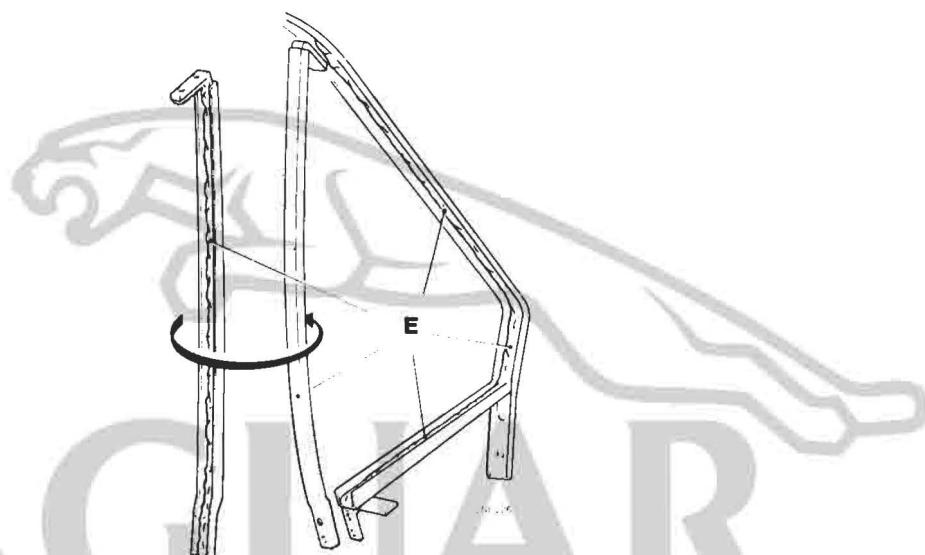
4. Water ingress and wind noise via rear door quarterlight – Series III only (Fig. 4)

Problem identification and rectification in this area is fully covered in Service Bulletin JD 04/83, Item 34. However, it is most important that ADEQUATE sealant is applied around the quarter light, especially at the base.

- A Refer to previous Bulletin and apply sealant "E" as directed in sufficient quantities to ensure that the excess will extrude when the quarter light is refitted.
- B Following assembly, wipe off all surplus sealant.

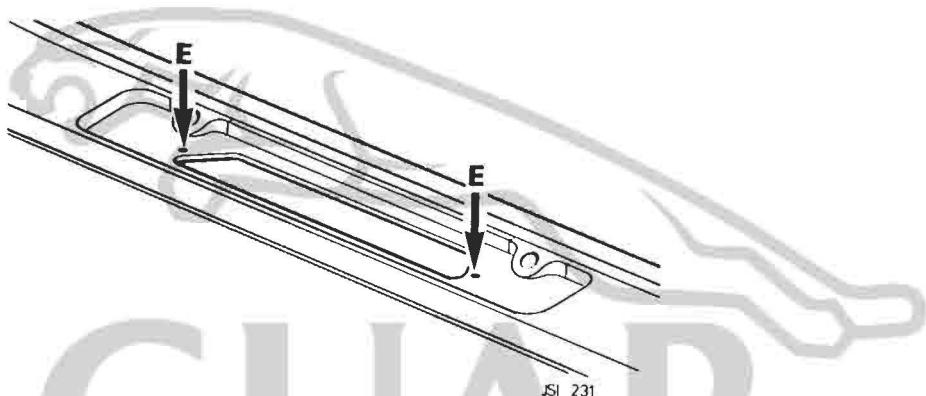
8. Water ingress via plenum grille mounting pin holes – Series III only (Fig. 8)

This may arise due to inadequate sealing around the two mounting pin holes, allowing water to enter the vehicle via the double skin.

- A Remove plenum grille (Workshop Manual Operation 80-15-29).
- B Remove two plastic inserts BD 26989.
- C Apply sealant "E" by brush to seal around the holes.
- D Allow ten minutes to dry and reassemble.

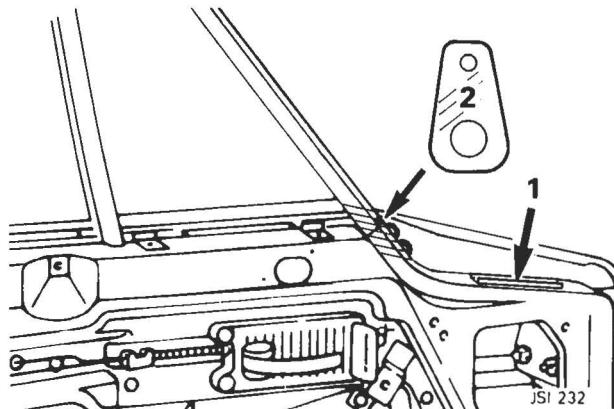
9. Water ingress and/or wind noise between door and "A" post at waist – XJ-S only (Fig. 9)

This may arise due to incompatible sealing surface between the window/door frame joint and the aperture seal, or distortion of the aperture seal by the door waist drain channel.

- A Remove and discard the door drain channel and plug the three redundant holes in the door, and paint as necessary (1 Fig. 9).
- B Test the vehicle to establish if the fault has been rectified.
- C If the fault is still apparent, remove the peardrop seal (2 Fig. 9).
- D Apply a proprietary body filler to the joint, DRESS OFF WHEN HARD TO ENSURE A GOOD PROFILE, refit screw and paint as necessary. This action, if properly carried out, will eliminate water leaks in this area.

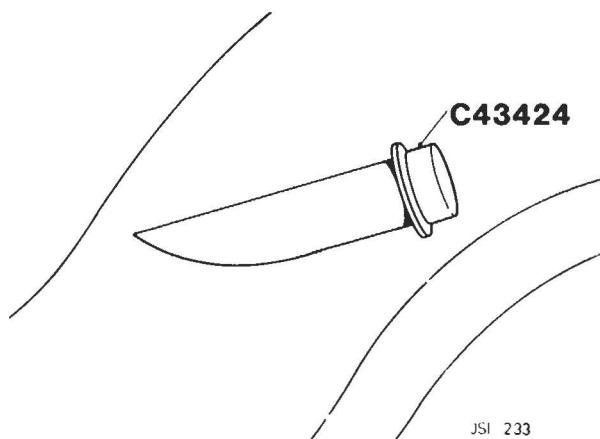
10. Water ingress via handbrake cable tube — XJ-S only (Fig. 10)

This complaint is caused by inadequate sealing of the cable exit, and/or blanking cap not being fitted. This area should be examined if water ingress is apparent in rear footwells only.

- A Check the sealing cap of the tube from which the cable exits, and rectify any leaks.
- B Check the plug C43424 for security over the blanking hole and rectify as necessary to ensure complete sealing.

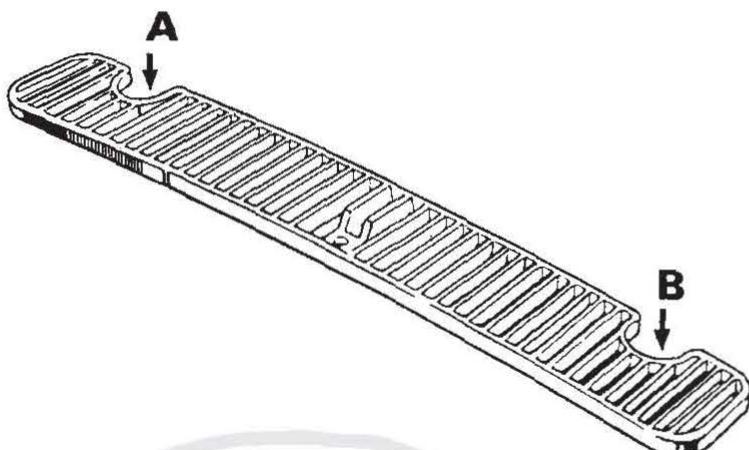
JSI-477

It is possible to damage the plenum grille using an incorrect method of removal, i.e. levering the grille free at the extreme ends.

To avoid damage, use a screwdriver with a narrow blade covered with cloth (preventing damage to grille paintwork), inserted at location A or B, between the plenum grille and panel. Gently lever the grille forward and up until the retention peg is free of the bush.

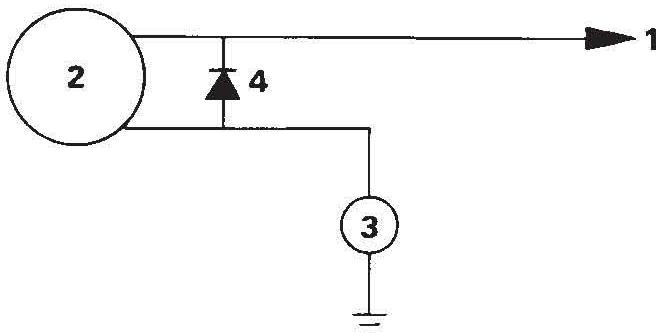
J86-510

The thermal fuse and superheat switch are deleted and replaced by a high side low pressure switch (HSLP). The superheat switch design was such that it detected pressure drop and superheated refrigerant vapour on the low pressure line. The HSLP switch is designed to monitor pressure drop on the high side line. At a low pressure condition of $25 \text{ psi} \pm 5 \text{ psi}$, the HSLP switch contacts, which are normally closed, open circuit, thus breaking the earth circuit to the compressor clutch coil; resulting in the clutch drive disengaging.

Where a definite fault is present in the air conditioning system e.g., low refrigerant, restriction, etc., the HSLP switch will remain open circuit until such time as the problem is corrected.

The need for the thermal fuse has been obviated with this system and significant benefits are gained especially where a transient fault occurs.

This condition has been experienced in service, and in some instances has resulted in vehicles being returned several times to a Dealer for the fuse to be replaced; although at the time the air conditioning system appeared to be fault free.

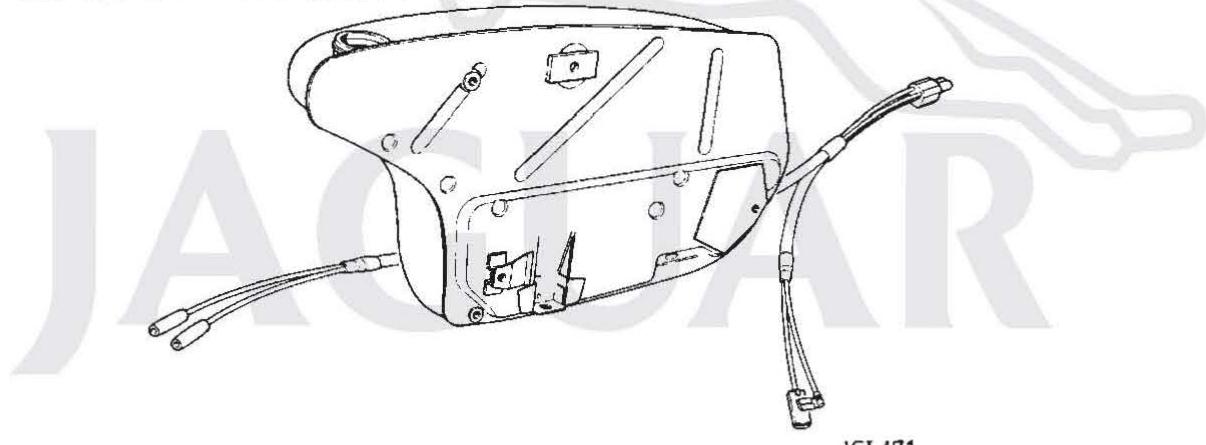
JSI-471

Due to service network demand, the fuel tank element and recirculation solenoid valve link harness, Part No. DAC 1744, is now available through the Parts Division.

DAC 1744 is routed/clipped beneath the fuel tank and is utilised on both R/H and L/H side tank assemblies.

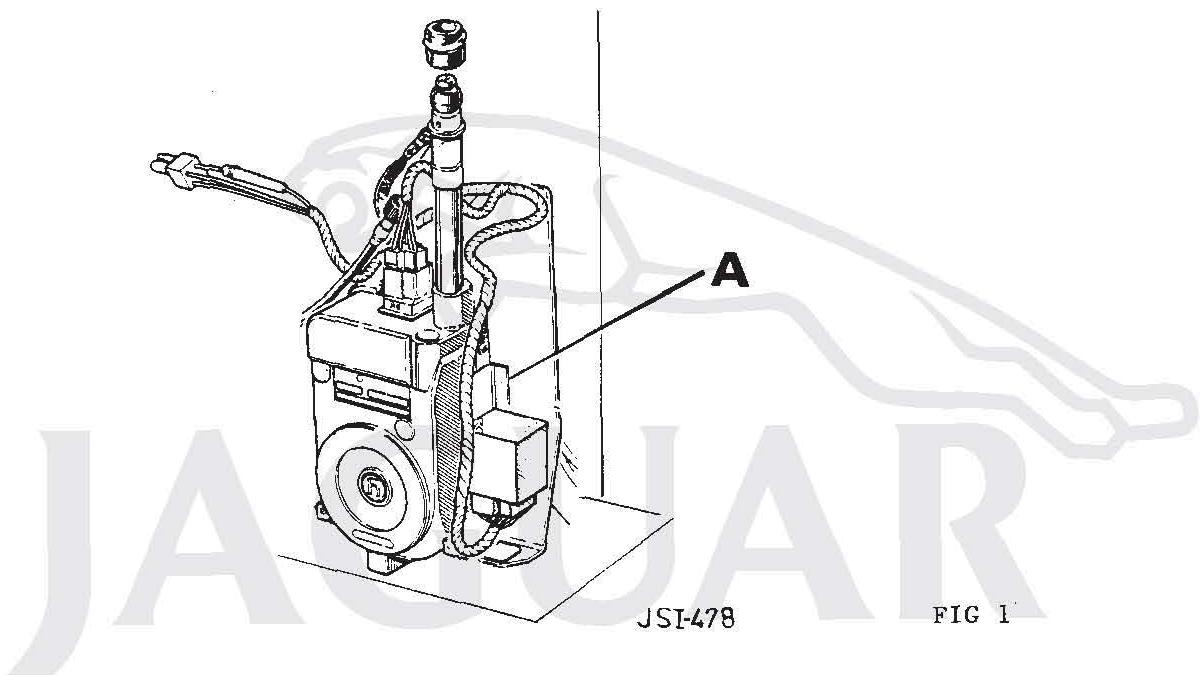
Vehicles in service prior to the safe VIN, where water ingress has affected the aerial relay, may be modified accordingly:

- a) Disconnect the battery and remove aerial trim panel.
- b) Release the excess relay harness from the clips beneath the inner wing panel.
- c) Remove the relay from the mounting bracket lug, invert and relocate onto lug.
- d) Ensure the harness is routed as Fig. 1 and is clear of the mounting bracket (A).

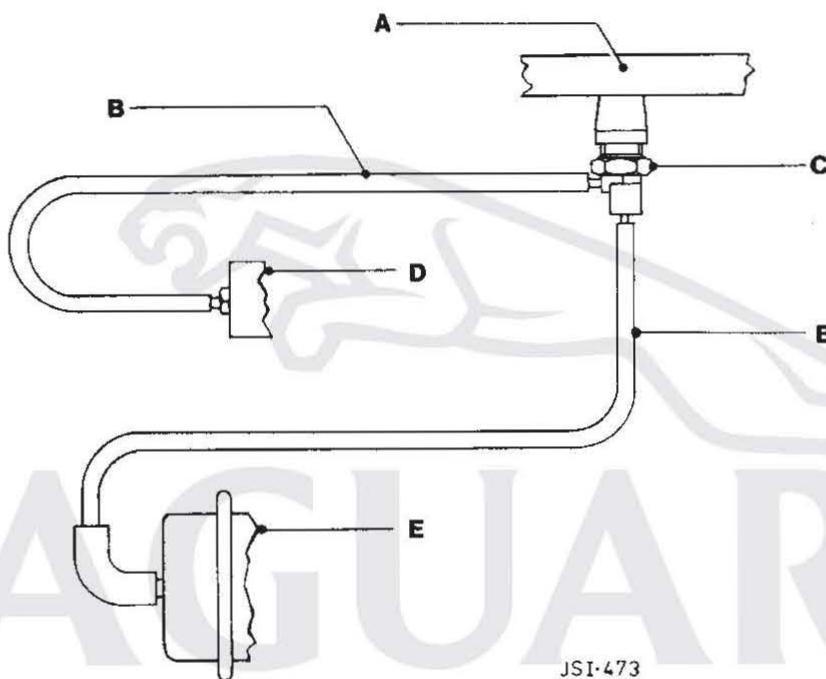
JSI-473

To overcome instances of poor hot start after heat soak, a thermal vacuum valve has been introduced to replace the fuel rail temperature sensing switch. This modification is intended for all V12 models but has been introduced initially on XJS in the above markets from VIN: 133461.

Remove and discard fuel rail temperature switch. Join wires together and tape back harness. Remove vacuum hose from outlet fuel pressure regulator to inlet manifold and discard, retaining the elbow and connector. Fit thermal vacuum valve to the fuel rail and cut 2 x 380mm (15") lengths of vacuum hose. Connect vacuum hoses as shown below.

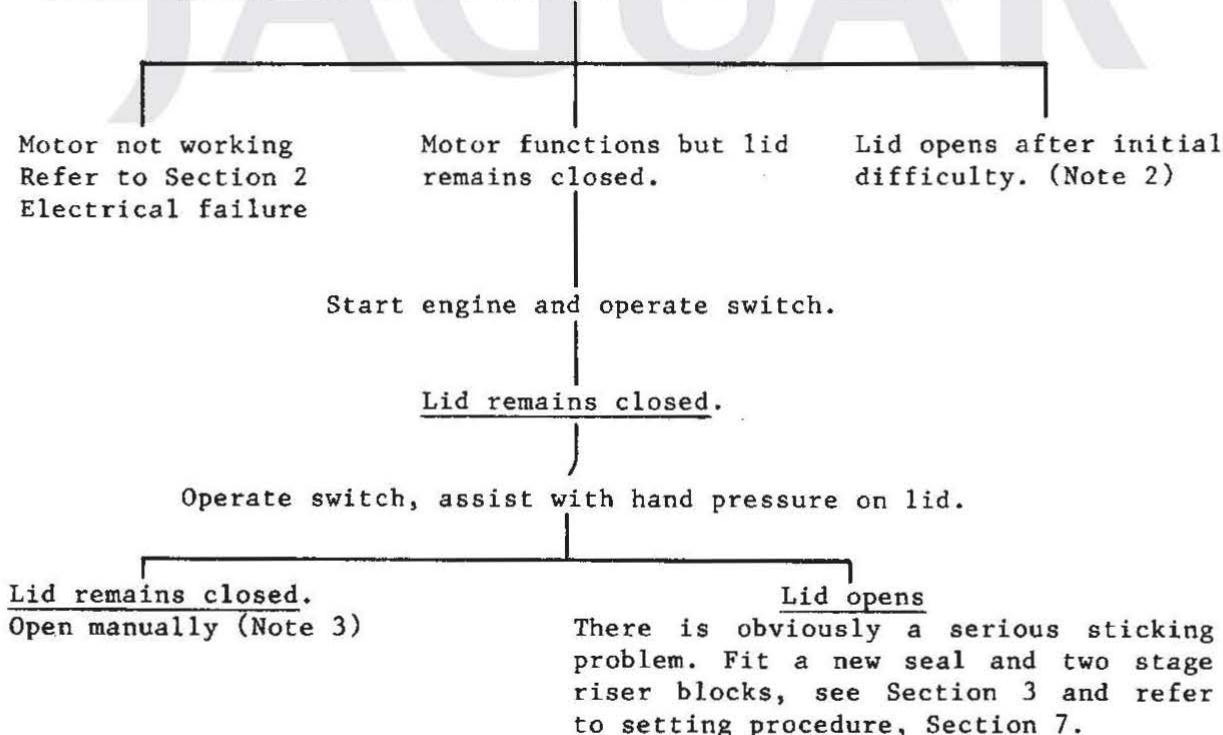
SECTION 1. LID FAILS TO OPEN.

NOTE 1. When the switch is operated intermittently, motor effort will be audible. If this cannot be detected then an electrical failure is indicated, refer to Section 2.

Switch ignition on, operate sunroof switch intermittantly. (Note 1)

NOTE 2. Thoroughly clean the seal and aperture with solvent SBP 3 or similar. DO NOT USE PAINT THINNERS. After cleaning smear the seal lightly with lubricant, e.g. Hellering or similar.

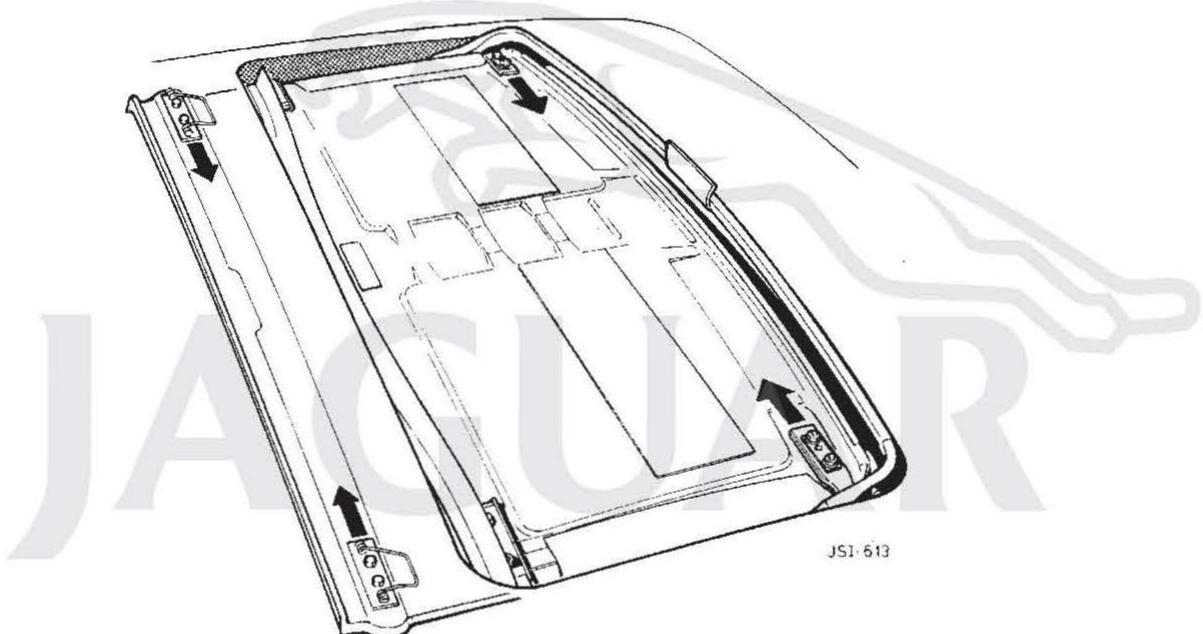
FIG 5

Check the sliding panel undertray for excessive side play and reset if necessary as follows:

1. Remove the sliding panel for access, refer to Section 3A.
2. Release front mounting bracket securing nuts and rear mounting setscrews sufficiently to allow movement of the brackets (Fig 5).
3. Ensure the undertray is fully forward onto the stops.
4. Slide the brackets in towards the centre line of the vehicle, and tighten the mounting brackets.
5. Lightly grease both panel slides.
6. Operate the sunroof electrically, open and closed, to test the movement.
7. If the vibration persists, check the drive cable and motor lubrication as detailed in Section 4.

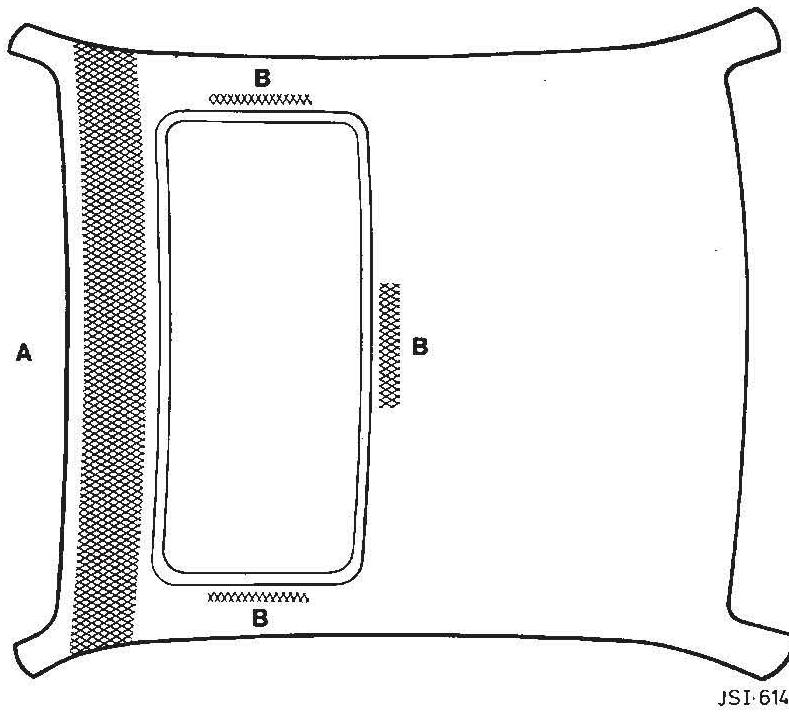
FIG 6

SECTION 6. CREAKS AND RATTLES**CREAKS.**

Sunroof creaks are identified in JD 01/86, Item 4. From information received it is recognised that the foam strips specified may need to be complemented with additional packing to rectify a severe creak.

1. Fully open the sliding roof panel.
2. Carefully displace the aperture flange finisher.
3. Remove the headlining retaining clips from the aperture flange.
4. Remove both sunvisors and the interior mirror and mounting.
5. Gently pull down the headlining sufficiently to insert foam packing (Fig 6).
Material A - 16.5 cm x 100 cm x 4 mm self-adhesive foam rubber.
Material B - BAC 1982 - 3 off.
6. Reverse operations 1 to 4.

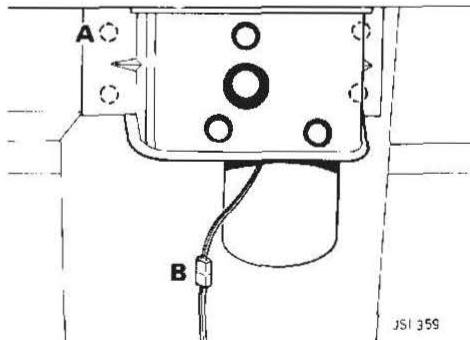
FIG 10

SECTION 8. SUNROOF MOTOR/WHEELBOX/DRIVE GEAR

1. Remove the rear seat cushion and squab, refer to operation 76-70-37/38.
2. Remove the two nuts securing the wheelbox cover and remove the cover.
3. Remove the racks from the housing.
4. Remove the four nuts securing the motor mounting bracket to the rear bulkhead (A Fig 10).
5. Open the boot lid and remove the front trim panel to gain access to the motor.
6. Disconnect the electrical harness (B Fig 10).
7. Remove the motor and mounting bracket assembly.
8. Remove the three hexagon headed screws securing the motor to the bracket (C Fig 10) and remove the motor.

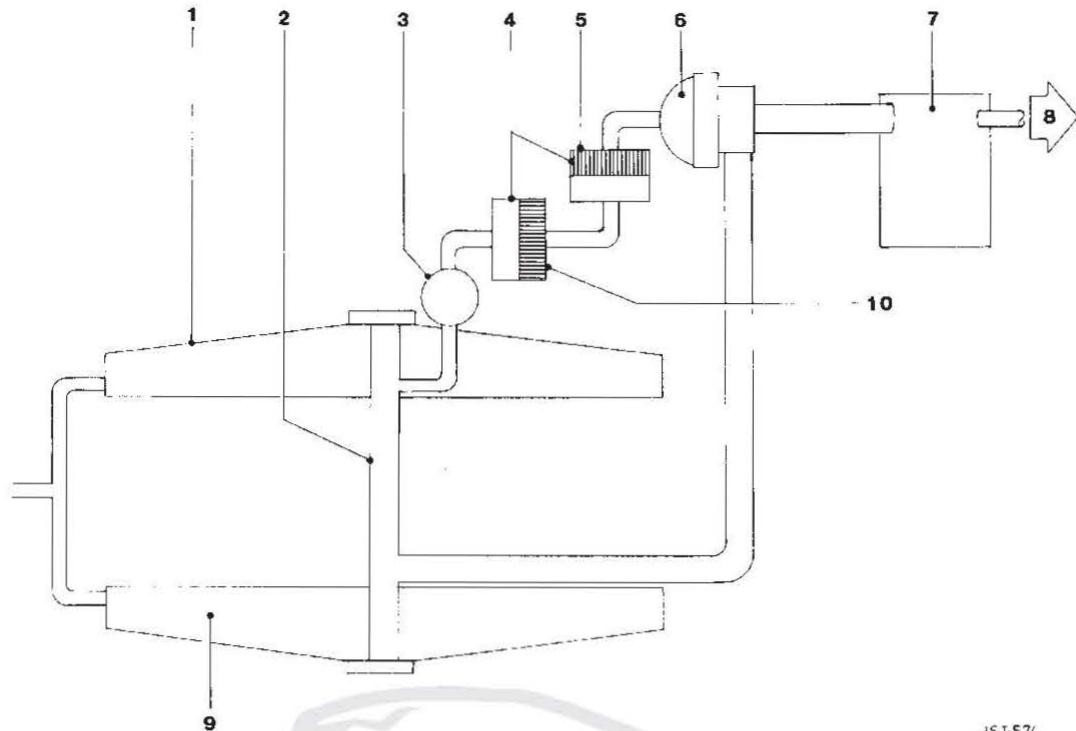
FIG.1

A revised purge control system with vacuum operated switching replacing electrical switching has been introduced on XJS V12 models providing a more stable idle condition when manouevring at low speeds (see Fig.1 on next page for schematic layout). This modification effectively delays carbon canister purging for a few seconds as engine speed increases just off idle, preventing a possible over-rich mixture.

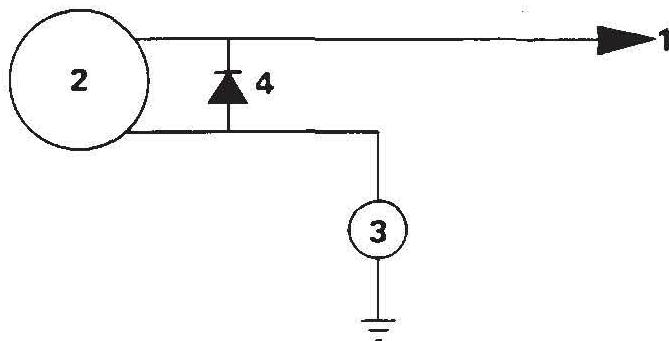
HSLP WIRING DIAGRAM

The HSLP switch is designed to monitor pressure drop on the high side of the system. At a low pressure condition of 25 psi \pm 5 psi, the HSLP switch contacts, which are normally closed, open circuit, thus breaking the earth circuit to the compressor clutch coil resulting in the clutch drive disengaging.

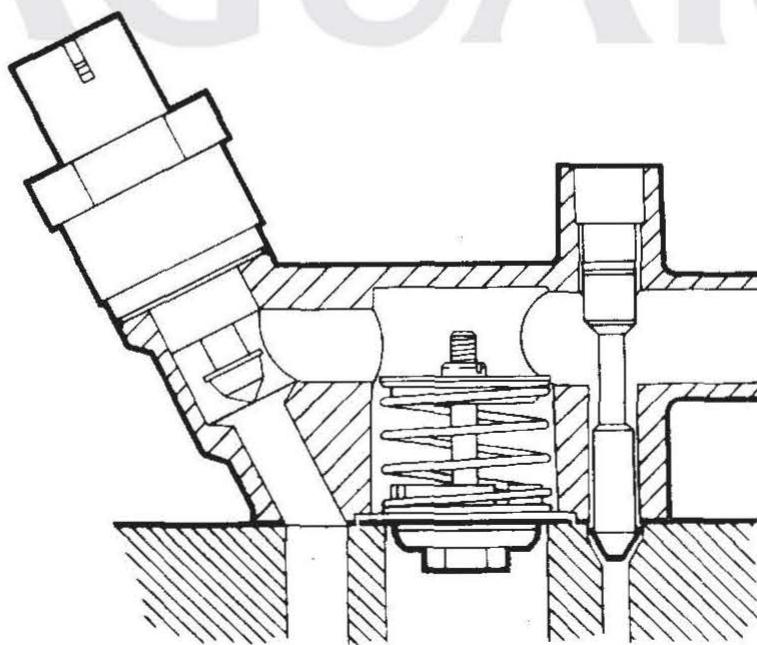
FIG 1

Reports have been received that following the replacement of the idle speed control valve, the engine base idle speed cannot be reduced to specification.

Should this problem be experienced, loosen the four idle speed control valve retaining screws and reposition the valve to ensure that the tapered end of the adjusting screw is centralised with the inlet manifold by-pass drilling (Fig 1).

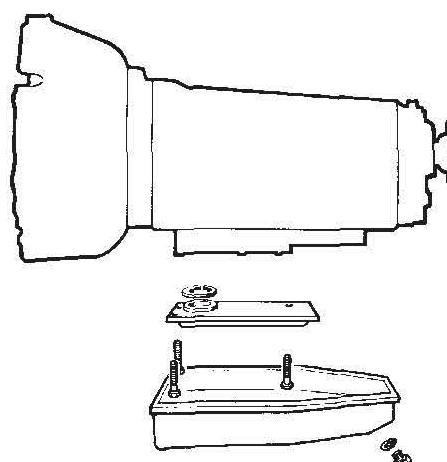
Fig 1

Where instances of this complaint are reported on **XJ6** 3.6 models the valve block assembly can be replaced by a revised valve block, which is available as a serviceable item. This instruction does not apply to XJS 3.6 Models.

1. Drive the vehicle onto a ramp. Ensure that the vehicle is in 'Park', with the handbrake applied. Raise the ramp.
2. Remove the transmission oil sump drain plug and drain the fluid into a suitable clean container. Protect against contamination.
3. Remove the oil sump pan and filter. Discard the 'O'-ring seal (Fig 1).

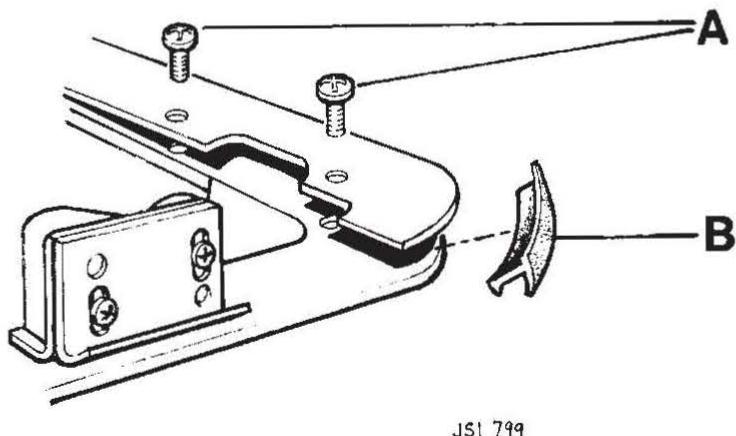
FIG 3

Where a dealer receives a complaint of poor rear profile of the sliding panel on sunroof vehicles, examination may highlight a condition where the sliding panel rear edge is unacceptably below the profile of the roof panel.

5. Release and remove two screws at each rear corner of the seal clamping plate (A Fig 3).

6. Apply adhesive to the seal inserts JLM 1500 (B Fig 3) and position under the clamping plate. Note position of seal section illustrated.
7. Refit and tighten the securing screws.
8. Refit the sliding panel, insert the forward screws but do not fully tighten. Close the panel, set the profile, re-open and tighten the screws.
9. Check the sliding panel operation.

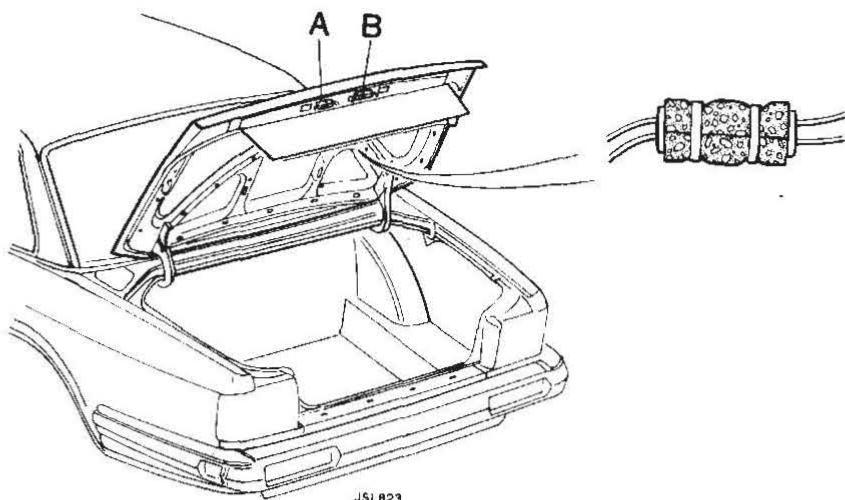
Fig 1

To prevent a rattle occurring between harness connectors (see Fig 1) for connector locations and the boot lid inner assembly, modification was introduced at VIN 530760. To rectify any vehicles which were built prior to this VIN the following procedure should be undertaken.

- 1 Open the boot lid, locate and remove the interior lamp and plastic cover panel. (Fig 1) items A and B.
- 2 Remove/expose the harness connectors for the boot interior light and boot latch switch. (Fig 1).
- 3 Using foam insulation sleeve CAC 4307/1 cut into 5 equal lengths of approximately 100mm. Then using a sharp knife or pair of scissors cut each sleeve along its length.
- 4 Wrap a sleeve around each of the exposed connectors. Secure in position using two tie straps (Part No ADU 9238). Cut the excess plastic tails on the tie straps. (Fig 1).
- 5 Replace the harness connectors, boot inner light and plastic cover panel.
- 6 Test the vehicle for rattles.

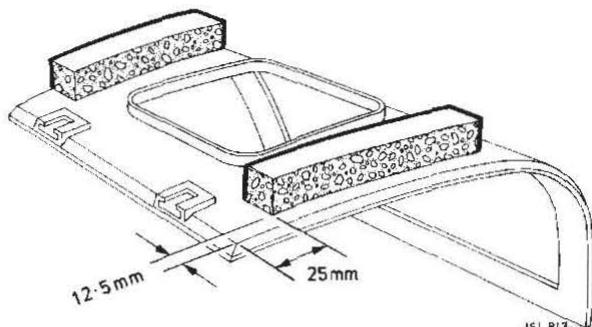
Fig 2

To eliminate a problem of harness connectors rattling/vibrating against the underside of the centre console finisher a modification was introduced on all model variants from VIN 525078. This modification called for foam pads to be added to the finisher at the locations indicated in (Figs 2 and 3).

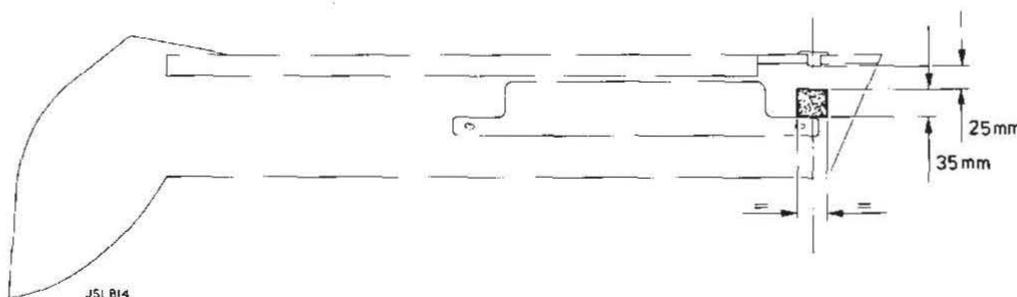
Fig 9

Reports have been received highlighting a rattle which occurs when the sill button makes intermittent contact with its bezel surround. To correct vehicles with this complaint modification has also been introduced on all new vehicles from VIN 531580. Fit the foam pad to the door top roll inner face at the location indicated in (Fig 9). This pad puts a constant load on the link sill rod, which prevents any intermittent movement of the sill button in its bezel. To modify cars in service which are experiencing this complaint prior to the previously stated VIN – the following rectification method should be carried out.

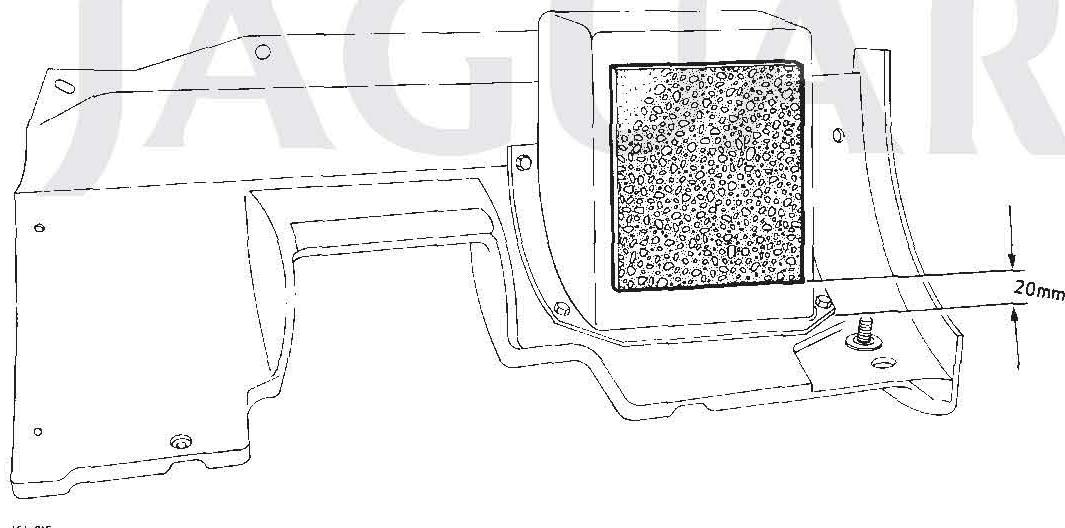
Fig 10

To prevent harness connectors rattling against the above component. An anti-rattle pad was introduced on all models from VIN 526250. The location of this pad is shown in (Fig 10).

- 1 Remove the driverside underscuttle assembly.
- 2 Apply self adhesive anti-rattle foam pad Part No BDC 6348 to the coin box at the position indicated in (Fig 10).
- 3 Replace the underscuttle assembly, and test vehicle for rattles.

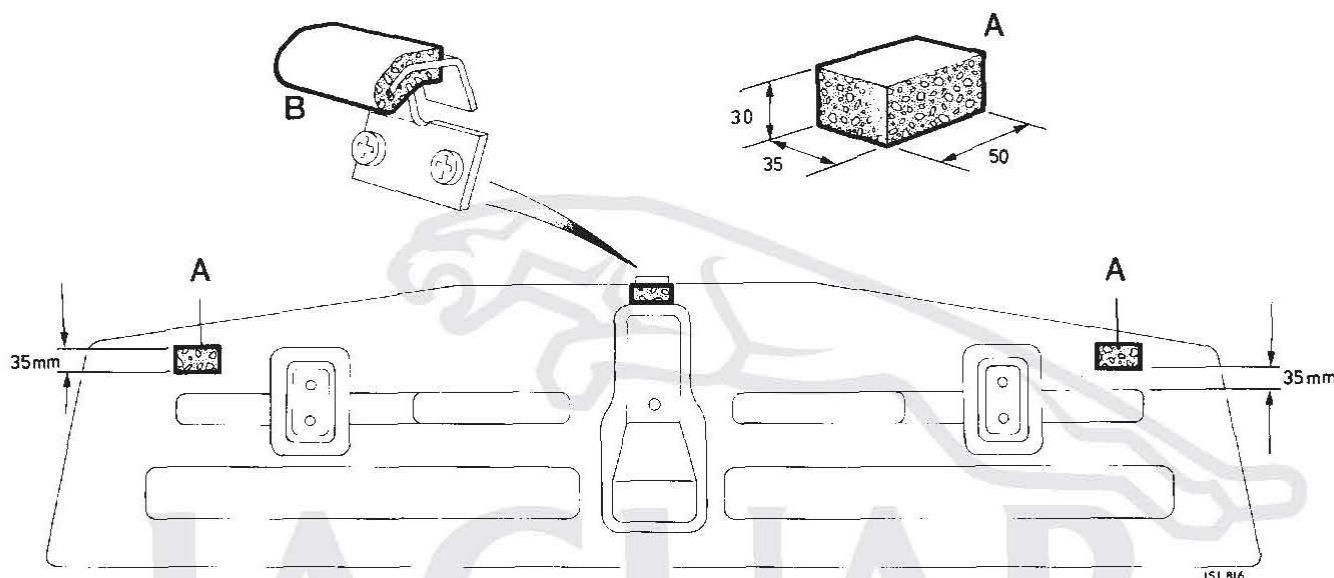
Fig 11

Rattles from the rear parcel shelf trim panel have been eliminated from VIN 527904 when a modification was introduced which incorporates the use of anti-rattle foam pads at three locations. (Fig 11).

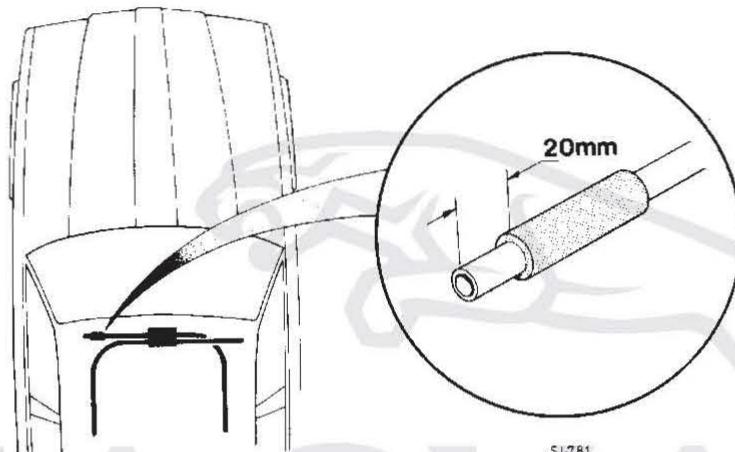
Fig 12

Service have identified a rattle caused by intermittent contact between the roof panel and one of the sunroof motor drive cable tubes. The location of this rattle is above the left-hand sunvisor between the roof panel and headlining. The cause is the free end of the right-hand motor drive cable tube. To eliminate this fault a foam covered tube was fitted to all vehicles with sunroofs from VIN 527420.

- 8 Fit the foam sleeve onto the end of the offending tube until 20mm of the tube protrudes through the sleeve (Fig 12).
- 9 Reverse the removal procedure to refit all components.

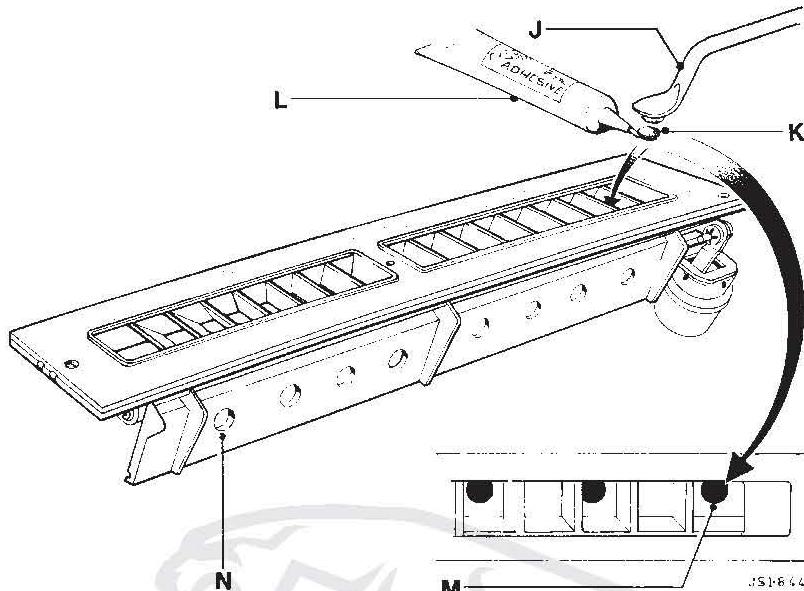
FIG 7

8. Repeat the operation on both screen flap assemblies until all accessible holes are plugged.
9. PLEASE NOTE that the bleed holes on both the right-hand and left-hand flap assemblies (Fig 7 N) are inaccessible when applying this service fix.

3. Switch the ignition on, start the engine and leave running to maintain vacuum to the air conditioning system.
4. Turn the air conditioning panel left-hand control knob to either 'High', 'Norm' or 'Low' position and ensure that the 'Air' button on the fascia control panel is off. The screen vents should now be fully closed.
5. Using a suitable tacky substance with low adhesive properties, attach a small quantity to the end of the tool (Fig 7 J) and attach a plastic plug, Part No. BAC 2698, to the tool (Fig 7 K).
6. Using a suitable proprietary trim adhesive, eg Dunlop 1358, apply sparingly to the outer edge of the plug (Fig 7 L).
7. Carefully locate and position the plug into a screen flap bleed hole (Fig 7 M) and ensure the plug is fully located by applying slight pressure.

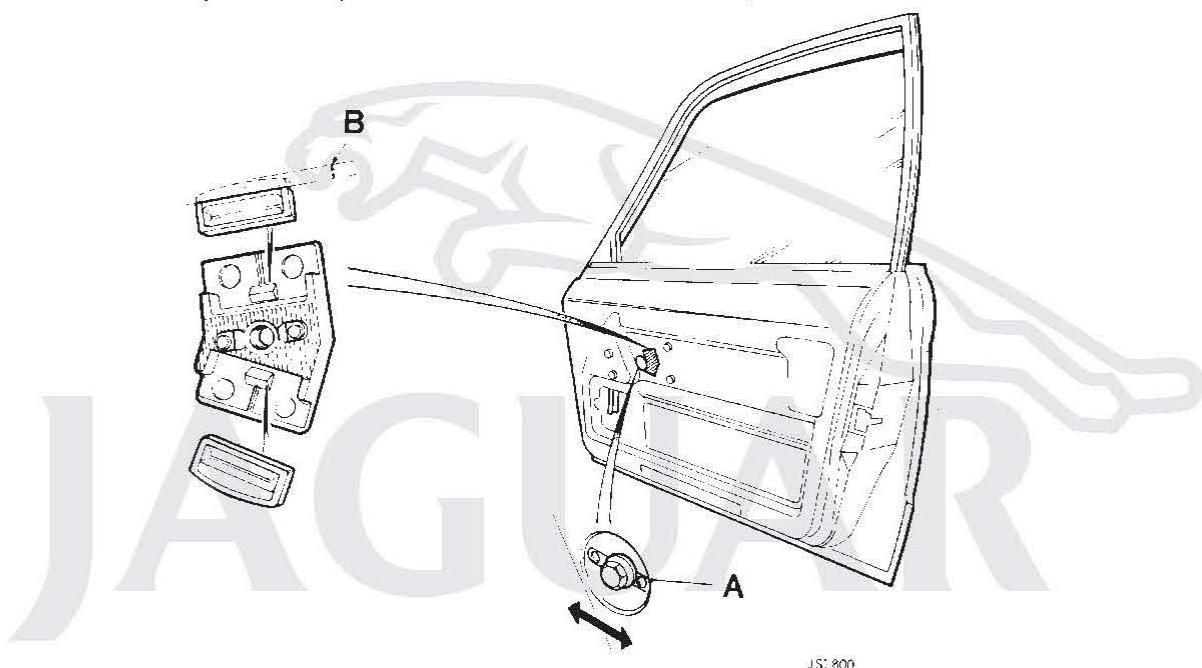
FIG 1

As a consequence of this modification, following replacement of a window regulator, some windnoise may become apparent if the glass will not seal fully into the upper channel at full closed position.

1. With a new regulator fitted, connect the window switches and turn the ignition on. Slightly release the regulator stop to allow full travel and motor the glass to fully closed position.
2. Check the glass position. Should a gap be evident the upper regulator stop must be modified.
3. Release and remove the window stop bolt (A Fig 1. Note: Front door shown). Remove the stop assembly.
4. Mark out and remove 3mm from the upper nylon block using a file (B Fig 1).
5. Refit the stop assembly into the door but do not fully tighten.

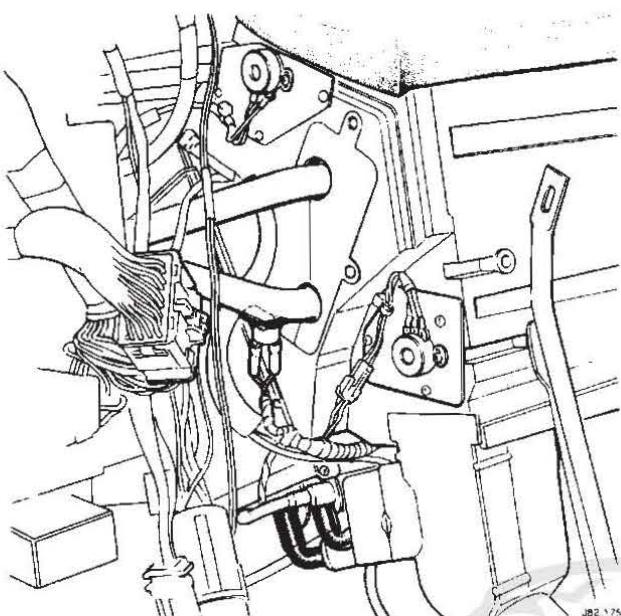
FIG 1

To achieve a more consistant differential and acceptable temperature blend, the supplier jig set position of the rotary flaps has been revised, with units to the latest condition being introduced from VINs:-

- 1) Remove the necessary passenger's and driver's side underscuttle trim to gain access to the lower feed back potentiometer (L/H side Fig 1), and E.C.U. (R/H side Fig 2).

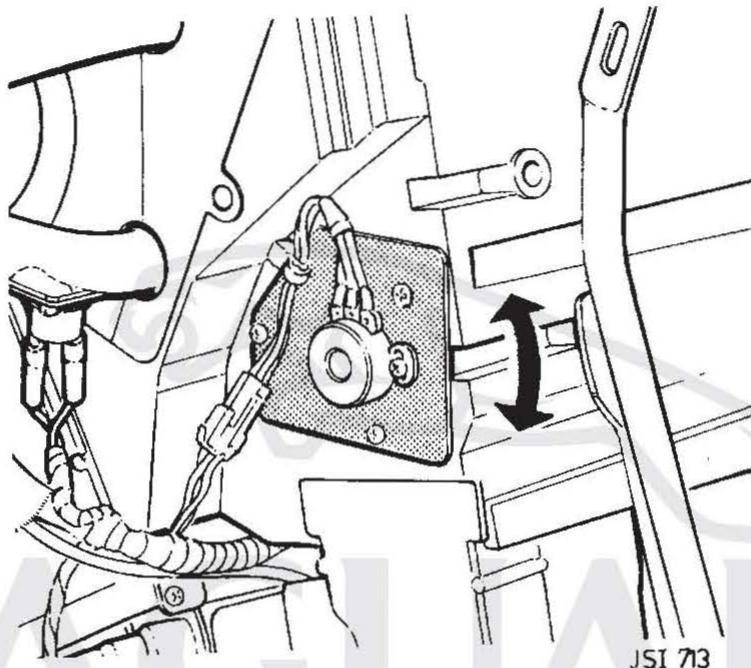
FIG 6

If the temperature differential is outside the specification or in extreme cases inverted, the following adjustment may be carried out. Slaken the lower feedback potentiometer securing screws and correct any temperature anomalies by adjusting the potentiometer as follows:-

- 1) Clockwise for cooler air at the footwell outlets to reduce the differential.
- OR
- 2) Anti-clockwise for warmer air at the footwell outlets to overcome inverted temperature differentials (Fig 6).

IMPORTANT: The slightest adjustment of the potentiometer results in a significant change in the position of the lower rotary flap.

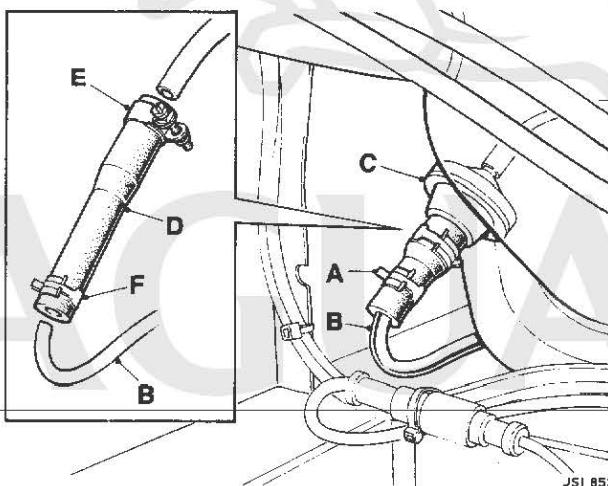
FIG. 1

Changes have been made in the design and specification of the fuel tank breather system and introduced on the above models to:

- Reduce pressurisation of the fuel tank
- Avoid instances of rough running during slow speed manoeuvring

2. Using a suitable pair of pliers, slacken the spring clip (Fig. 1 A) to enable the vapour pipe (Fig. 1 B) to be disconnected from the hose.
3. Bend back the tag securing the fuel tank plastic vapour pipe to the tank. Reposition the pipe and valve assembly for access.
4. Remove the valve (Fig. 1 C) from the plastic vapour pipe. Remove the hose from the valve and place the valve to one side.
5. Cut off the swaged end of the plastic vapour pipe.
6. Fit the larger bored end of hose, Part Number CAC 1853/5, (Fig. 1 D) to the fuel tank plastic vapour pipe. Secure with the hose clip, C43599/6 (Fig. 1 E).
7. Position the plastic vapour pipe along the side of the fuel tank and secure with the retaining tag.
8. Refit the underfloor vapour pipe to the other end of the hose and secure with spring clip, CAC 8772 (Fig. 1 F).

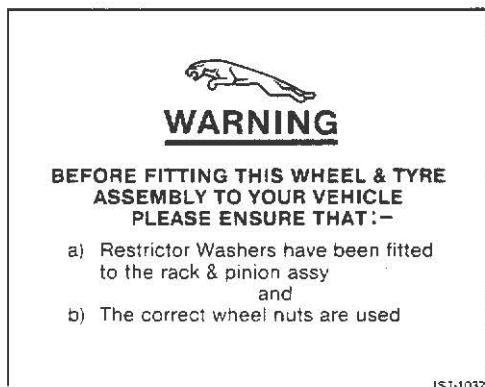
FIG 2

To emphasize this, a warning label is supplied with each wheel/tyre assembly as shown in Fig 2 below. Instances have been noted where the warning label has been disregarded and sports alloy wheels fitted without the fitting kit. Dealers are advised that this practice is highly unsatisfactory.

The 12mm restrictor washers supplied in the fitting kit, **MUST** be fitted to prevent a foul condition between the sports alloy wheels' low profile 235/60 tyres and the bodywork, as the steering approaches full lock.

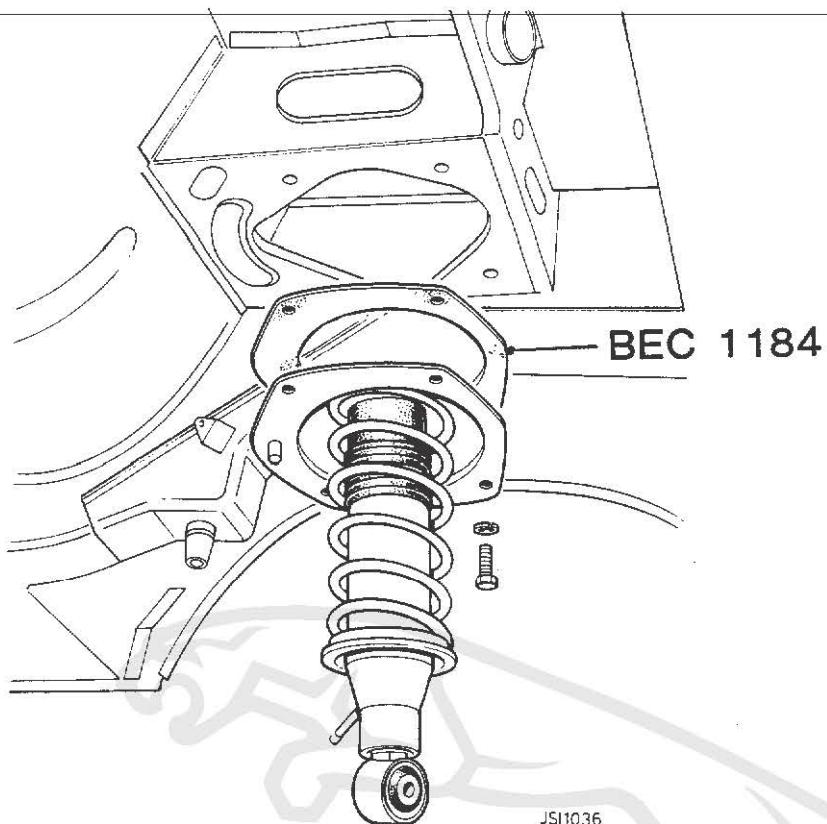
FIG 1

Investigation into noises emanating from the rear suspension has identified that a creak can occur where the upper shock absorber assembly mounting bracket locates into the body aperture. To eliminate further instances of this fault, a spacer has been fitted (Fig 1) on all XJ6 vehicles built from VIN 571642.

This spacer is now available via Parts Supply and may be used as a retrospective in-service fix on vehicles with this fault.

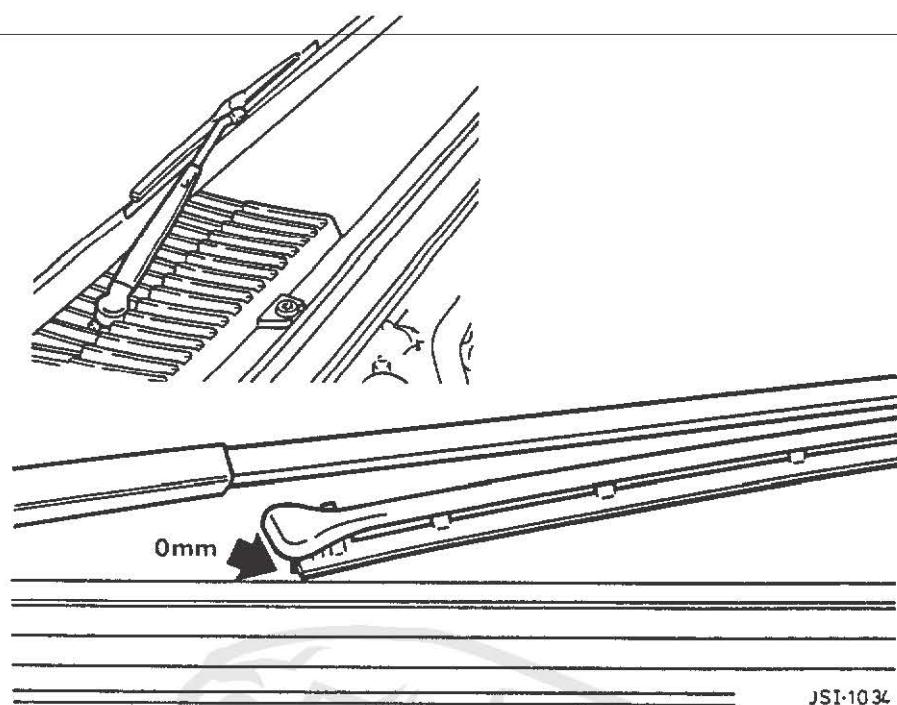
DIAGRAM C

Passenger side RH Drive shown.
LHD is symmetrically opposite.

Fit the wiper arms and blades as shown in Fig 2, Diagrams (C) and (D).

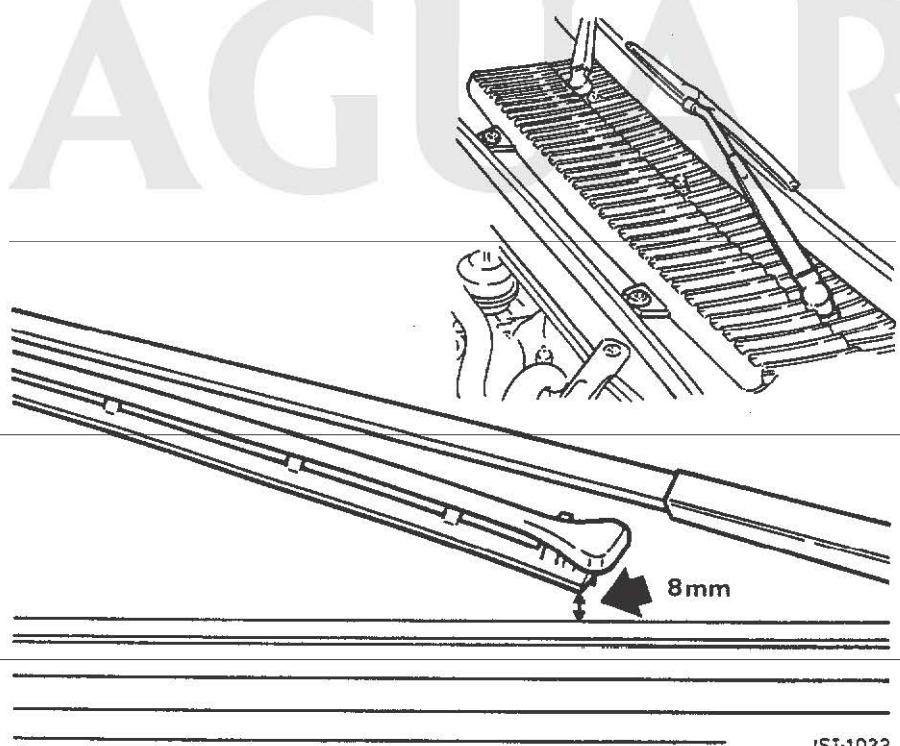
DIAGRAM D

Driver's Side LH Drive shown
RHD is symmetrically opposite.

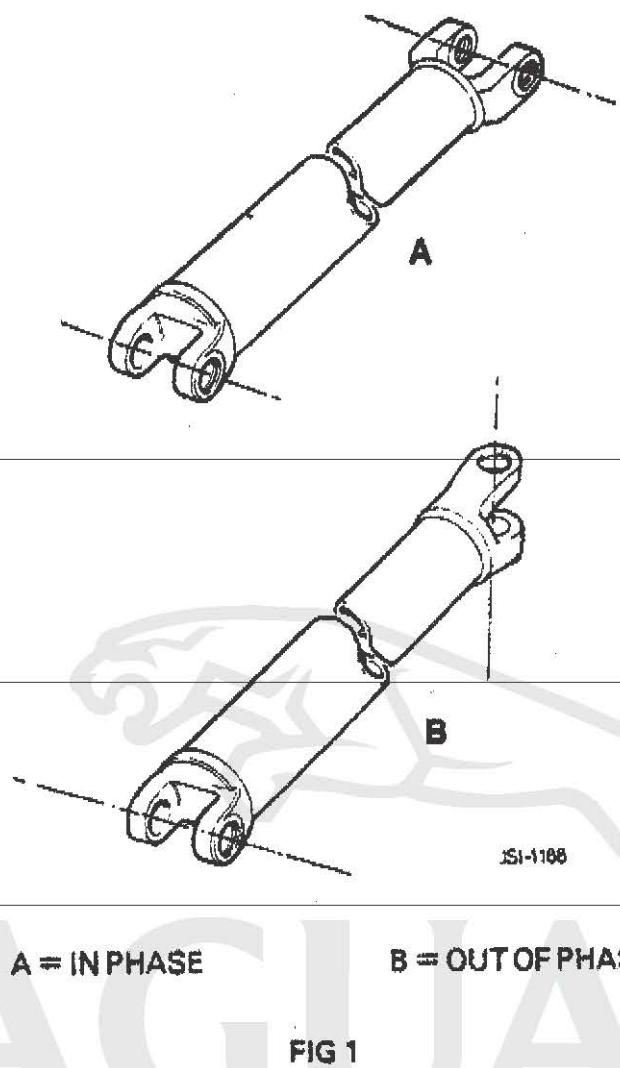
Instances of shudder at 15 mph (25 kph) on early "OUT OF PHASE" front propeller-shaft joints have been reported. To overcome this condition the fitment of an "IN PHASE" joint, Part No. EBC 3810, is required.

A = IN PHASE

B = OUT OF PHASE

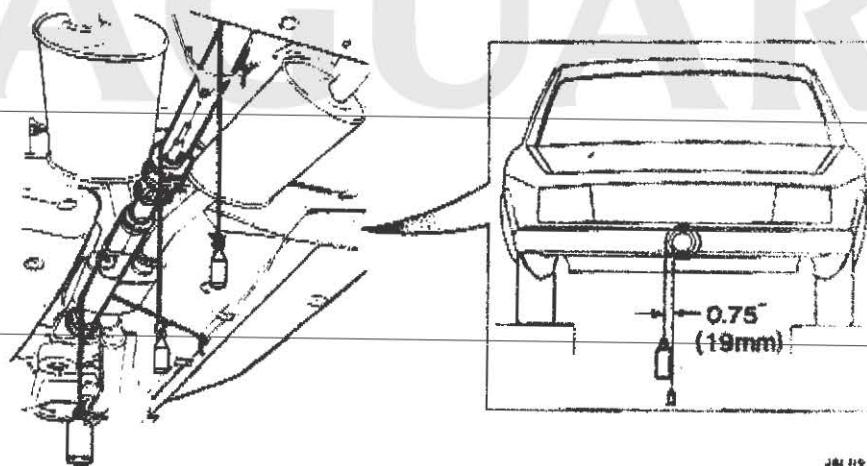
**FIG 2**

With the propeller-shaft in perfect alignment the plumb-lines will be offset by 19mm, see Fig 2C. This offset is caused by the differing front/rear propeller-shaft tube diameters. The required alignment is 21mm and the centre bearing should be adjusted to the left until this is achieved.

- a) Check the drive-in alignment.
- b) Check the gearbox mountings and ensure that it is set correctly, i.e. the centre stud is central to the inspection hole in the base of the cross-member.
- c) Ensure that the gearbox cross-member is central on the body fixings, i.e. not hard to one side and also ensure that there is no side load due to the incorrect setting of the front engine mountings.
- d) Check the propeller-shaft alignment using plumb-lines, i.e. attach taut strings to the propshaft, see Fig 2. Position plumb-lines at each end of the tube, avoiding welds and balance weights. This means that allowing for the difference in the propeller-shaft tube diameters, when correctly aligned, the distance differential between the centre plumb-line and the straight line through the fore and aft plumb-lines should be 19mm.
