Service Bulletin

JAGUAR

Date JANUARY 1984
Sheet 1 of 9
Bulletin JD.01/84

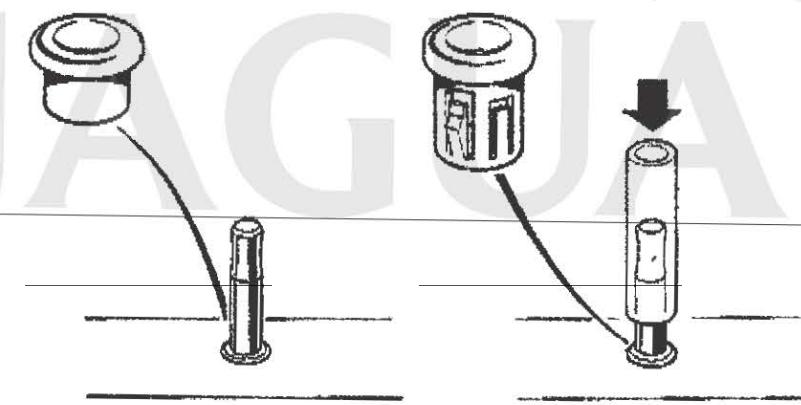
FIG 1

A new self-locking, door top crash roll chrome bezel (locking button surround) has been introduced on all XJ6 models built from VIN 603711. The new bezel, Part No. BCC 9790, replaces the existing 'bonded' bezel, Part No. BBC 9033.

1. Remove and discard the detached bezel, Part No. BBC 9033 (See Fig 1).
2. Fit the new bezel over the locking button and locate in the door top crash roll.
3. Push home the bezel into the crash roll until fully located (refer to Fig 2). To avoid damaging the chrome finish, use a length of suitable diameter hose.

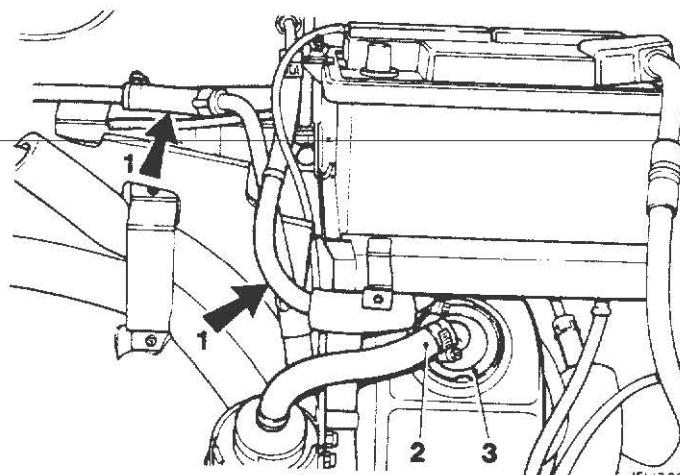
FIG 1

An improved sump tank venting kit has been introduced as a service fix for all XJS models to overcome drive hesitation caused by fuel vaporisation under adverse climatic/fuel supply conditions.

1. Open the boot, remove the spare wheel cover and the wheel, battery cover, boot floor carpet and the RH boot side liner. Pull back the RH side of fuel tank carpet.
2. Using suitable tools, clamp the hoses in the positions shown (1 Fig 1) to the fuel tank/auxiliary tank hoses.

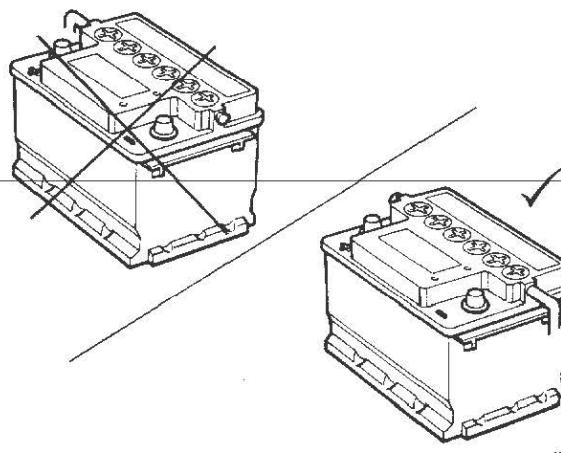
**FIG 1**

A new DIN 55 battery has been progressively introduced on XJS models from VIN 175174.

Any supplies of this new unit obtained through Parts Operations will require the re-locating of the vent elbow from the positive side to the negative side of the casing. The blanking plug in the opposite side will also need to be transposed as in Fig 1 below.

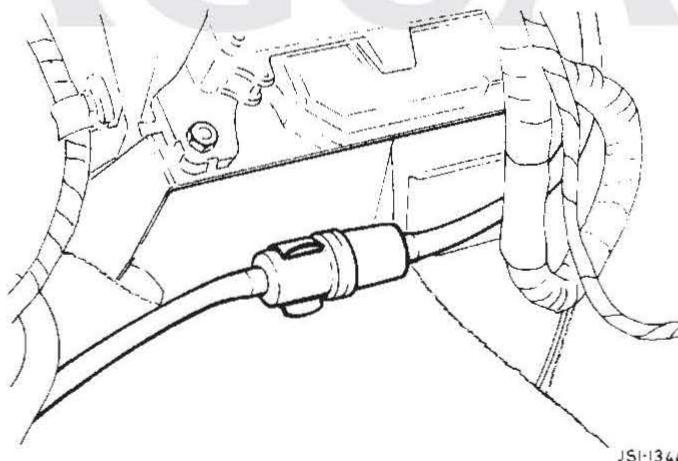
PLEASE NOTE: WITH REFERENCE TO SERVICE RECALL ACTION R.351 (FUEL SYSTEM PURGE MODIFICATION), THE IN-LINE CAPSULE CAC 4968 REFERRED TO IN THIS BULLETIN IS DELETED ON V12 NON ELC (EVAPORATIVE LOSS CONTROL) MODELS WHEN THE PURGE MODIFICATION KIT IS INSTALLED.

Replacement capsules are available through the Parts Operations, Part No. CAC 4968.

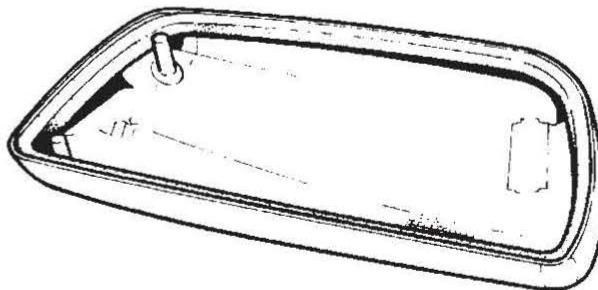
FIG 5

4. Inspect the self adhesive foam gasket. Displacement of the gasket from its correct position, and the resultant gaps between the finisher and the housing, is an indication of the probable source of wind noise. Fig 5 shows the correct position of the foam gasket.

5. Correct the faulty condition by applying a bead of adhesive to the inner surface of the finisher, as shown in Fig 6.

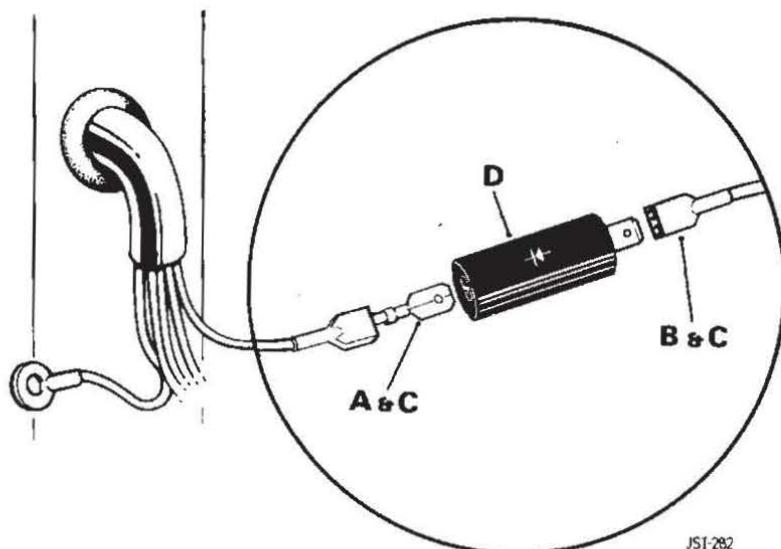
FIG. 2

Through subsequent investigations, the cause has been traced to a feed back circuit developing through the interior light circuit which is also protected by the same fuse link.

3. Locate the interior door switch purple/white (PW) cable and cut.
4. Fit insulations sleeves (C, Fig. 2) and crimp/solder Lucas connector (A and B, Fig. 2), to the purple/white (PW) cable. Connect diode unit (D, Fig. 2) in circuit and strap or tape to the harness.

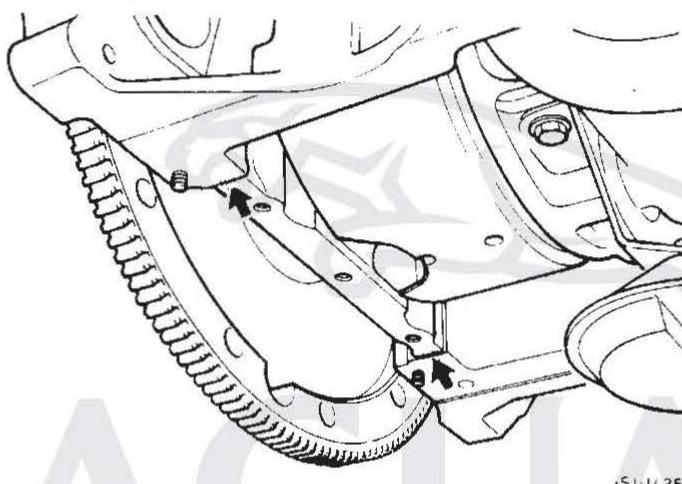
FIG 1

When removing or replacing the sump sandwich plate gasket, would Dealers please note that to help prevent the possibility of oil leaks, additional RTV sealant should be applied as follows:-

A bead of RTV sealant approximately 3 mm wide and 10 mm long should be applied in the middle of the joint line between the cylinder block and the rear main bearing cap in two positions (Fig 1) before the sump sandwich gasket is fitted.

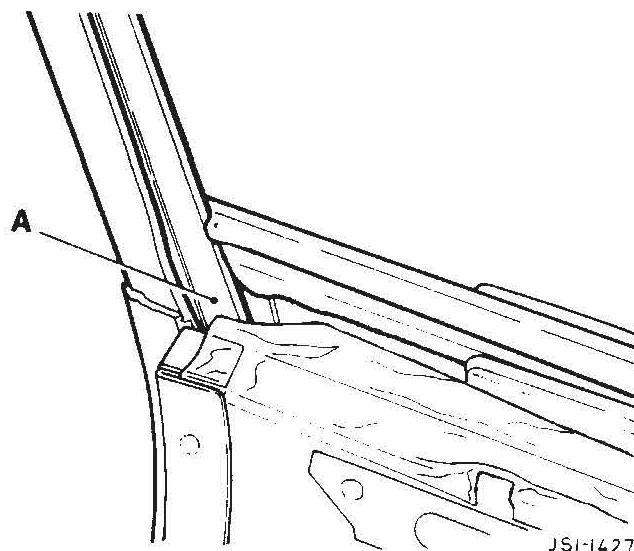
FIG 1

1. Remove the door trim (refer to S.R.O. 76 34 01) to gain access to the door glass window lift regulator assembly.
2. Disengage the regulator assembly from the door glass and allow it to rest in the lower door panel.
3. Place hands on either side (surface) of the door glass, then move the glass up and down. Refer to Fig 1, Point 'A'. The glass movement becomes restricted at this point as full contact is made between the glass and upper to lower guide channels. Close observation of the glass channel seal at the foul point 'A' will invariably show signs of pressure marking and wear.

Note: When excessive wear is apparent on the inner surface of the seal, it MUST be renewed.

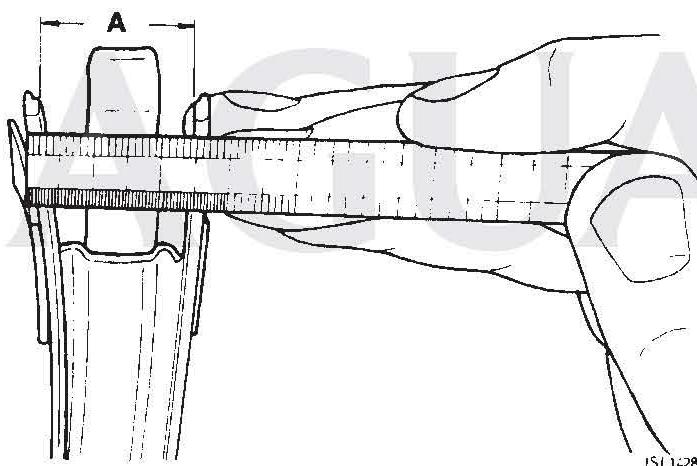
FIG 2

4. Remove the lower door glass channel from the door and place it on a work bench.
5. Refer to Fig 2, which shows the lower guide channel being measured at the position it must be opened out to prevent the door glass sticking. The nominal dimension at this position should be 19.8 to 20.8 mm; subsequently the channel should be opened up to 26,0 to 28,0 mm.

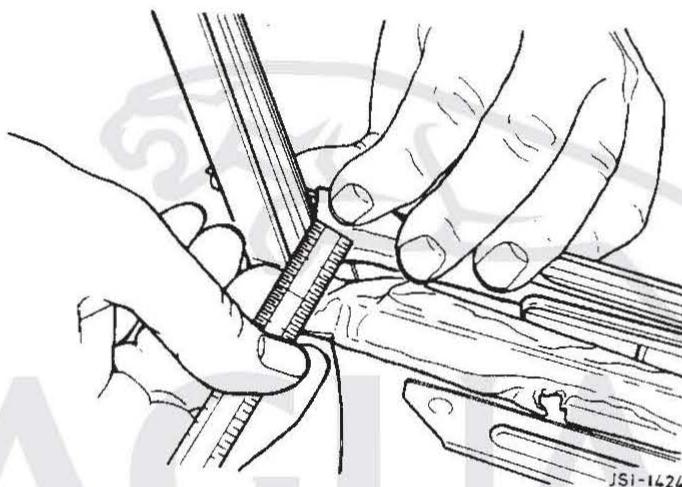
FIG 4

7. Refer to Fig 4; using an engineer's steel rule, measure the external width of the frame as shown. The correct dimension should be 19.5 to 20.5 mm.

8. If this dimension is less than 19.5 mm, the door glass movement will still be restricted at this point. Should this dimension be correct, items 9 to 11 can be disregarded. When this width is less than 19.5 mm, the door/window frame channel will have to be opened out.
9. To open out this channel, insert a 15 mm thick steel drift approximately 12 cm long x 25 mm wide into the channel as shown in Fig 5.

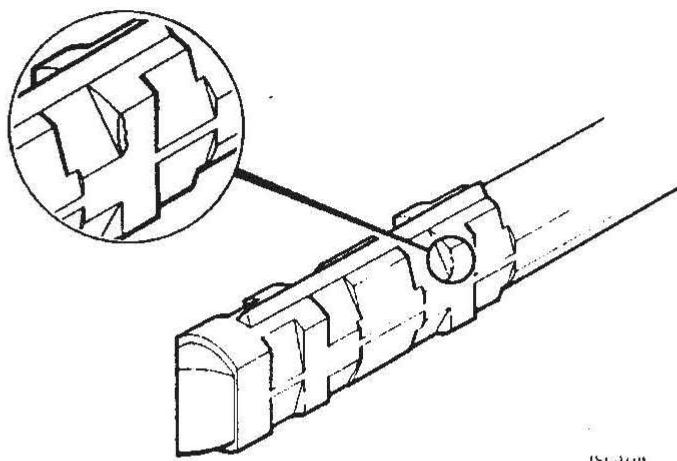
Reports have been received of keys sticking, baulking or not turning in the lock, as a result of key damage, in particular to the edge of the No.1 key cut – see Fig 1:-

Investigations into this problem have identified that key damage occurs when the key is rotated whilst not being fully inserted into the lock barrel. Subsequently, the resulting damage to the edge of the No. 1 cut prevents the key being rotated when correctly inserted into the lock barrel.

A new lock has been fitted to all saloons built from VIN 646128. The new lock has a re-profiled driving disc which transfers the initial lock open / close loading from the No.1 cut to the No.3 cut position on the key.

In the event of customer complaint follow the lock repair / procedures outlined in Service Bulletin JD 06 / 90 – Item 27 and replace the damaged key.

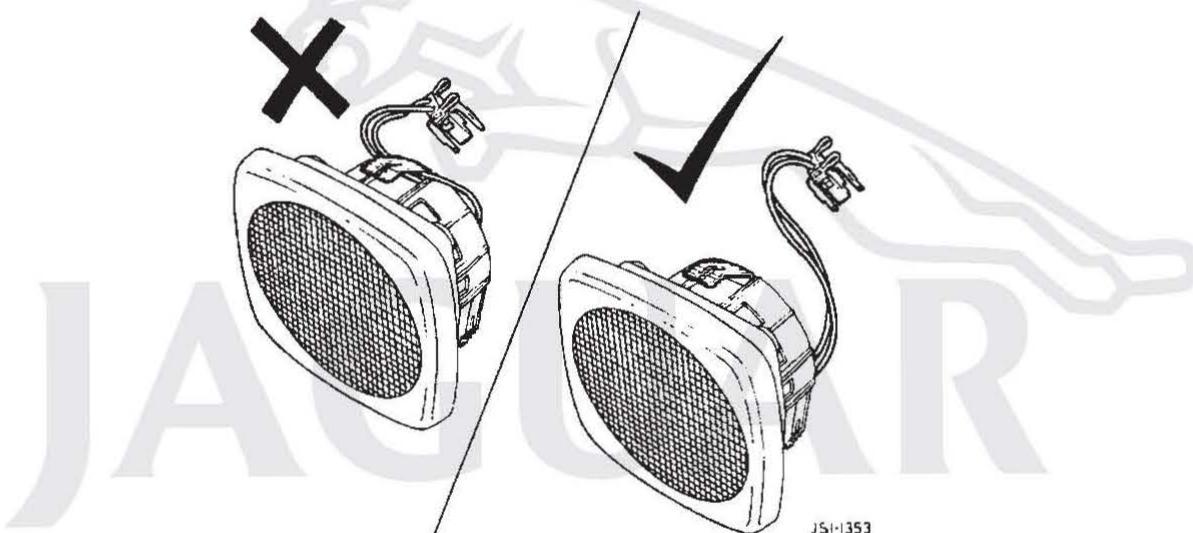
**FIG 1****FIG 2**

If the wiring is trapped between the speaker housing retaining clips (Fig 1) and the steel heelboard panel, the insulation may wear away, allowing the wire to ground.

BEFORE replacing the radio / cassette, check both speakers for correct wire routing (Fig 2) using the following procedure:

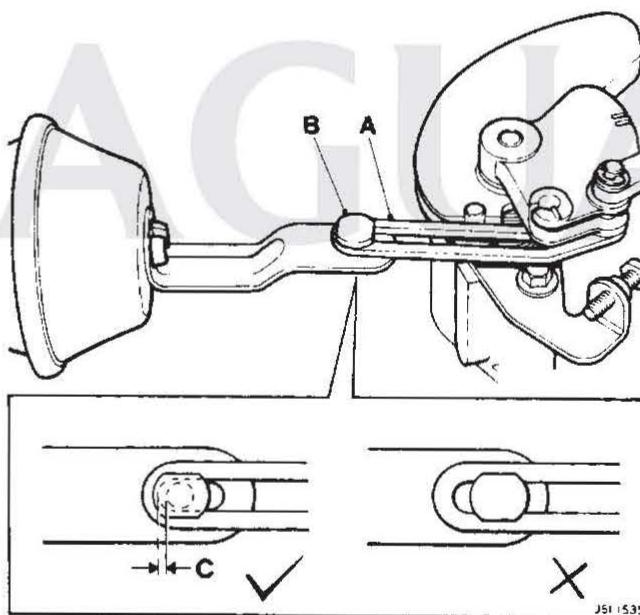
FIG 1

Dealers should ensure that the clearance between the end of the actuator to throttle link slot (A Fig 1) and the shoulder bolt (B Fig 1) is 0.5mm to 1mm (C Fig 1).

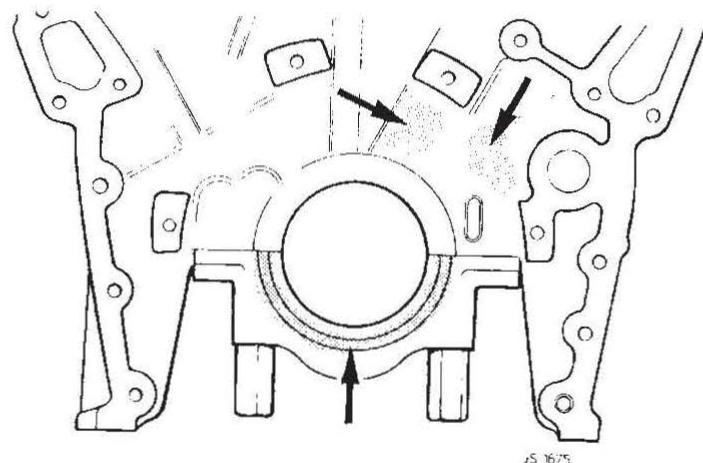
FIG 1

In most cases, the new pump can be used as a direct replacement with no modification to the block; however, in some cases, a foul condition may exist between the pump and certain areas of the old sand-cast block. To check for any foul condition, the pump should be offered in the correct position to the mounting bosses. If it lies flat against the bosses, the condition is correct. If the pump lies proud of the bosses, material should be removed from the foul area of the block (refer to shaded areas in Fig. 1 for possible foul areas) by careful use of a rotary file or similar implement.

Care should be taken when removing material to ensure that swarf produced by the operation is completely cleared from the area and that no other part of the engine, i.e. crank, main bearing, is damaged during the operation.

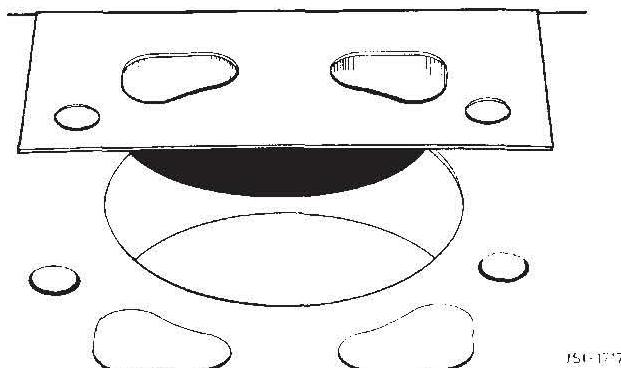
FIG. 1

ONLY IF THE EROSION ON THE HEAD OVERLAPS THE CORED HOLE CUT-OUTS SHOULD THE HEAD BE CHANGED.

Make a paper template of the cored holes in the cylinder block that correspond with the affected water holes in the head. To orientate the template to the head water holes, include the cylinder head bolt holes on the template. (See Fig. 1)

Position the template on the cylinder head by aligning the cylinder head bolt holes on the template to those on the head.

If the erosion is within the cut-out the cylinder head should be refitted in the normal manner.

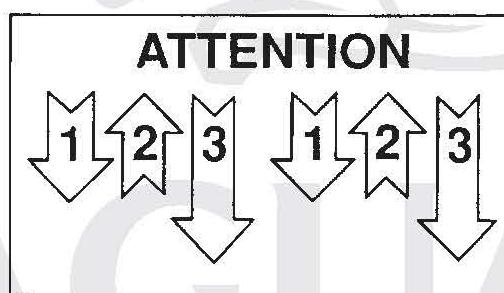
FIG 3

Note: This strut has a bright red warning label, showing the method of operation
– Refer to Fig 3.

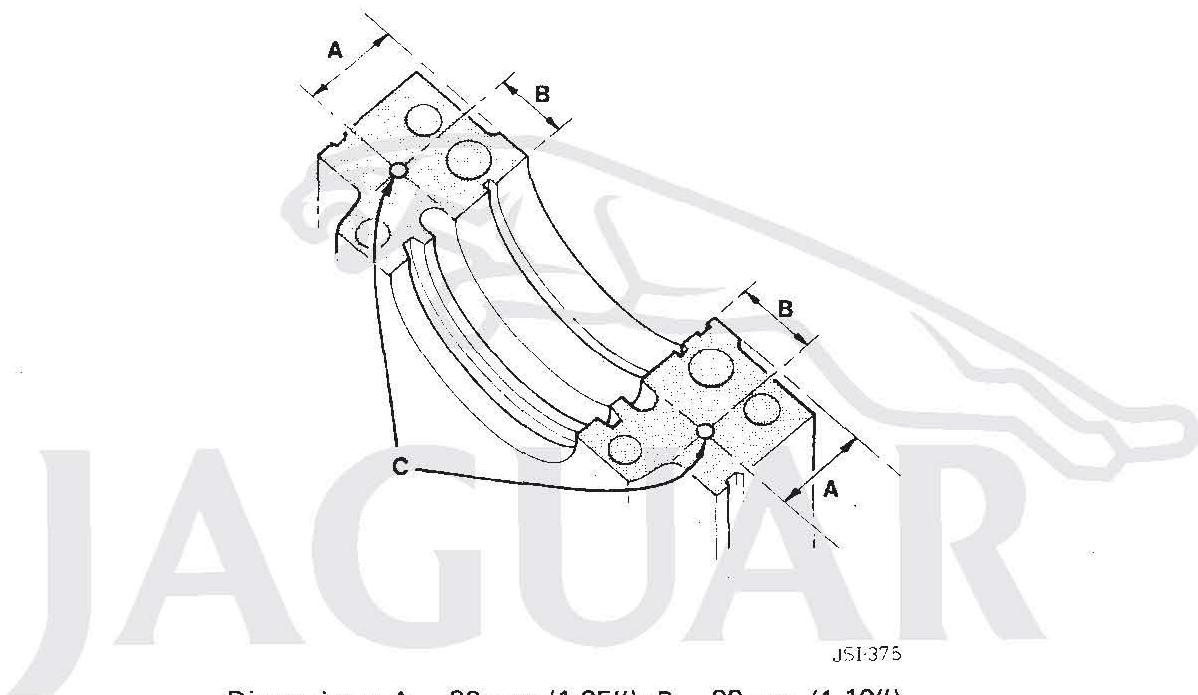
FIG. 1

Investigations into reported oil leaks from the area of the rear crankshaft oil seal on V12 engines have identified a possible leak path between the rear main bearing cap joint faces and the outer fixing stud holes. To prevent the possibility of leakage from this area, a sealant is now applied to the joint during assembly. This was introduced at Engine Nos:

To remove old sealant from the joint faces, cellulose paint thinners on a soft lint free cloth should be used.

DO NOT SCRAPE SURFACES TO REMOVE OLD SEALANT.

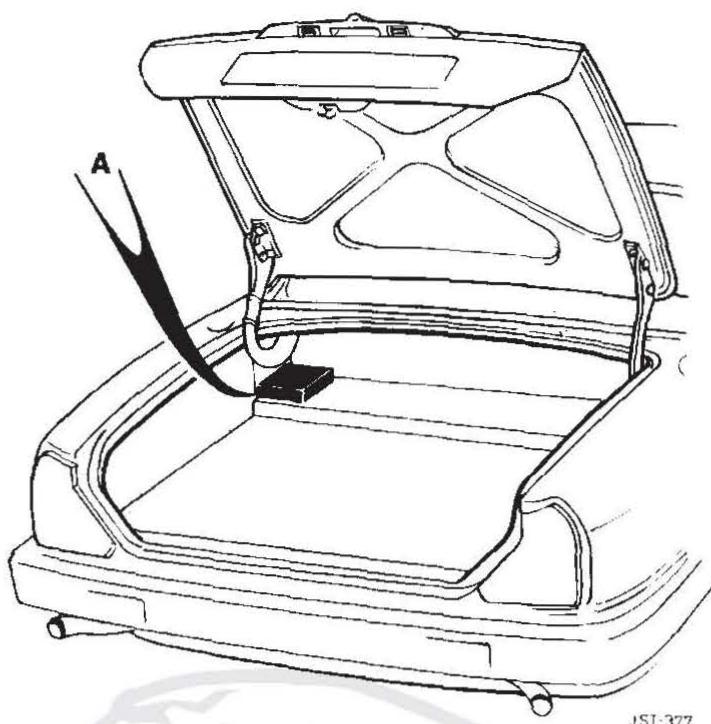
FIG. 1

Investigations have traced the fault to a punctured fuel line, caused during installation of the amplifier unit in the boot compartment, A, Fig. 1. The fuel line concerned, Part No. CAC 2474, is routed beneath the raised floor level of the boot compartment and connects the RH and LH recirculation solenoids to the main fuel return pipe. The damage is caused either when drilling the location holes, or by the fixing screws penetrating or chafing the fuel line.

Would all Dealers involved in telephone installations please ensure that their Communications Engineers are made fully aware of the position of ALL fuel lines prior to fitting the telephone equipment.

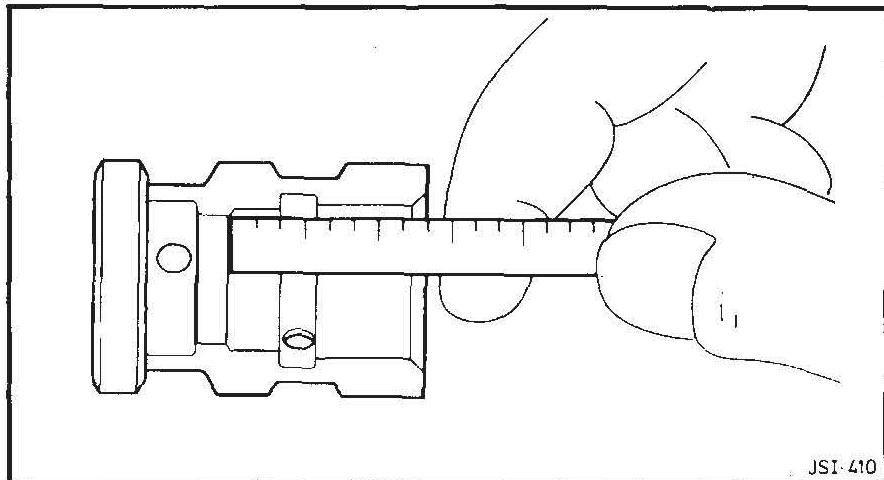
FIG. 1

Some GM 400 transmissions manufactured during 1984 may exhibit the following faults:—
Slipping in all gears, loss of drive.

If either of these symptoms is evident then the unit should be dismantled and the forward clutch ring checked to ensure that it is correctly seated. If it is found that the forward clutch snap ring is incorrectly located, or not seated correctly and that some seals have also been dislodged from their seats then the reverse boost valve must be removed from the oil pump and the depth of the bore checked, see Fig. 1. If this measurement exceeds 15.8mm (5/8") then the valve should be replaced with Part No. AAU 6640.

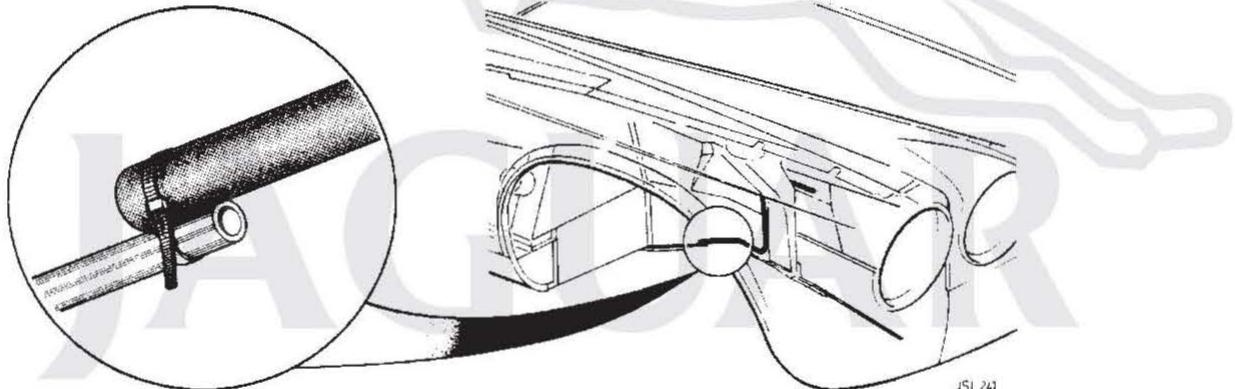
JSI 241

Therefore between the above VIN's a mixed condition may exist, however after VIN 436841 all vehicles arriving at Los Angeles will be disconnected. During the vehicles PDI, the flexible breather pipe situated to the rear of the front right hand wheel arch, must be connected to the steel bundy pipe.

It is important that if a blanking cap is fitted to the vent pipe, then this must be removed prior to connection.

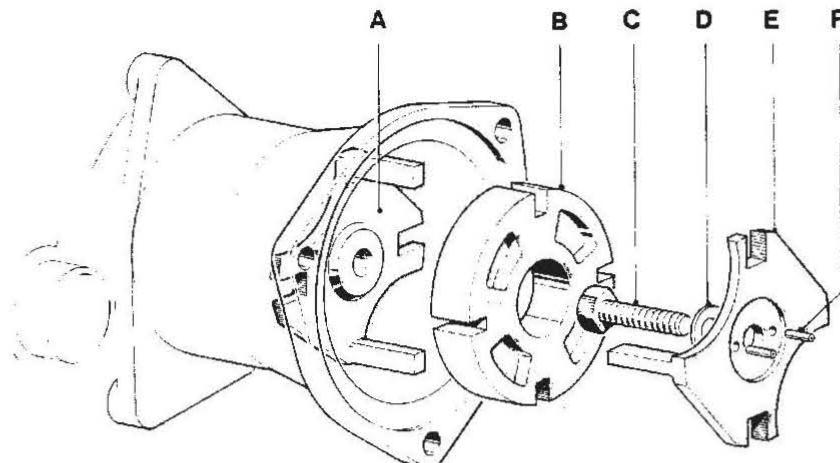
FIG 1.

To improve the power steering pump drive durability on 3.6 models, a revised drive arrangement, illustrated in Fig. 1, has been introduced from engine number 9D 102539.

The engine auxiliary shaft has been modified to accommodate the new driving dog. As a result these new components are not interchangeable with engines built prior to the above number. When replacement engines are supplied with the later type auxiliary shaft (Part No. EAC 6747) and drive dog fitted, the P.A.S. pump should be modified by fitting the later type drive dog (A Fig. 1) using Service Tool 18G 1445.

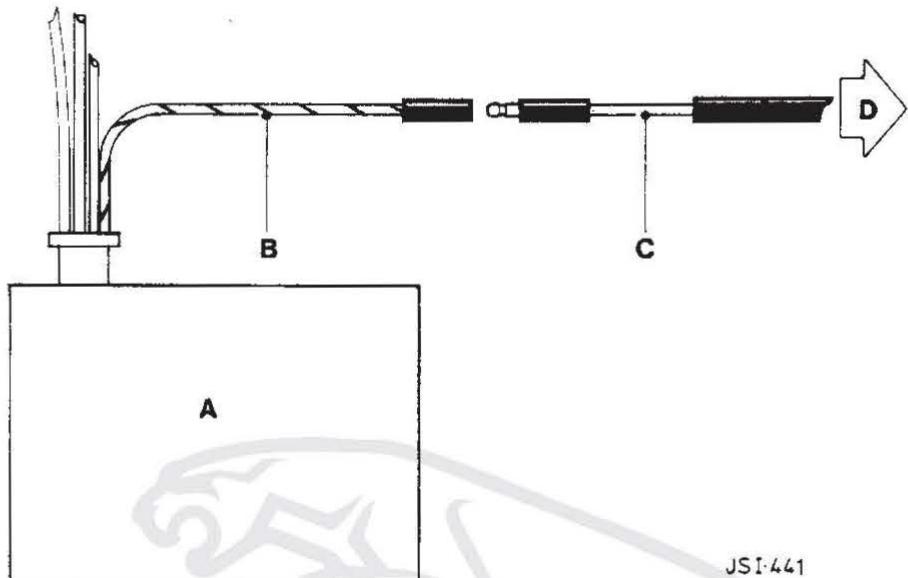
FIG 1

To prevent any further incidences of this problem occurring, a new type of posi-lock connector has been introduced from VINs:-
