Service Bulletin

Date MAY 1984
Sheet 1 of 2
Bulletin JD.05/84

XJ-S/XJ-SC

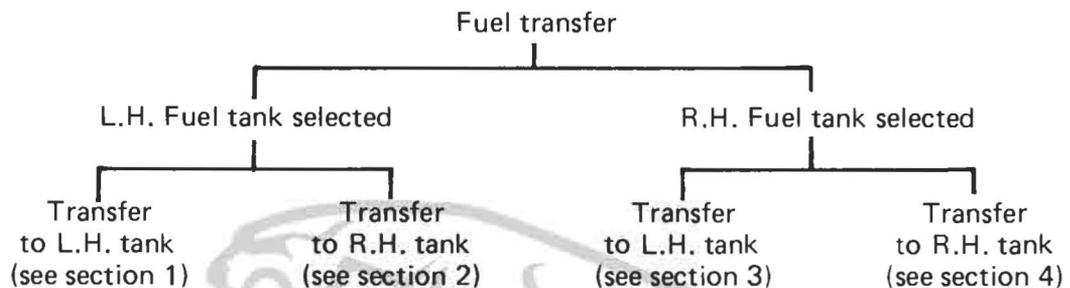
DIAGNOSTIC CHART

- (i) Tank change over solenoid (CAC 8000) stuck partially open.
- (ii) Dirt on change over solenoid (CAC 8000) R.H. seat.
- (iii) Pick up filter in L.H. tank partially blocked. This may be accompanied by excessive fuel pump noise.

If whilst investigating reports of fuel transfer, it is found that the solenoids are contaminated, the fuel tanks MUST be drained to ensure contaminant is removed.

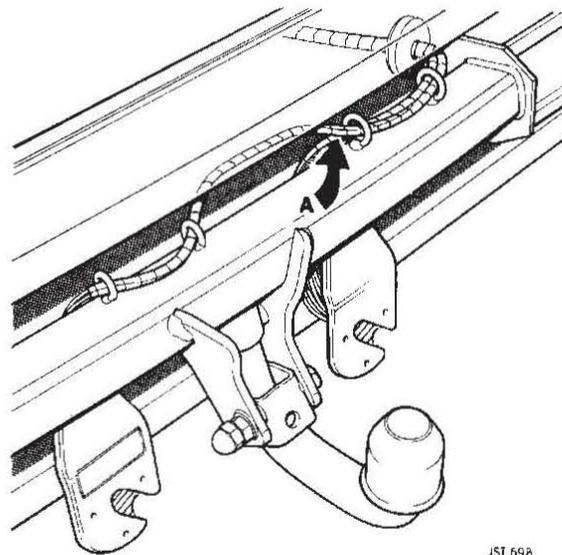
FIG 2

Short Lead Lengths

- 1) Should the lead lengths to the 12N and 12S connectors prove to be too short, increase the twin lead separation length by cutting back 50 to 80 mm (2 to 3 in) of joining tape from point 'A' Fig.2.
- 2) Alternatively, modify the existing connector mounting plates by extending each slot (maintaining the existing width) to the centre point triangulated from the three screw holes (Fig.2 - cut away sections shown shaded).

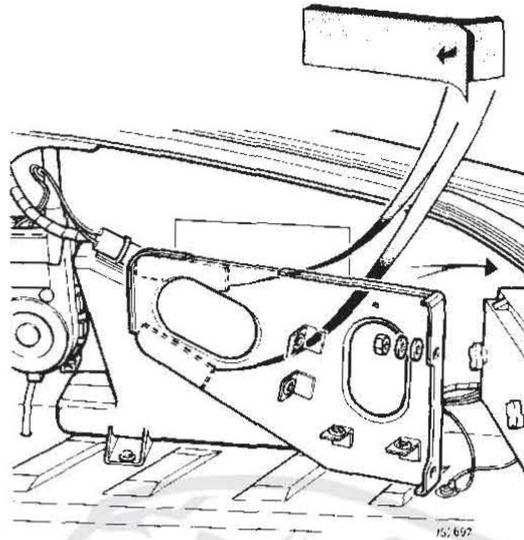
FIG 3

Bracket to Wing Contact

- 3) Should a rattle be suspected between the module mounting bracket and the rear wing, fit two self-adhesive foam pads to the bracket rear face (Fig.3).

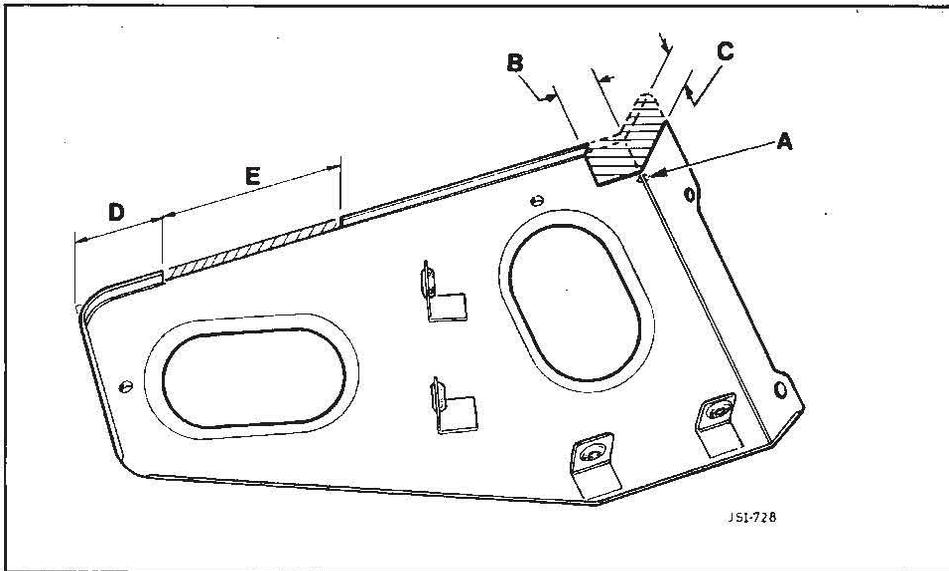
FIG 4

In certain cases the caravan/trailer module may not seat flush with the module mounting bracket thus preventing the securing bolt from engaging into the bracket. In this instance carry out one of the following solutions:

1. In place of the supplied module securing bolt, substitute a longer (M6 x 19 mm) bolt used in conjunction with a 7 mm spacer (not supplied).
2. Alternatively, remove a flange section to the dimensions referred to on Fig.4, where 'D' = 50 mm (2 in.) and 'E' = 100 mm (4 in).

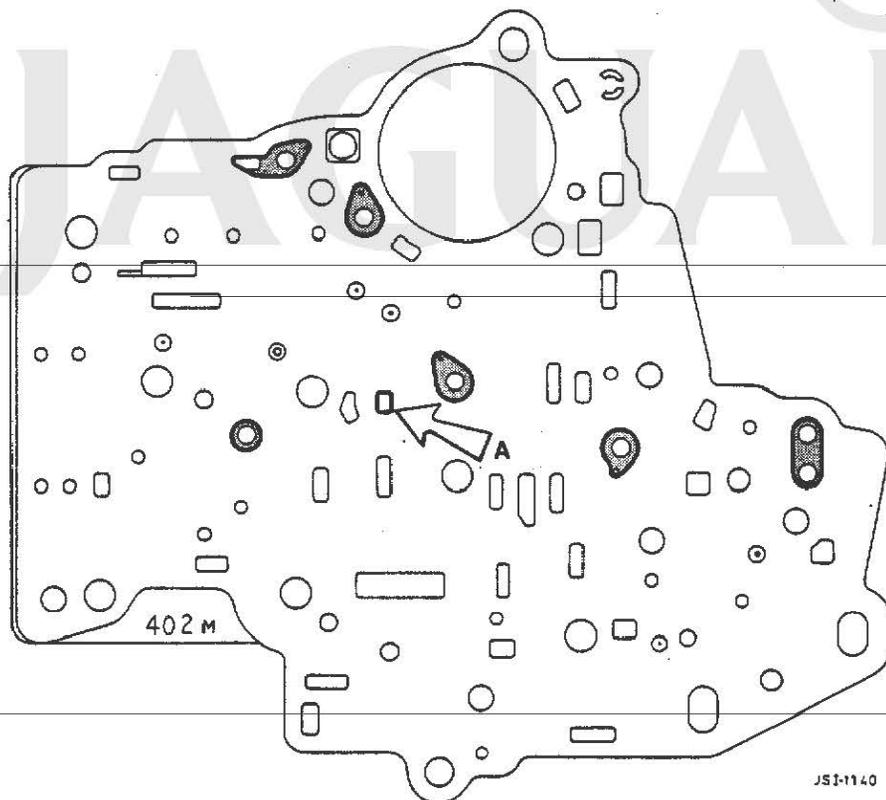
FIG 1

IMPORTANT: It is very important that the 1-2 shift valve is polished/cleaned when checking for a 1-2 judder condition as there have been instances of a brown rust-like substance deposited on the valve surface. Vehicles with transmissions prefixed ZVA and ZXA are not affected by this modification as it is already incorporated.

Fig 1 shows the separator plate face and gasket as it would be offered up to the transmission casing. The larger holes shown within the shaded area are the positions for the steel check balls.

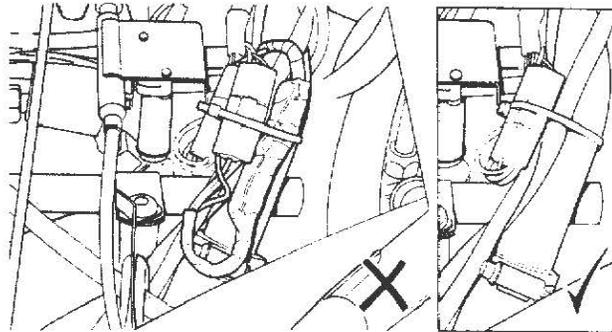
Remove transit fuelling link harness from throttle potentiometer before driving on road.

- * Locate the link harness and remove the securing strap.
- * Disconnect the link harness from the potentiometer harness and discard (NOTE: The harness is not required to be returned and should be disposed of by the Dealer).
- * Reconnect the potentiometer harness and resecure to the balance pipe (see Fig 1), using a suitable ratchet strap, recommended Part Number ADU 9028.

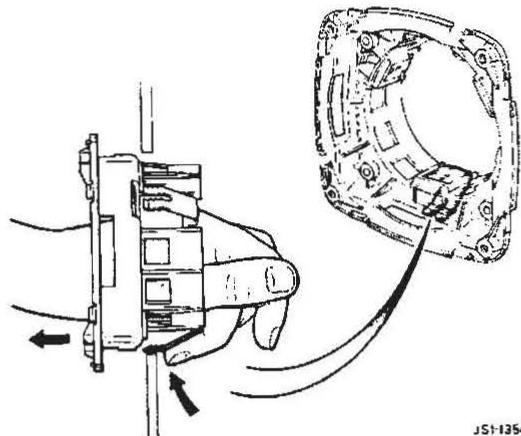
FIG 3

If the wiring is trapped between the speaker housing retaining clips (Fig 1) and the steel heelboard panel, the insulation may wear away, allowing the wire to ground.

Reach in and locate the three retaining clips holding the speaker housing to the heelboard (Fig 3). Depress the clips and remove the housing.

Disconnect the speaker harness multi-plug. Remove the speaker and inspect the wiring for damage.

If wiring damage exists, repair as necessary.

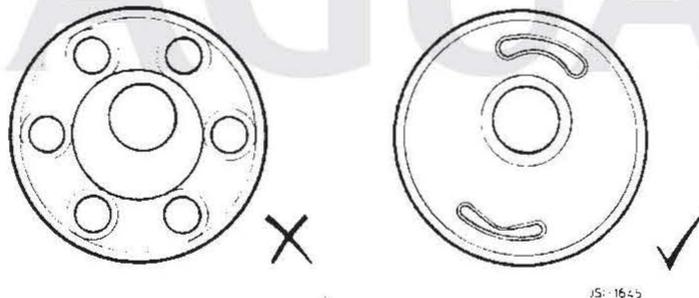
FIG 1

Note: The bushes originally used were termed as 'six-shooter' bushes. These have now been redesigned / replaced by the 'smiley-faced' bushes currently being used, see Fig. 1 for identification.

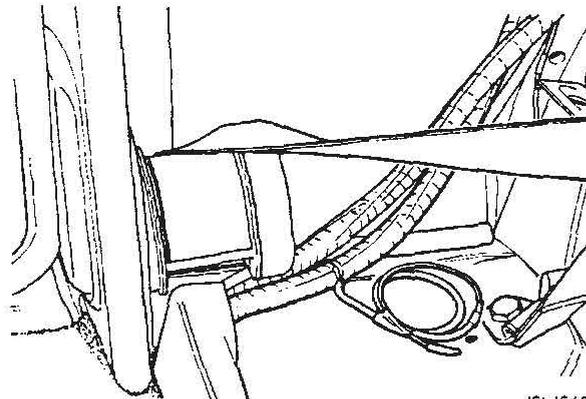
FIG 1

Investigation into Dealer reports of poor operation of the alarm system on XJ-S 92 MY vehicles has shown that a final operation has been omitted from the supplied installation instructions. Therefore, where customer complaints are received, the following action should be taken.

1. Remove the right-hand rear quarter lower trim pad assembly.
2. Identify the alarm antenna coiled in the harness (refer to Fig 1).

3. Remove the adhesive tape from the antenna, uncoil and straighten.
4. Position the rear quarter trim panel assembly to the vehicle.
5. Attach the straightened antenna to the rear of the trim panel in vertical attitude, using suitable adhesive tape (refer to Fig 2).

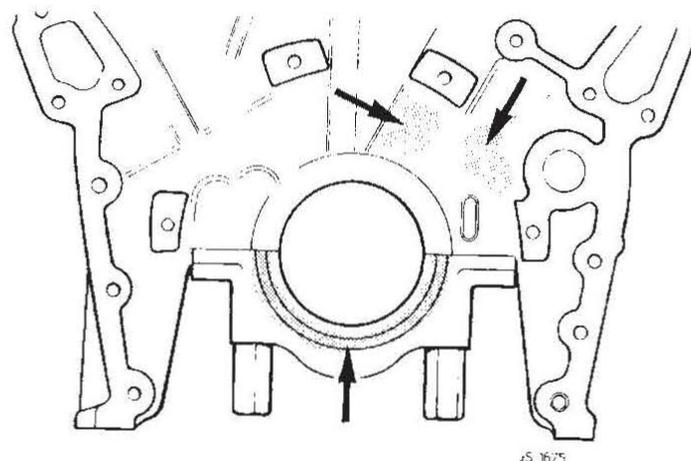
FIG 1

In most cases, the new pump can be used as a direct replacement with no modification to the block; however, in some cases, a foul condition may exist between the pump and certain areas of the old sand-cast block. To check for any foul condition, the pump should be offered in the correct position to the mounting bosses. If it lies flat against the bosses, the condition is correct. If the pump lies proud of the bosses, material should be removed from the foul area of the block (refer to shaded areas in Fig. 1 for possible foul areas) by careful use of a rotary file or similar implement.

Care should be taken when removing material to ensure that swarf produced by the operation is completely cleared from the area and that no other part of the engine, i.e. crank, main bearing, is damaged during the operation.

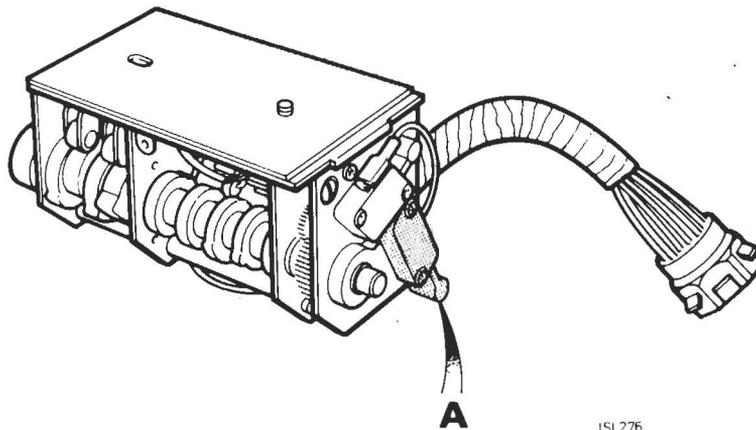
NOTE: A significantly high percentage of thermal fuse failures, occurring during high ambients, have been identified as a direct result of selecting low fan speed whilst the unit is in full cooling mode. Prolonged operation of the system in this condition can result in a significant pressure drop in the low pressure side of the system. Should this be the preferred mode selection whilst driving, then Step 3 should be implemented immediately.

1. Disconnect the battery.
2. Remove the centre console right hand side trim panel to gain access to the air conditioning/heater unit.
3. Remove the plastic retaining plug from the black plastic cover surrounding the servo motor unit.
4. Carefully move aside the shield to gain access to the Ranco override micro switch, A.
5. Disconnect the green/brown (GN) lead and insulate.
6. Reverse procedure 1 to 4.

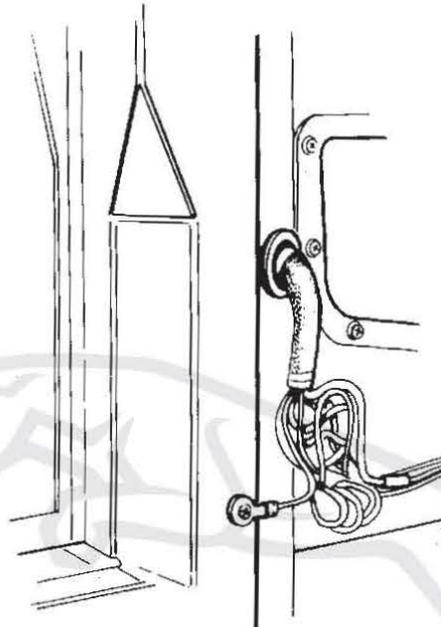
FIG. 1

1. Disconnect the battery.
2. Remove the passenger side 'A' post lower trim panel to expose the lower bulkhead/door harness (See Fig. 1). Passenger side RHD is shown, LHD is symmetrically opposite.

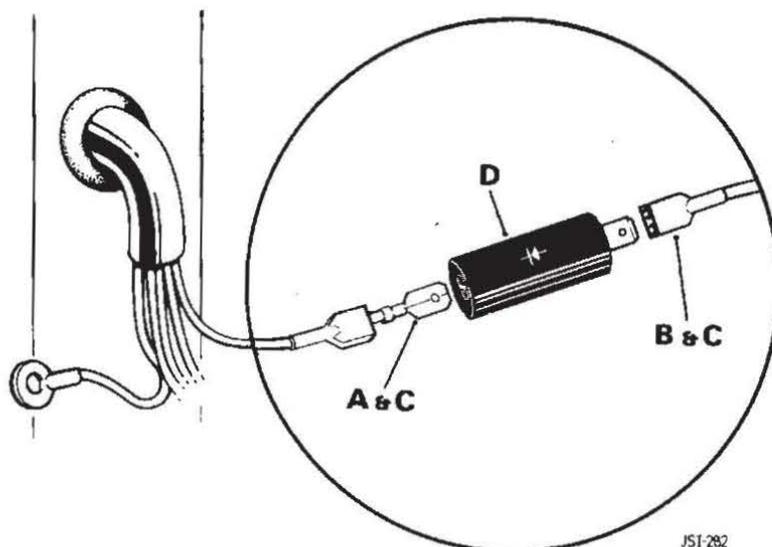
FIG. 2

3. Locate the interior door switch purple/white (PW) cable and cut.
4. Fit insulation sleeves (C, Fig. 2) and crimp/solder Lucar connector (A and B, Fig. 2), to the purple/white (PW) cable. Connect diode unit (D, Fig. 2) in circuit and strap or tape to the harness.

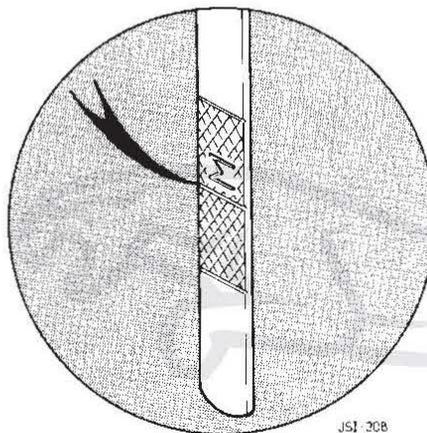
To improve oil level checking, a new dipstick with revised marking has been introduced on AJ6 engines. The oil level checks detailed below **MUST** be used with this new dipstick.

1. Forecourt Check:
 - (a) Stop engine – wait one minute.
 - (b) If oil is **on cross hatch** add no oil.
 - (c) If oil is below the cross hatch – add 1 litre and recheck.
2. Overnight Check:
 - (a) If oil is above the mark 'M' Fig. 1 – add no oil.
 - (b) If oil is below 'M' – add 1 litre and recheck.

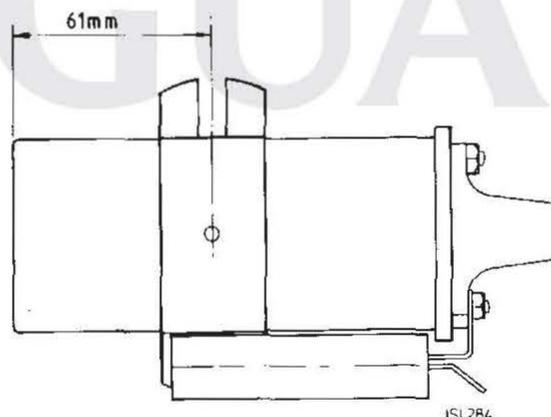
**FIG 1**

1. Disconnect the battery earth lead.
2. Disconnect and remove the existing coil.
3. Fit the new coil and ballast resistor assembly to the engine. It is necessary to slide the mounting bracket along the coil to gain access to the slot on the fixing bracket hidden by the ballast resistor. Fit and tighten the outboard fixing screw securing the bracket to the engine.

Move the coil to the position shown in Fig. 1 and tighten the bracket clamping bolt to the correct torque, DO NOT overtighten. Fit and tighten the coil bracket inboard fixing screw.

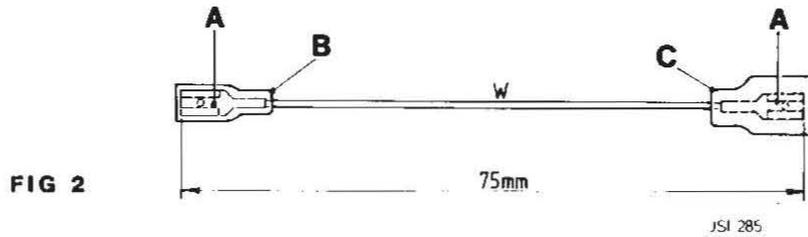
FIG 2

4. Construct a link harness as shown in Fig. 2, and connect it between the ignition coil feed wire (W) and the coil ballast resistor, Za, Fig. 4.

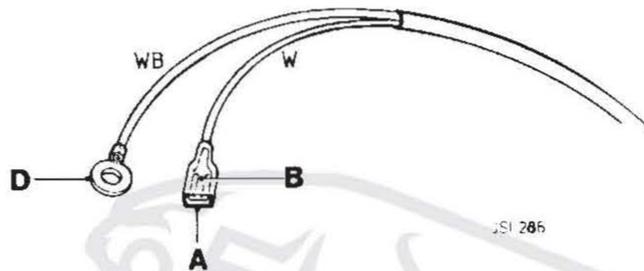
FIG 3

5. Modify the existing ignition harness by cutting off the terminals. Fit lucar connector (GHF 2051) and sleeve (GHF 2151) A & B, Fig. 3 to the white (W) wire and eyelet (GHF 2431) D, Fig. 3 to the white/black (WB) wire. Connect the white (W) wire to the ballast resistor.

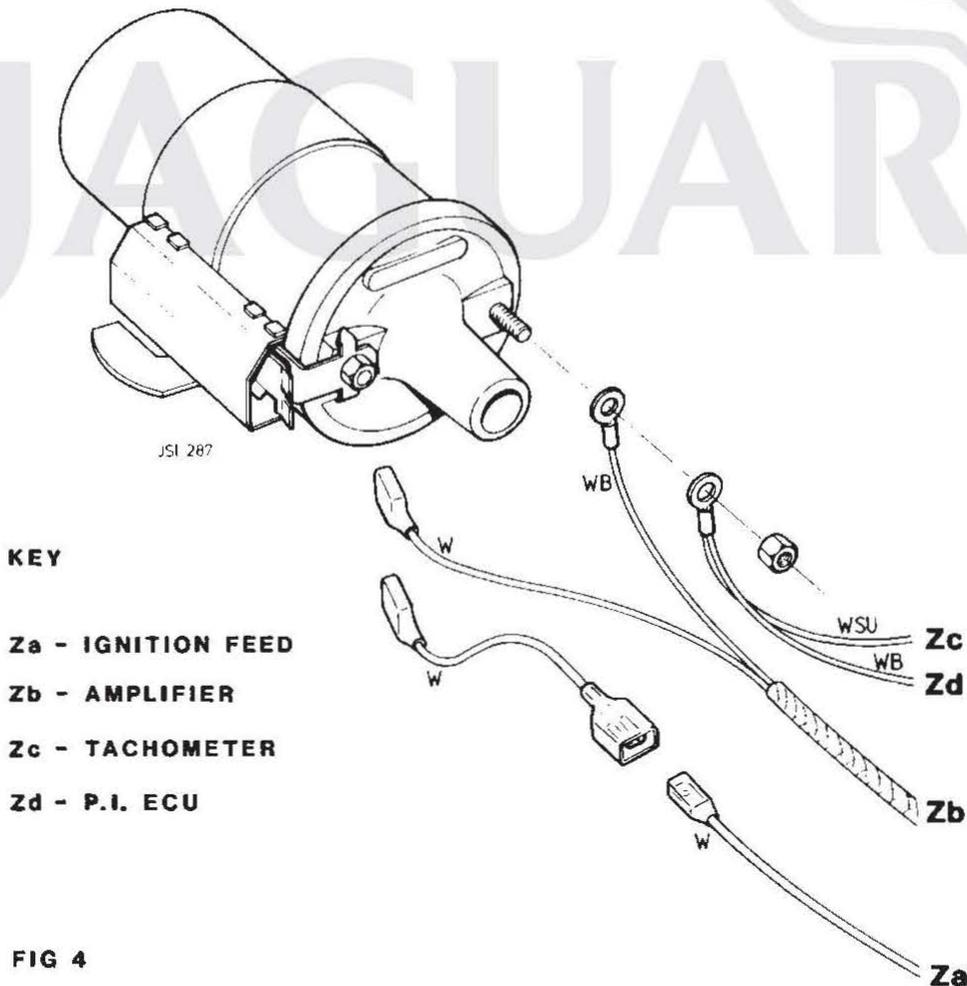
FIG 4

6. Cut off the existing terminals from the white/black (WB) engine harness – coil to ECU wire, and the white/slate/blue (WSU) tachometer feed wire. Join these two wires together and fit the other eyelet (GHF 2431) to them.

7. Connect the two eyelet connectors, one on the ignition amplifier harness and the other on the engine harness, to the coil negative stud and secure, (see Zb, Zc and Zd, Fig. 4).
8. Reconnect the battery earth lead and check operation.

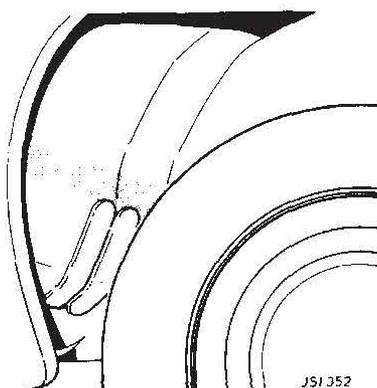
JS1.352

2. Front Wheel Arch Housing
Using a hammer or hard faced mallet reduce the bulge present in the panel at the rear of the wheel arch, to conform with the level of the surrounding panel.

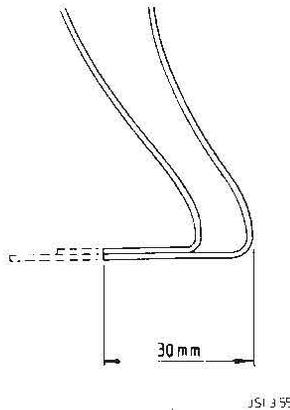
Fig. 3

3. **Rear Wheel Arch Flange**
Trim off excess metal to ensure a maximum flange width of 31mm (1.25 ins).

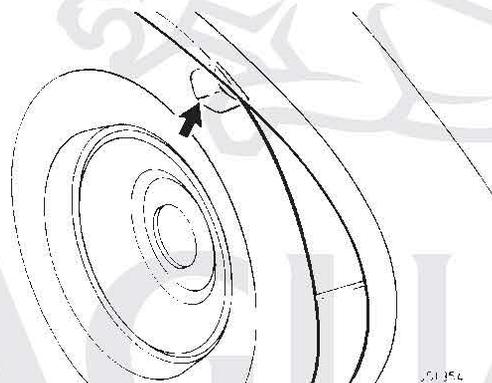
Fig. 4

4. **Rear Wheel Arch Housing**
Using a hammer or hard faced mallet reduce the bulge present in the panel at the front of the wheel arch, to conform with the level of the surrounding panel.

5. Repair any paint damage resulting from the above procedures by applying an approved paint process.
6. Repair any damaged underseal, do NOT apply directly on to bare metal.
