Service Bulletin

Date JANUARY 1984
Sheet 1 of 9
Bulletin JD.01/84

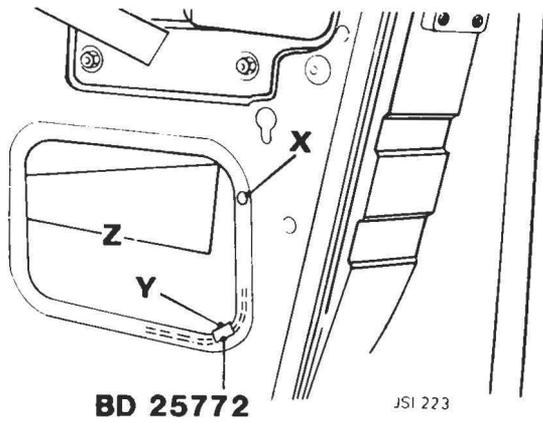
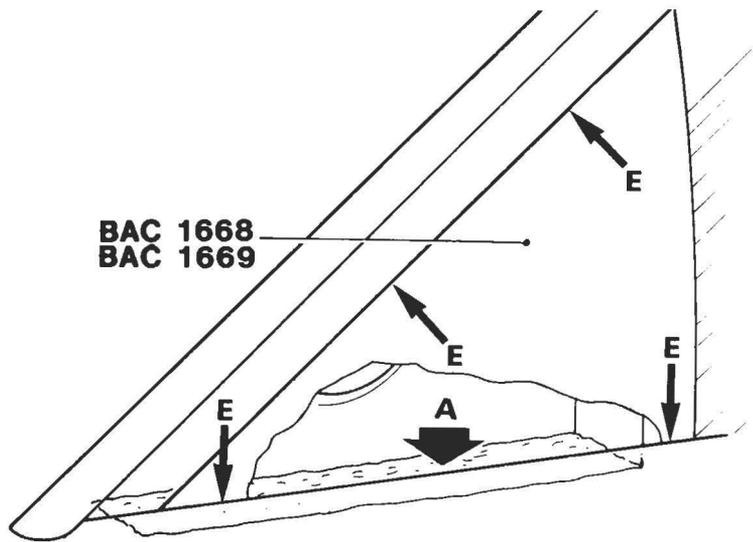
This problem may be caused by any or all of the following:

- A
 - i. Lower window fully and remove outer weather strip BAC 1298 R/H BAC 1299 L/H.
 - ii. Remove finisher BAC 1668 and/or BAC 1669.
 - iii. Apply sealant A into the door channel (Fig. 2A) refit finisher and apply sealant E around the edge (Fig. 2A) wipe off surplus and refit weather strip.
- B
 - i. Examine the water curtain and repair any tears, ensure that the curtain is hanging correctly.
 - ii. Check all securing bolts, regulator mountings, etc. for seepage. Dry off any doubtful bolts and apply sealant D around the heads.
- C
 - i. Remove the clip securing the wires to the door at "X" (Fig. 2B) fit clip BD 25772 at "Y" and attach the harness so that it is secured below the orifice "Z".

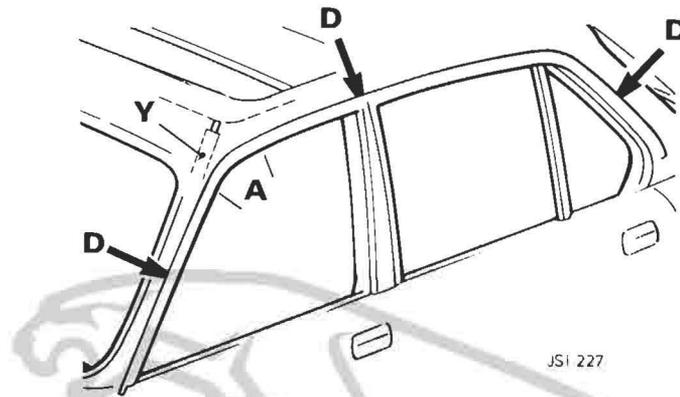
**5. Water ingress drip channels – Series III & XJ-S**

- i. Remove drip rail finishers BAC 2480/2481/2482/2483 for access.
- ii. Apply sealant "D" by tube or brush along the seams of the drip channel (Fig. 5).

- A Remove headlining (Workshop Manual Operation 76-64-01). Leave in car but remove to allow access to forward sunroof drain tubes.
- B Identify fault, i.e. badly fitted or split hose, at point "Y" (Fig. 5).
- C If the hose requires replacing, remove front wheel arch rear stone guard.
- D Feed a length of wire down the drain tube so that it protrudes from the wheel arch.
- E Pull out the faulty hose, leaving the wire in position.

- F Slide a new drain hose over the wire to ensure correct routing.
- G Remove wire and fit hose on to sunroof. Drain.
- H Refit headlining, etc.

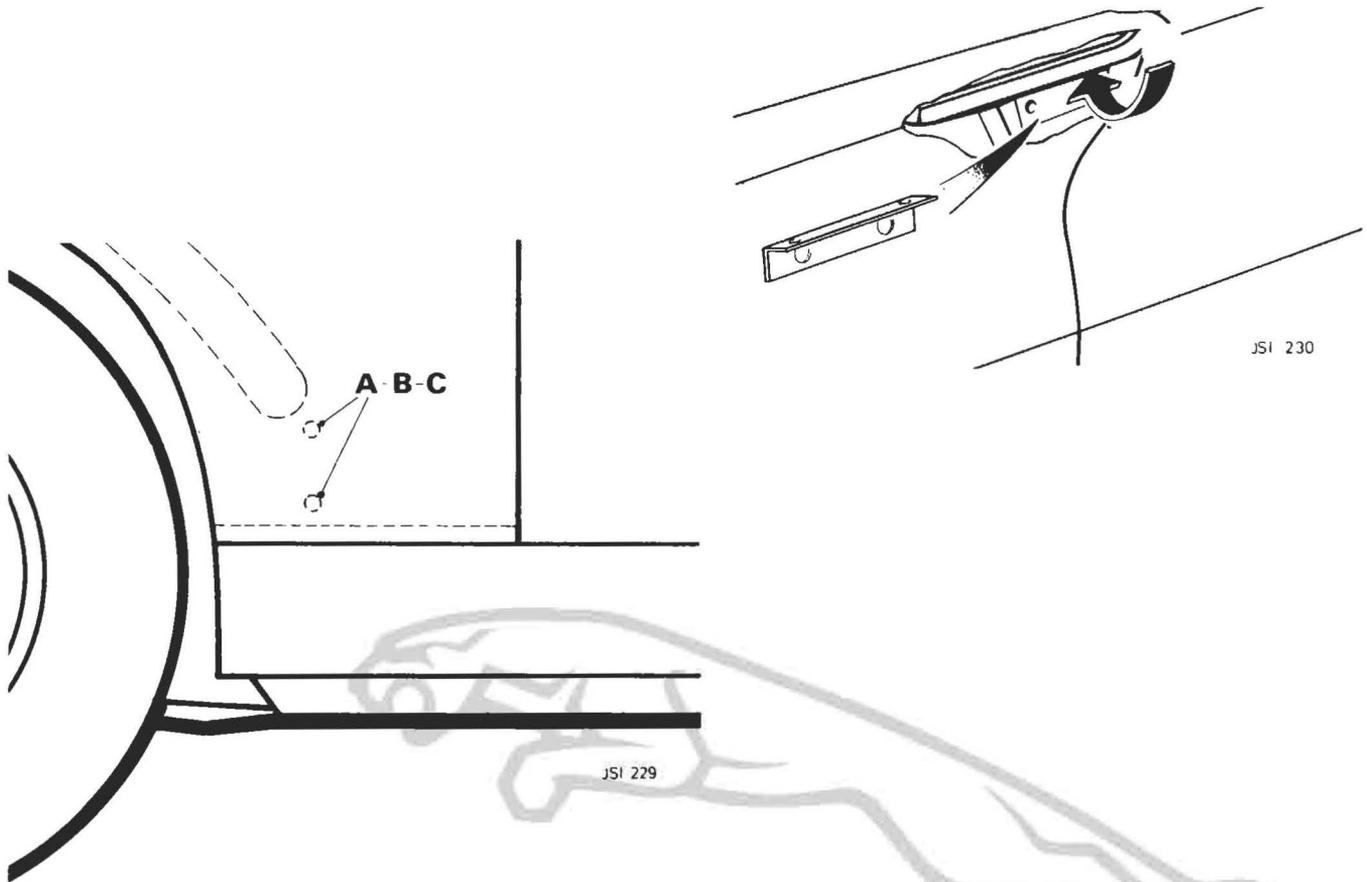
6. Water ingress via seams at "A" post waist – Series III

This problem may occur if there is an open seam at the base of the drip rail which allows water to enter the car interior via the "A" post box section.

- A Remove the "A" post draught welt.
- B Remove trim from footwell at base of "A" post (BD 43251 – RH, BD 43252 – LH, BAC 9906 – RH VDP, BAC 9907 – LH VDP).
- C Examine interior of the box section whilst water is "poured" down drip rails.
- D Refer to Fig. 6A and 6B for possible leak areas, and rectify using one of the following methods:
 - i. Leakage from point 6A – remove front wheel arch stone guard and apply sealant "A", "B", or "C".
 - ii. Leakage from point 6B – remove front wing (Workshop Manual Operation 77-28-29) and apply sealant "A", "B", or "C".

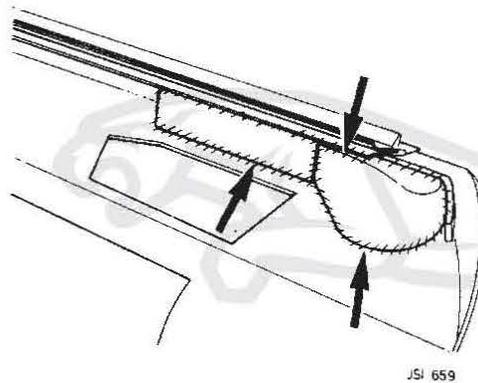
FIG. 6

Some incidence of air leakage has been identified at the locations indicated in Fig 6. If when checking the vehicle for wind noise this area is suspected, the following rectification should be carried out:

- 1 Remove the door top roll trim to expose the inner plastic demist air duct.
- 2 Apply sealant C around the edge of the plastic air duct to seal between the duct and the top roll (Fig 6).
- 3 Refit the top roll and road test.

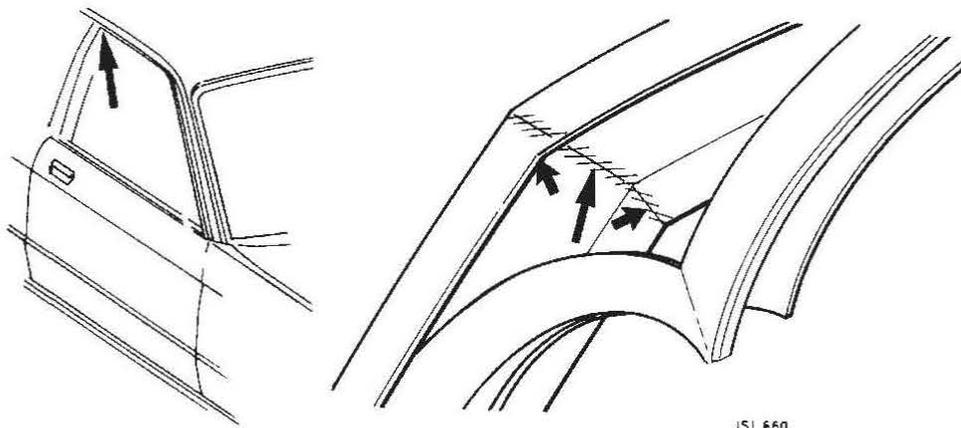
FIG. 7

When investigating wind noise/ingress around the top rear corner of the window frame (Fig 7), the following rectification should be carried out. This area has been clearly identified as an air leakage point.

- 1 Displace the glass channel seal to expose the area where the sealant should be applied.
- 2 Apply sealant A to the area as indicated in Fig 7.
- 3 Refit the channel seal and remove any surplus sealant.
- 4 Road test.

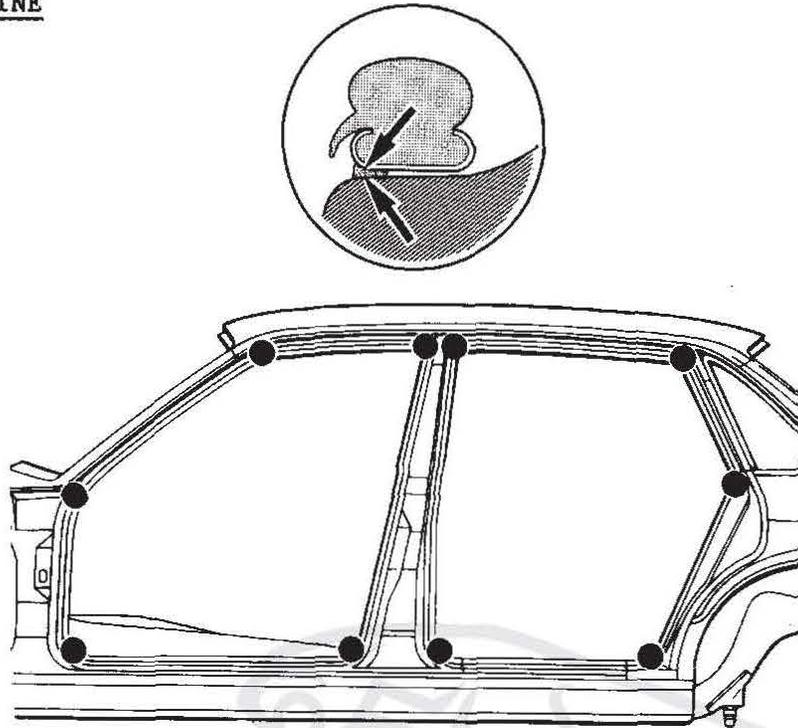
FIG.9

The points indicated on Fig 9 identify where there is a probability of wind noise/ingress. This is due to poor/inconsistent fit between the door aperture and the aperture seal retainer (Section C) channel. This may result in pronounced gaps in these areas.

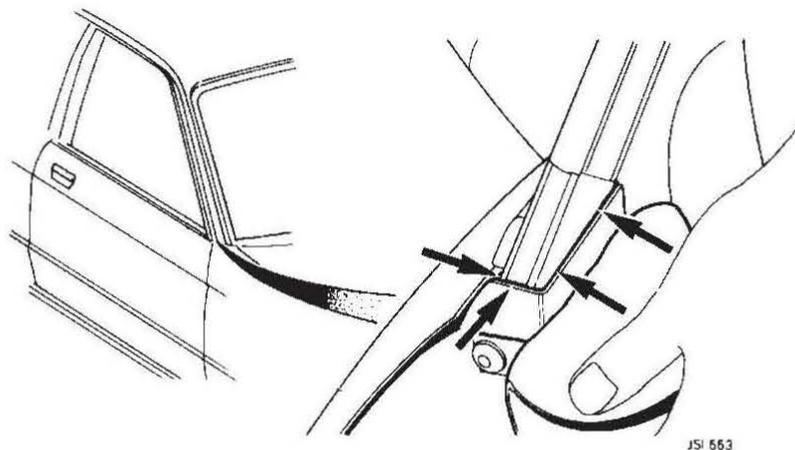
FIG.10

Early cars may be subject to air leakage at this point. This is due to poor/inconsistent fit of the rubber moulded finisher to the body. A modification was introduced on later cars whereby a mechanical fixing operation (plastic rivetting) improved the seal/fit of the rubber moulding.

To correct any leakage at these finishers the following fix should be carried out.

- 1 Remove the rubber finisher (Fig 10) to expose the door to window frame junction.
- 2 Apply sealant 'A' as indicated in Fig 10. Remove any surplus sealant.
- 3 Apply adhesive 'D' to inner surface of the rubber finisher as per adhesive application instructions.
- 4 Refit the rubber moulded finisher pressing firmly to achieve a good bonded seal. Remove any surplus adhesive.
- 5 Road test for wind noise.

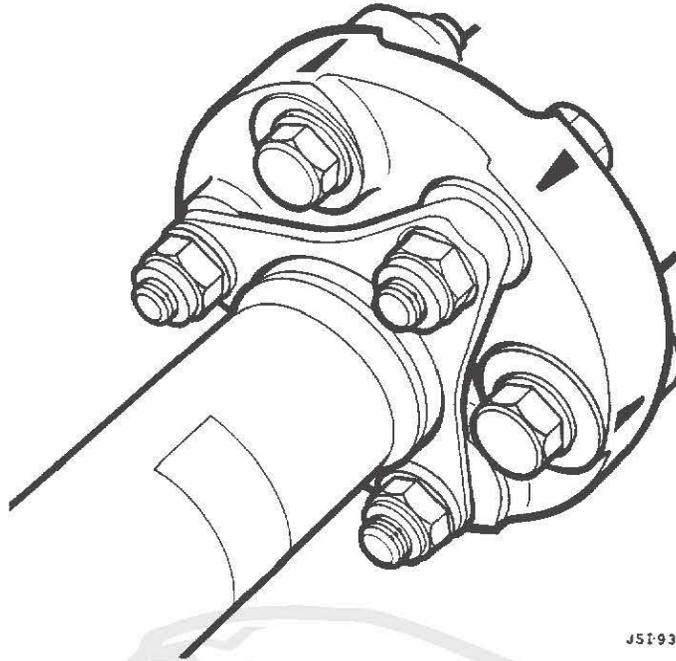
FIG 1

Should any vibration be evident after coupling replacement, a slight out of balance of the propshaft and coupling assembly has resulted. This may be improved by rotating the coupling 120 degrees relative to the propshaft.

- Thoroughly clean and regrease the propshaft centring bush prior to reassembly.
- Always renew the coupling fixing bolts, nuts and washers whenever these are disturbed.
- Align the moulded arrows on the circumference of the coupling with the propshaft and pinion flange arms as shown in Fig 1.

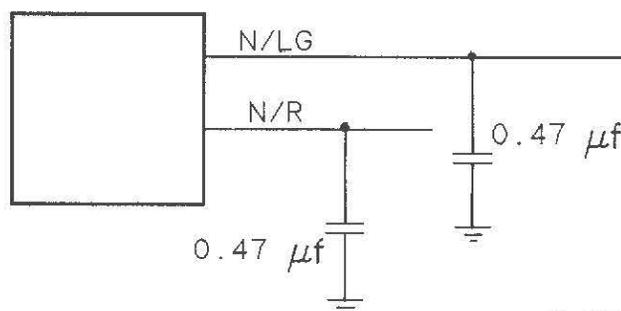
FIG 1

IT IS IMPORTANT THAT 0.47µf CAPACITORS MUST BE USED. IF CAPACITORS OF A HIGHER VALUE ARE USED THEY WILL AFFECT THE BULB FAIL MONITORING CIRCUIT AND CAUSE SPURIOUS BULB FAIL INDICATIONS ON THE INSTRUMENT PACK VCM.

Connect one of the capacitors from the N/LG (brown/light green) cable of the RH rear bulb fail module harness to a good earth point and the second capacitor from the NR (brown/red) cable to a good earth point ensuring a metal to metal earth contact (Fig 1).

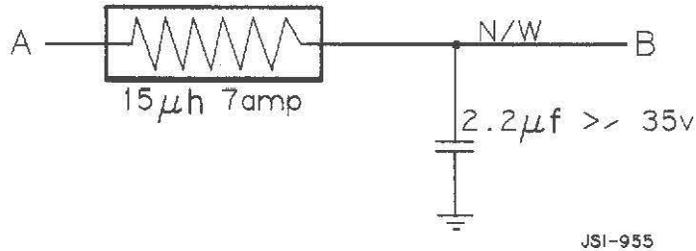
FIG 3

To determine along which cable the interference is being conducted, disconnect in turn, the battery supply and the lighting input cables to the radio/cassette player. Once the cable(s) conducting the interference have been identified proceed as follows:-

Connect a $15\mu\text{H}$ (Microhenries) encapsulated choke with a 7 amp rating in the offending cable(s) and connect a $2.2\mu\text{f}$ (Microfarad) capacitor with a rating of 35 volts from the cable(s) to a good earth point ensuring metal to metal contact. (Fig 3).

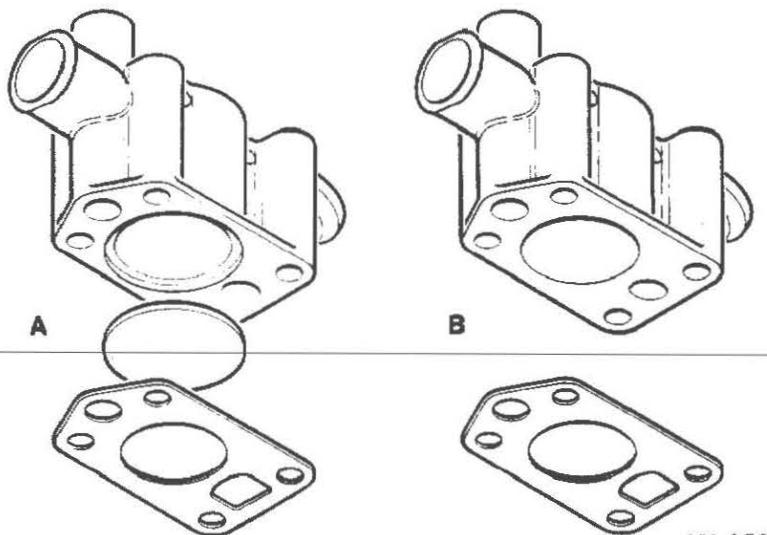
FIG 1

Following this, problems have been experienced with air leakage due to insufficient clamping area for the idle speed control valve gasket. To overcome the leakage a blanking plate has been fitted in place of the deceleration valve to restore the original gasket clamping area (Fig 1 A).

Service replacements should be made as follows:

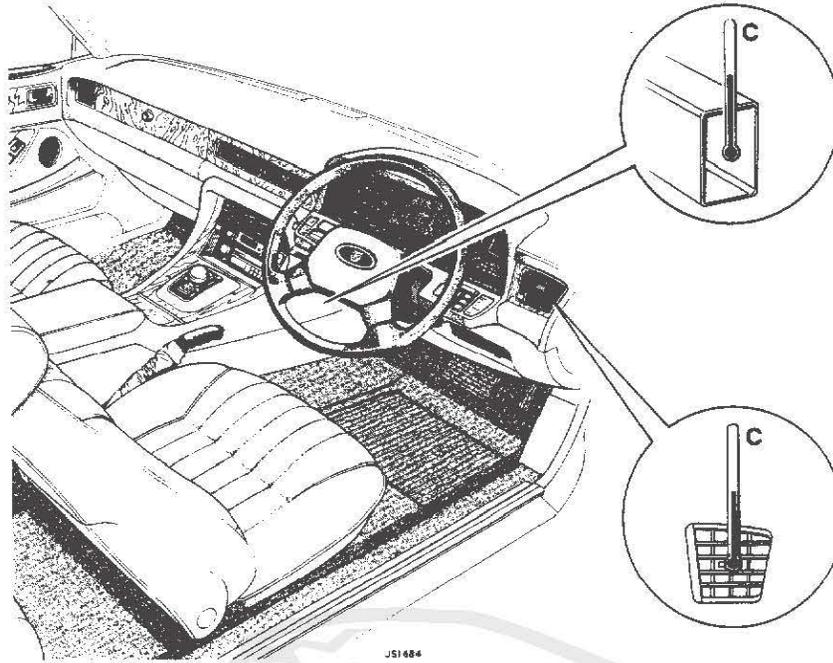
FIG 7

31. With the engine rpm maintained at approximately 1500 rpm and utilising temperature monitoring equipment, observe the temperature difference at the facia side vent and the footwell outlet on the same side of the car. The temperature difference should be 0°C - 5°C with the facia level cooler than the lower level.
NOTE: When positioning temperature monitoring equipment probes, ensure that they are positioned in the outlet airflows so that an average temperature reading is taken (Fig 7).

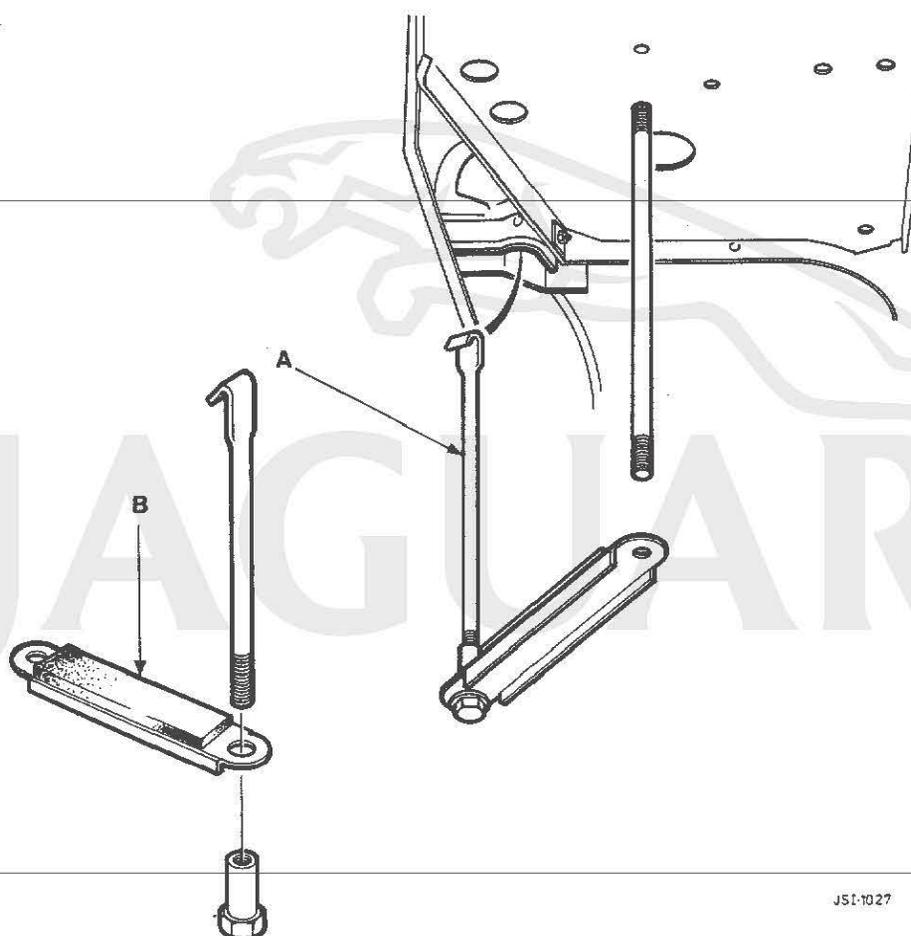
As a result of investigations into screen wash reservoir fluid leakage, various modifications to the assembly have been instituted. These are a revised upper and lower reservoir with an improved 'O' ring seal introduced at VIN 562596.

Due to instances of reservoir cracks/splits in the area where the support bracket is located, two modifications have been introduced. The outer support rod (A) has been turned through 180°. A self-adhesive pad (B) has been added to this bracket (Part No. BCC 7496). Both modifications introduced at VIN 563702.

NOTE: When replacing reservoirs, the above installation modification must be carried out. It is most important that the reservoir fixing torques (1-3 Nm) 4lb/ft are adhered to.

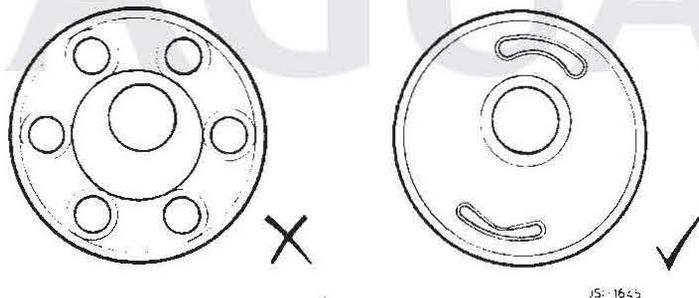
FIG 1

Note: The bushes originally used were termed as 'six-shooter' bushes. These have now been redesigned / replaced by the 'smiley-faced' bushes currently being used, see Fig. 1 for identification.

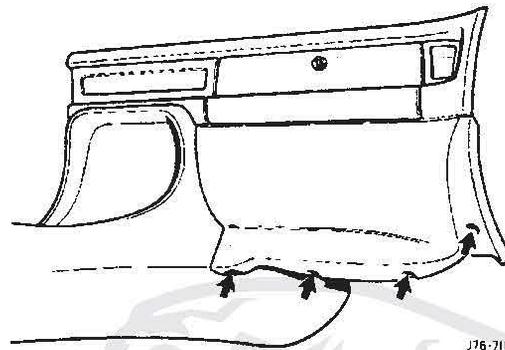
FIG 1

A quantity of dash liners has been replaced due to damage caused by their removal. A Service Tool (JD 188) has now been developed to assist with this procedure. To remove a dash liner, driver's or passenger's side of vehicle, proceed as follows:

Open the appropriate door to gain access to the dash liner. Undo and remove the dash liner securing screws (Fig.1).

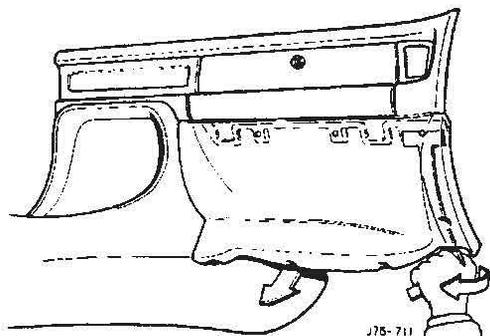
FIG 2

The number of dash liner retainers is different between Federal and U.K. vehicles. To avoid any damage to the dash liner, always ensure all retainers have been carefully displaced before removal.

Insert Service Tool JD 188 behind the dash liner. Locate onto the upper flange with the 'V' cut-out in the tool either side of the first fir tree retainer (Fig. 2). Displace the fir tree retainer from the plastic retainer socket by gently twisting the tool handle (Fig. 2). Remove the remaining retainers in the same manner.

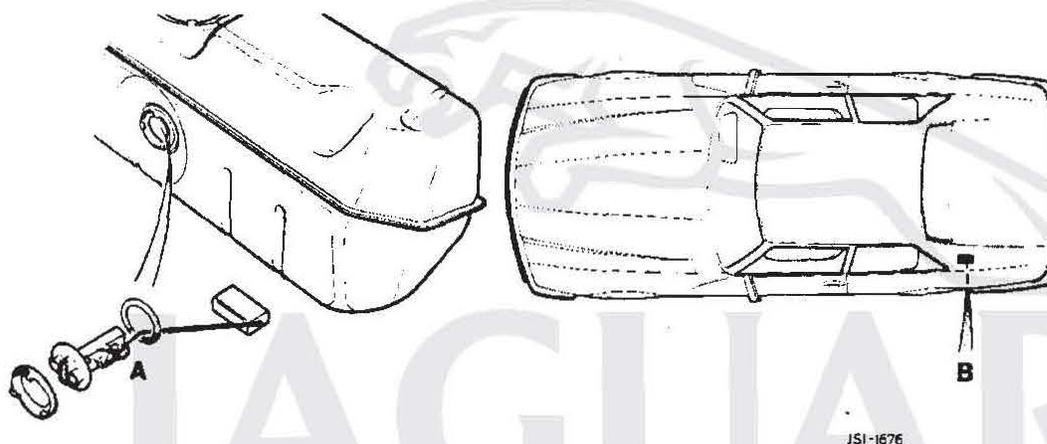
COMPONENT LOCATION

Following isolated concerns with this circuit, some Dealer confusion has arisen during fault diagnosis, which has resulted in the unnecessary replacement of components.

POSSIBLE FAULT CONDITIONSLoss of damping

Disconnect the upper wire of the sender from ground and check that the fuel gauge starts to fall. If the low fuel warning light illuminates within 12 seconds of this operation, replace the anti-slosh module.

If the warning lamp fails to illuminate, check the voltage on the warning lamp output of the anti-slosh module (pin 2). If the voltage is less than 0.9 volts, the fault does not lie in the anti-slosh module; therefore, check the lamp and harness. If the voltage is more than 0.9 volts, change the anti-slosh module.

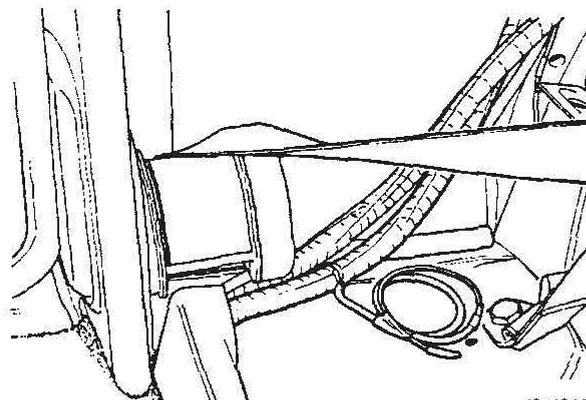
FIG 1

Investigation into Dealer reports of poor operation of the alarm system on XJ-S 92 MY vehicles has shown that a final operation has been omitted from the supplied installation instructions. Therefore, where customer complaints are received, the following action should be taken.

1. Remove the right-hand rear quarter lower trim pad assembly.
2. Identify the alarm antenna coiled in the harness (refer to Fig 1).

3. Remove the adhesive tape from the antenna, uncoil and straighten.
4. Position the rear quarter trim panel assembly to the vehicle.
5. Attach the straightened antenna to the rear of the trim panel in vertical attitude, using suitable adhesive tape (refer to Fig 2).
