Service Bulletin

Date JANUARY 1984
Sheet 1 of 9
Bulletin JD.01/84

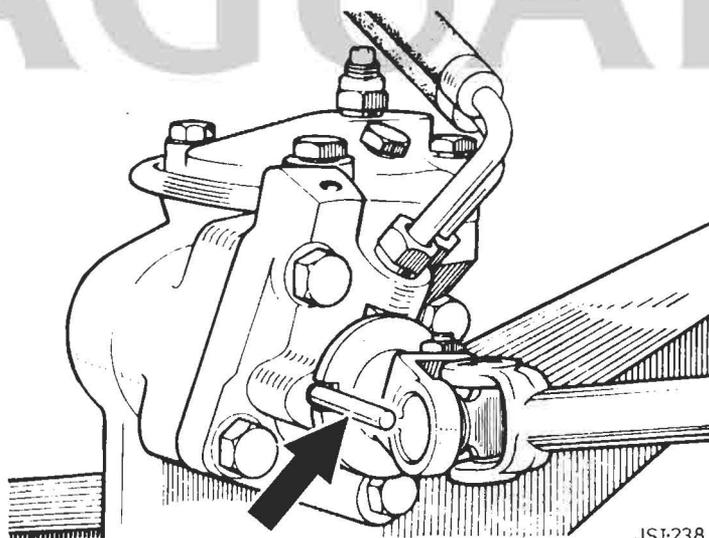
JSI:238

1. Inflate all tyres to the recommended pressures.
2. Set the front wheels in the straight ahead position.
3. Centralise the steering unit by adjusting the position of the steering wheel, until the cut out in the centralising plate, on the input shaft, aligns with the hole in the steering box (Fig. 1). Check by inserting a 6.4mm (1/4in) rod suitably bent into the steering box.

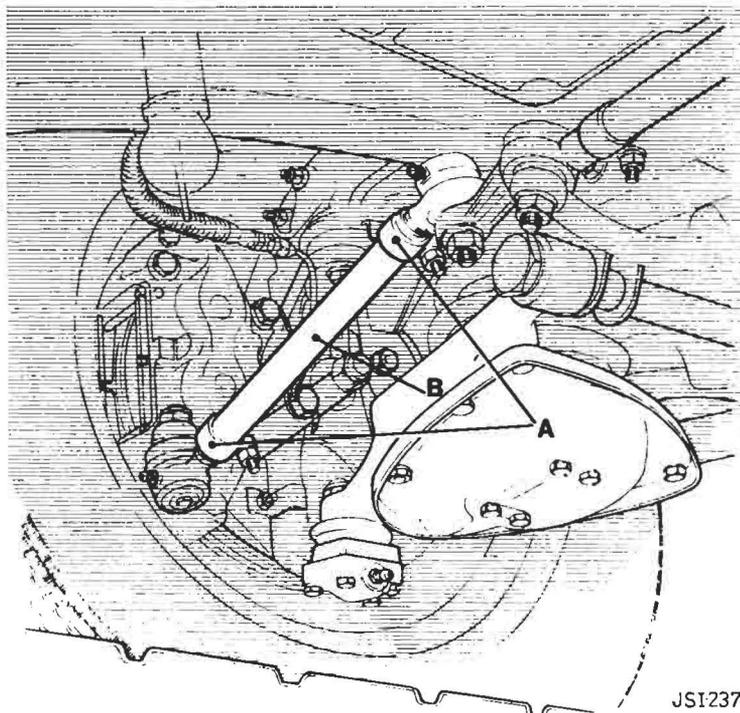
JSI237

4. Use light beam equipment to check wheel alignment.
5. Adjust the outer tie rod by loosening the clamps (A Fig. 2) at each end of the centre tube (B Fig. 2). The rod length is adjusted by rotating the centre tube (B Fig. 2).
6. When the correct wheel alignment figure is achieved, i.e. half the total toe-in of 0–3.2mm (0–1/8in), secure the clamps.

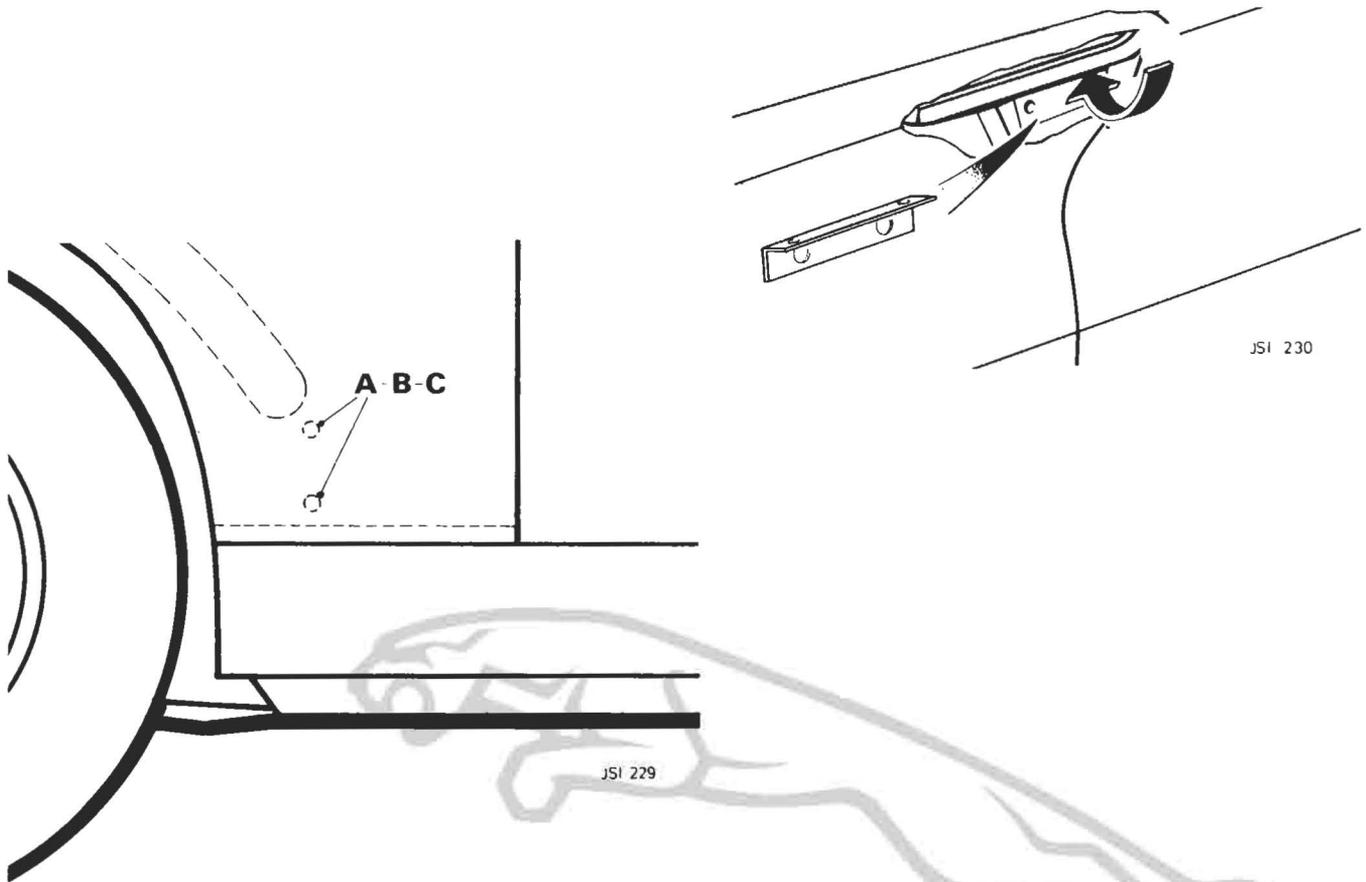
6. Water ingress via seams at "A" post waist – Series III

This problem may occur if there is an open seam at the base of the drip rail which allows water to enter the car interior via the "A" post box section.

Apply sealant "E" along the seams identified in Fig. 6, allow to dry and water test vehicle.

- A Remove the "A" post draught welt.
- B Remove trim from footwell at base of "A" post (BD 43251 – RH, BD 43252 – LH, BAC 9906 – RH VDP, BAC 9907 – LH VDP).
- C Examine interior of the box section whilst water is "poured" down drip rails.
- D Refer to Fig. 6A and 6B for possible leak areas, and rectify using one of the following methods:
 - i. Leakage from point 6A – remove front wheel arch stone guard and apply sealant "A", "B", or "C".
 - ii. Leakage from point 6B – remove front wing (Workshop Manual Operation 77-28-29) and apply sealant "A", "B", or "C".

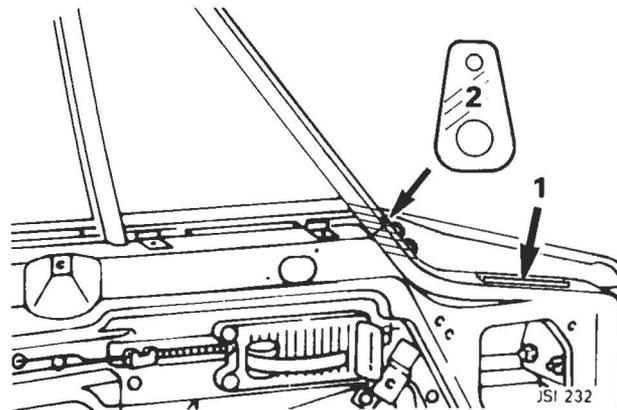
9. Water ingress and/or wind noise between door and "A" post at waist – XJ-S only (Fig. 9)

- A Remove and discard the door drain channel and plug the three redundant holes in the door, and paint as necessary (1 Fig. 9).
- B Test the vehicle to establish if the fault has been rectified.
- C If the fault is still apparent, remove the peardrop seal (2 Fig. 9).
- D Apply a proprietary body filler to the joint, DRESS OFF WHEN HARD TO ENSURE A GOOD PROFILE, refit screw and paint as necessary. This action, if properly carried out, will eliminate water leaks in this area.

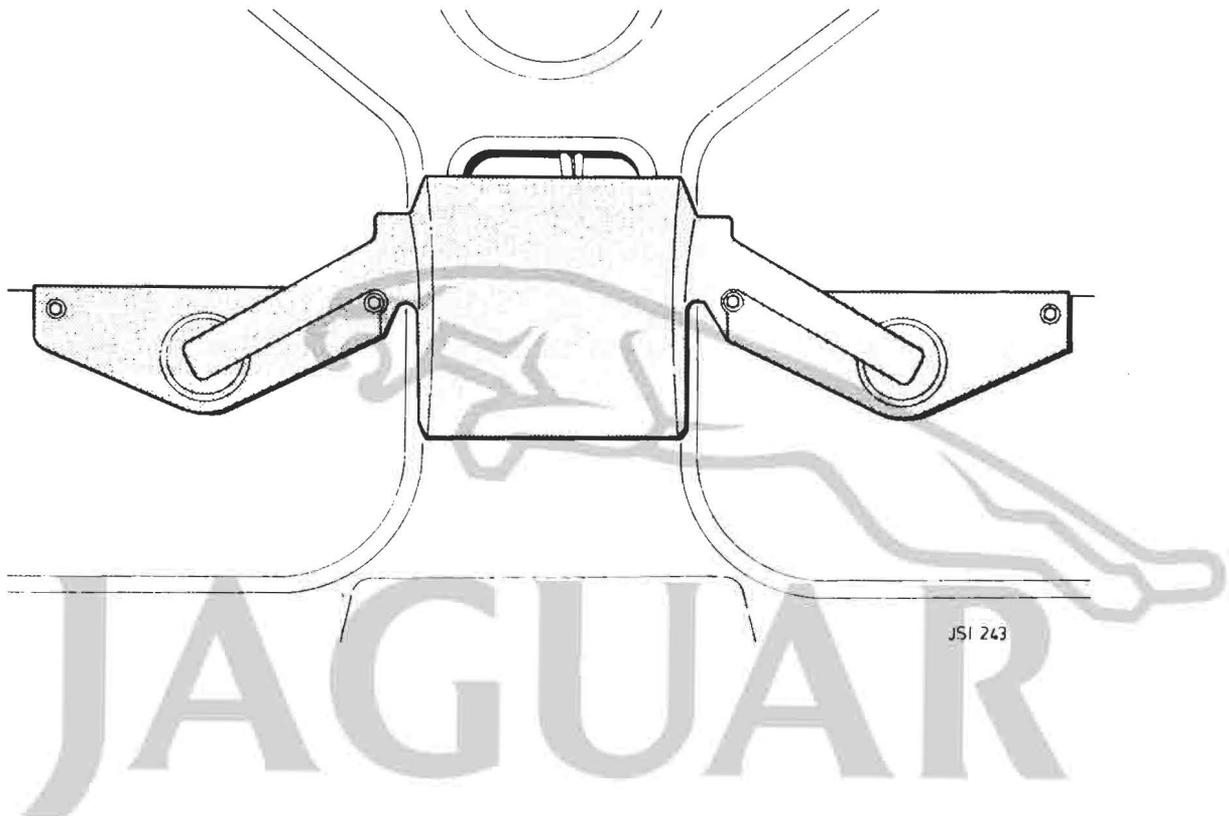
To provide increased security against illegal entry into the boot, a plastic shield, DAC 1030, has been introduced on all XJS vehicles from VIN 114455. This shield completely encloses the lock linkage and prevents access to the lock assembly.

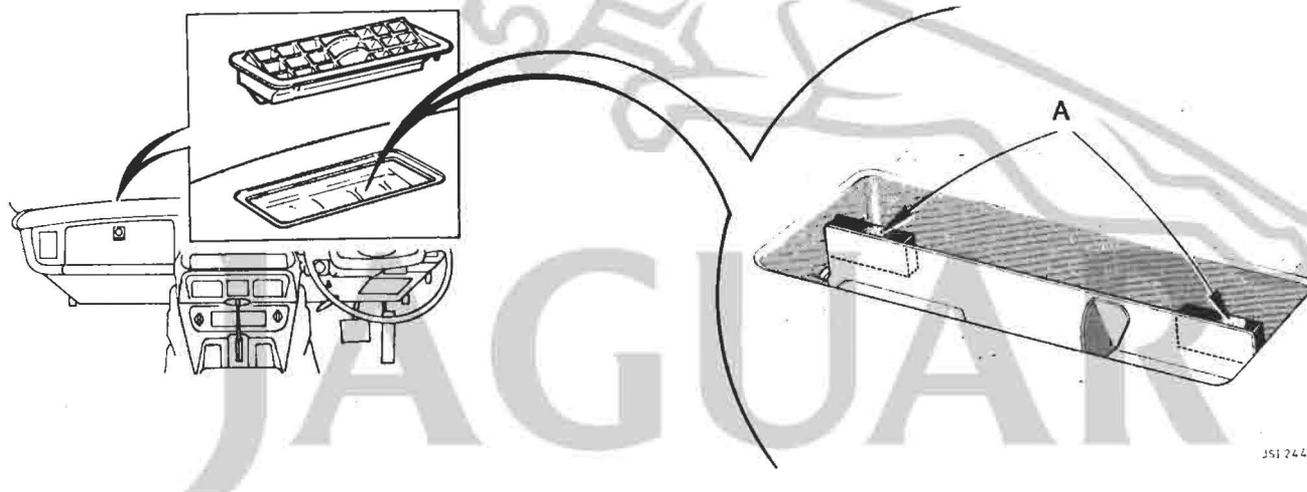
Investigations into screens misting on Series III Non Air Conditioned models, whilst the system is selected in positions other than defrost, have identified the cause to be insufficient air flow at the screen vent apertures. To overcome this problem, modified screen vent assemblies providing improved air flow distribution have been introduced at:

1. Carefully remove both screen vent aperture grilles from the facia crash roll.
2. Switch unit to defrost position to open screen vent flaps.
3. Use 4 off self adhesive rubber strips (not foam) to the dimensions detailed:

25mm long x 12mm wide x 6mm thick

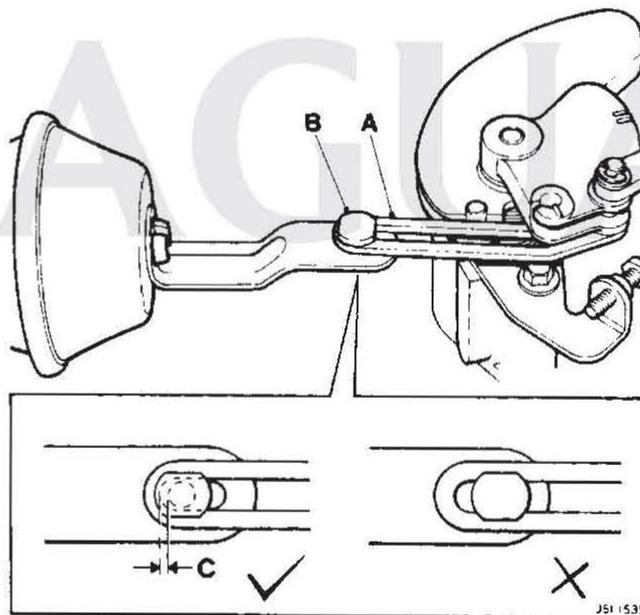
FIG 1

Dealers should ensure that the clearance between the end of the actuator to throttle link slot (A Fig 1) and the shoulder bolt (B Fig 1) is 0.5mm to 1mm (C Fig 1).

S.R.O.	19.75.11
Allowance	0.10 hrs
Complaint Code	7VCP

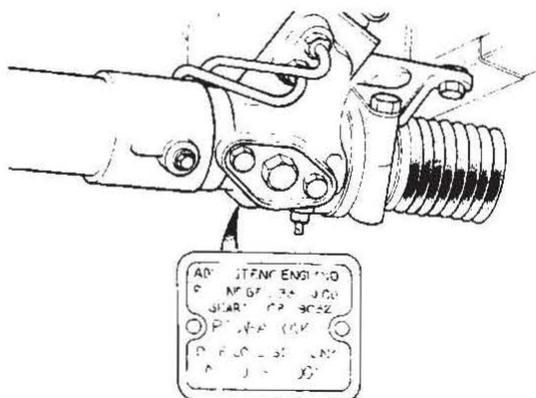
FIG 1

Note: Energised pinion seals should only be fitted to steering racks with plated pinion bores. Plated bore racks were fitted from VIN 597940. The plated racks are also identified by the part number stamped on the plate on the underside of the rack (Fig. 1). Part No. CBC 9052 – Right-hand drive vehicles. Part No. CBC 9053 – Left-hand drive vehicles. Energised seals were introduced from Part No. CCC 5650, XJ6 and Part No. CCC 5660, XJS.

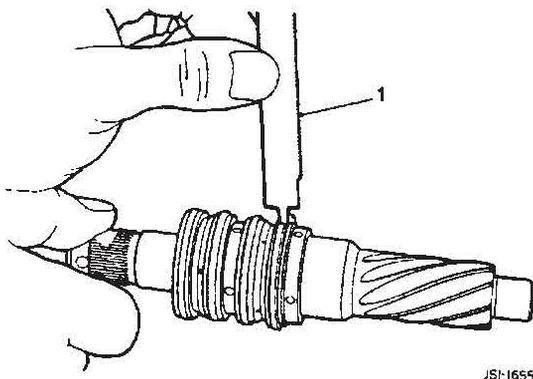
FIG 7

Cut and remove the P.T.F.E. sealing rings from the pinion valve (Fig. 7). Ensure the valve walls are not marked or scored whilst carrying out this operation.

Note: A suitable tool can be made by grinding a broken hacksaw blade to a narrow chisel shape (1 Fig. 7).

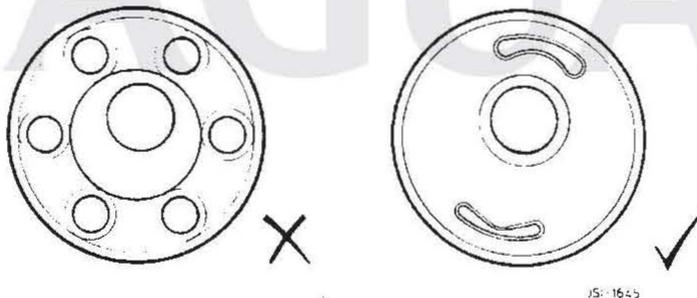
FIG 1

Note: The bushes originally used were termed as 'six-shooter' bushes. These have now been redesigned / replaced by the 'smiley-faced' bushes currently being used, see Fig. 1 for identification.

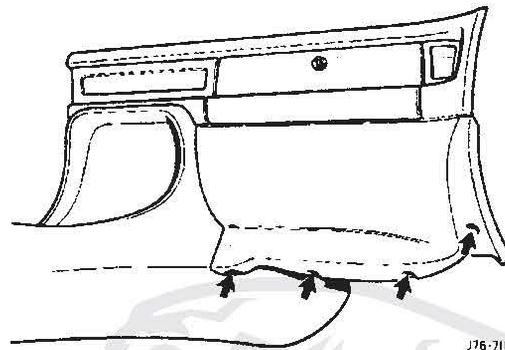
FIG 1

A quantity of dash liners has been replaced due to damage caused by their removal. A Service Tool (JD 188) has now been developed to assist with this procedure. To remove a dash liner, driver's or passenger's side of vehicle, proceed as follows:

Open the appropriate door to gain access to the dash liner.
Undo and remove the dash liner securing screws (Fig.1).

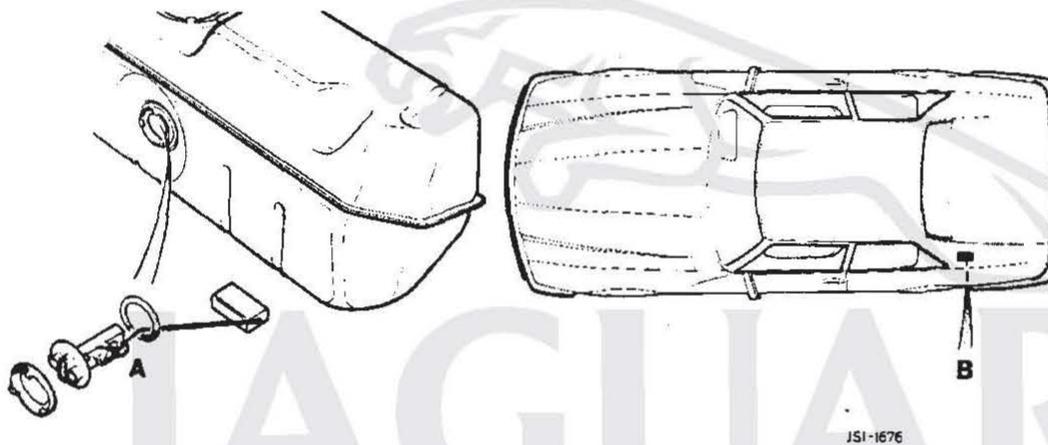
COMPONENT LOCATION

Following isolated concerns with this circuit, some Dealer confusion has arisen during fault diagnosis, which has resulted in the unnecessary replacement of components.

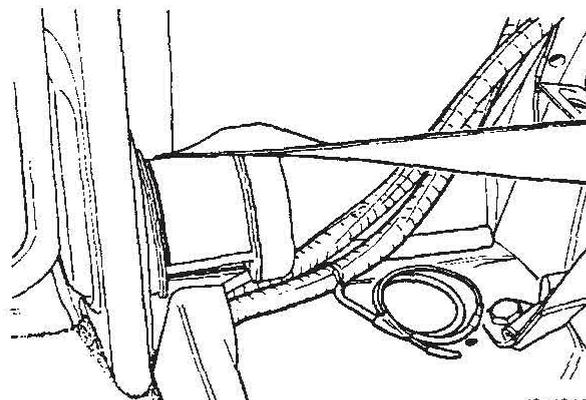
FIG 1

Investigation into Dealer reports of poor operation of the alarm system on XJ-S 92 MY vehicles has shown that a final operation has been omitted from the supplied installation instructions. Therefore, where customer complaints are received, the following action should be taken.

1. Remove the right-hand rear quarter lower trim pad assembly.
2. Identify the alarm antenna coiled in the harness (refer to Fig 1).
