DATE: OCTOBER 1991

REF: JD 08/91

**XJS**

# Service Bulletin

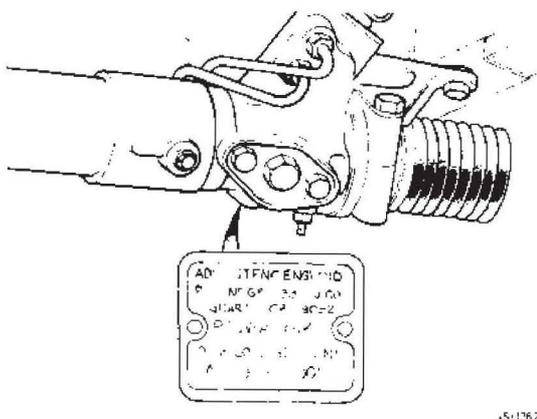
FIG 1

A set of Service Tools has been developed (JD 184, JD 185, JD 186 and JD 187) to assist in renewing the steering pinion valve energised seals; Service Tool JD 120, steering rack centralising pin, is also needed to carry out the operation.  
 As a general guide, if lack of steering assistance from cold is experienced, renew the seals. A seal kit is available, Part No. JLM 10839.  
 To renew the seals, proceed as follows:

**Note:** Energised pinion seals should only be fitted to steering racks with plated pinion bores. Plated bore racks were fitted from VIN 597940. The plated racks are also identified by the part number stamped on the plate on the underside of the rack (Fig. 1). Part No. CBC 9052 – Right-hand drive vehicles. Part No. CBC 9053 – Left-hand drive vehicles. Energised seals were introduced from Part No. CCC 5650, XJ6 and Part No. CCC 5660, XJS.

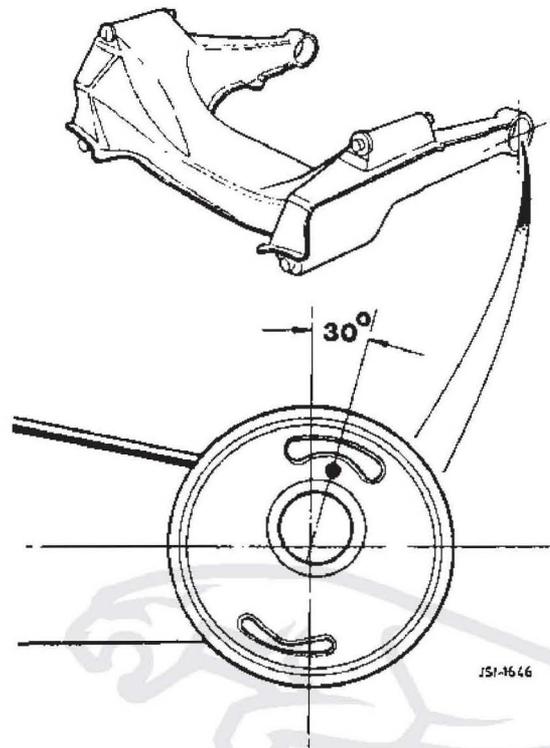
FIG 2

**Note:** The bushes originally used were termed as 'six-shooter' bushes. These have now been redesigned / replaced by the 'smiley-faced' bushes currently being used, see Fig. 1 for identification.

Carefully align the crossmember to the press / tool.  
 Fit and align a new bush to the crossmember, ensuring that the scribe mark matches to the mark on the crossmember.  
 Fit and align the replacer tool, JD 143-5, to the bush.  
 Using the press, fully seat the new bush into the crossmember.  
 Remove the replacer tool, JD 143-5, and place to one side.  
 Remove the crossmember from the press and repeat the procedure to fit the other new crossmember bush.  
 When the new bushes are correctly aligned and fully fitted to the crossmember, refit the crossmember to the vehicle, as detailed in operation 76.10.05.  
 On completion, check that the steering geometry is correct, prior to re-using the vehicle.

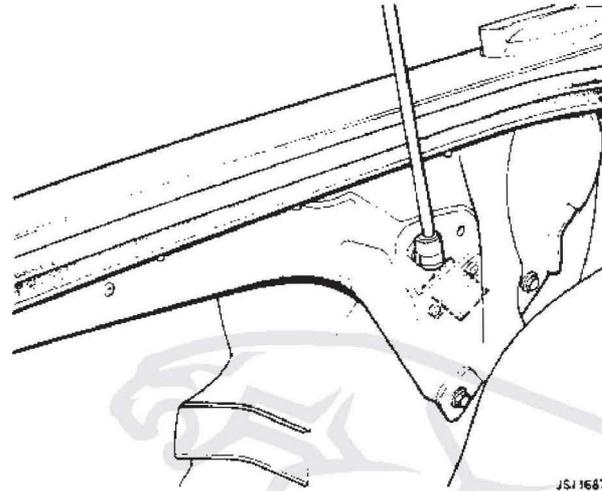
FIG. 1

From VIN 179737 (92MY Facelift XJS), the stop light failure sensor module is located in the boot of the vehicle, attached to the inside of the boot side reinforcement panel (drainage channel) L.H. (Fig. 1).

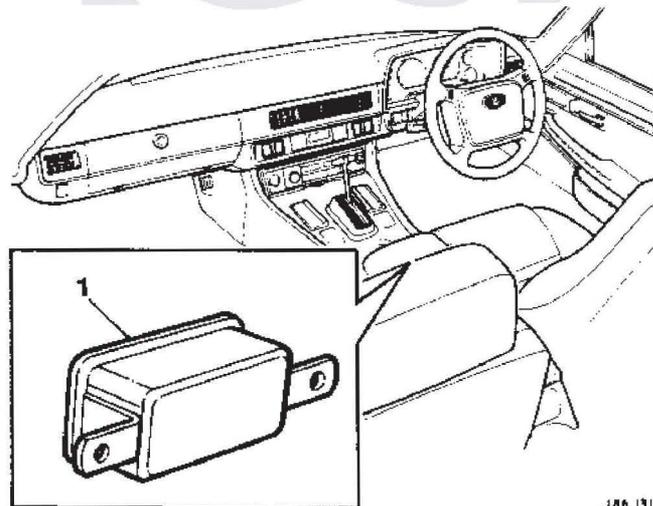
FIG. 2

Prior to VIN 179737 (90MY XJS), the module is located beneath the centre console veneer finisher, attached to a bracket in front of the stowage compartment (Fig. 2).

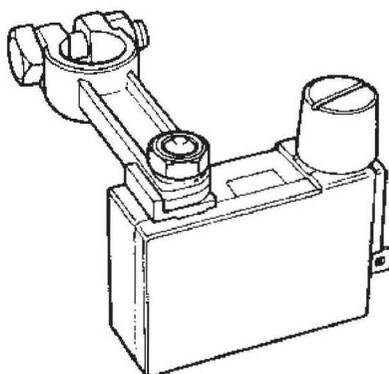
FIG 1

Owing to the relocation of the battery into the boot at 93 MY, a revised battery transit relay has been introduced, (see Fig 1).

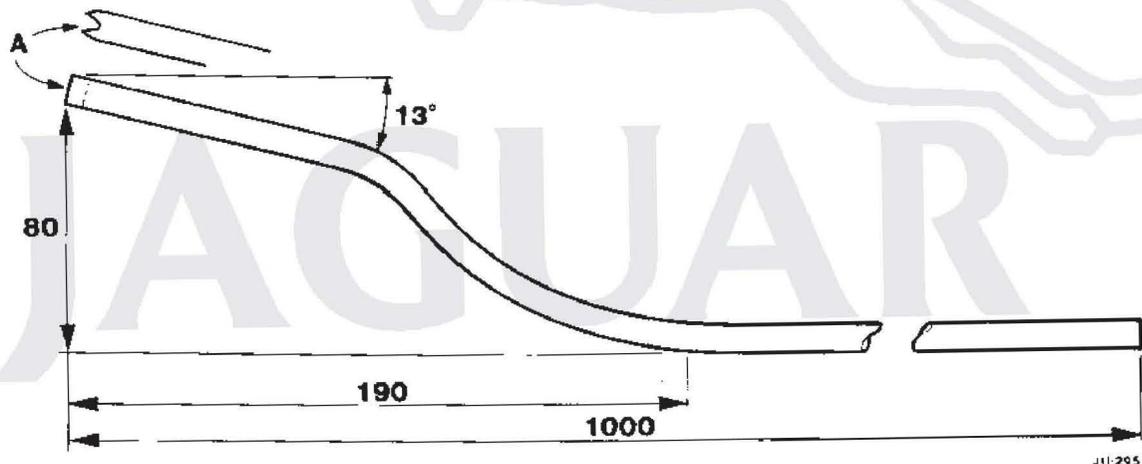
7. Release the RHS catch by operating the latch arm directly by hand.
8. Using the locally-made release tool illustrated in Fig. 1. below, the LHS catch may be released after passing the release tool across the top of the engine. The notch on the end face of the tool prevents slippage from the catch.
9. Remove the bonnet by lifting it up and away from the engine compartment aperture.
10. Trace and rectify the release problem.
11. Refit and adjust the bonnet to the aperture.
12. Refit the front grille.
13. Reconnect the battery and refit the battery cover.
14. Re-code the radio; re-set the clock.

The tool illustrated above should be locally manufactured from a length of steel rod, 6.00mm diameter, approximately 1000mm long. The overall length, however, is not critical, provided that the tool is sufficiently long to provide access across the engine compartment.
