Service Bulletin

DATE: JANUARY 1992

REF: JD 02/92

XJ-S FACELIFT

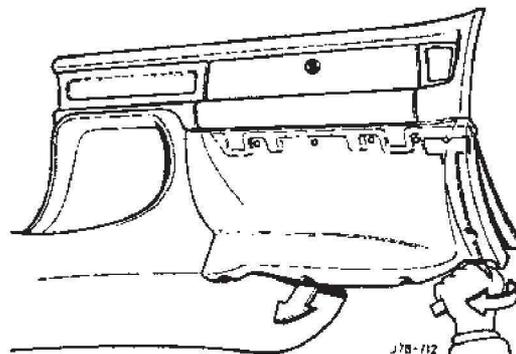
FIG 3

The number of dash liner retainers is different between Federal and U.K. vehicles. To avoid any damage to the dash liner, always ensure all retainers have been carefully displaced before removal.

A quantity of dash liners has been replaced due to damage caused by their removal. A Service Tool (JD 188) has now been developed to assist with this procedure. To remove a dash liner, driver's or passenger's side of vehicle, proceed as follows:

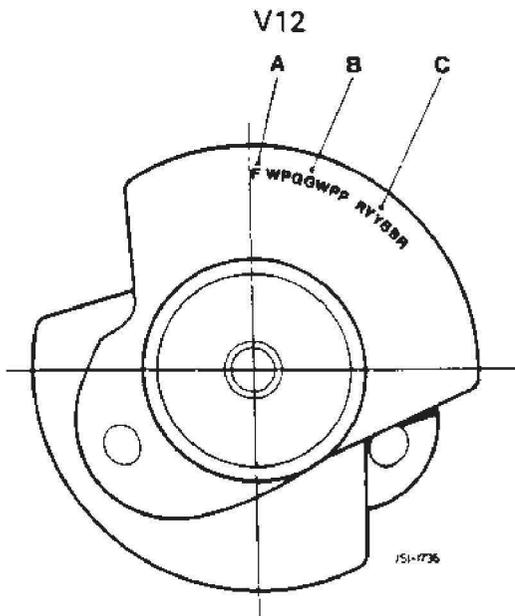
The three different grade diameters of the journals and pins are represented by a letter which corresponds to a colour, i.e. "P" equals Pink, "R" equals Red, etc. The grade of each individual journal and pin on each crankshaft is identified by having the grading diameter colour stamped on the No 1 balance weight, indicating the grade of shell to be fitted, as follows:

A: F Indicates front
 B: Journals 1 to 7
 C: Pins 1 to 6

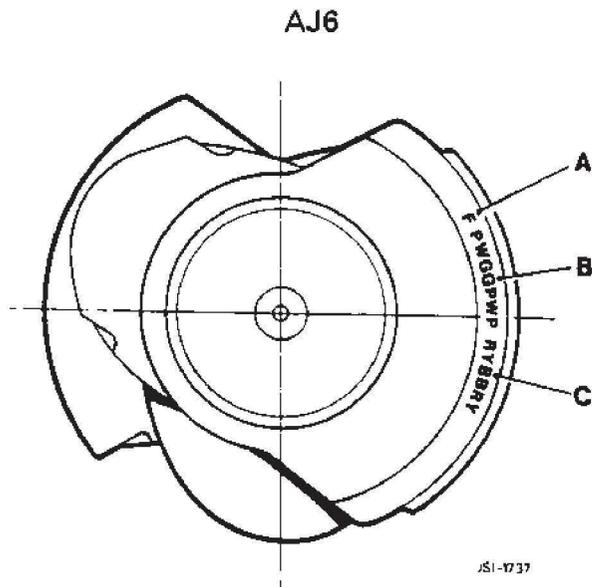
A: F Indicates front
 B: Journals 1 to 7
 C: Pins 1 to 6
