Service Bulletin

JAGUAR

Date: DECEMBER 1985/JANUARY 1986

Bulletin: JD 01/86

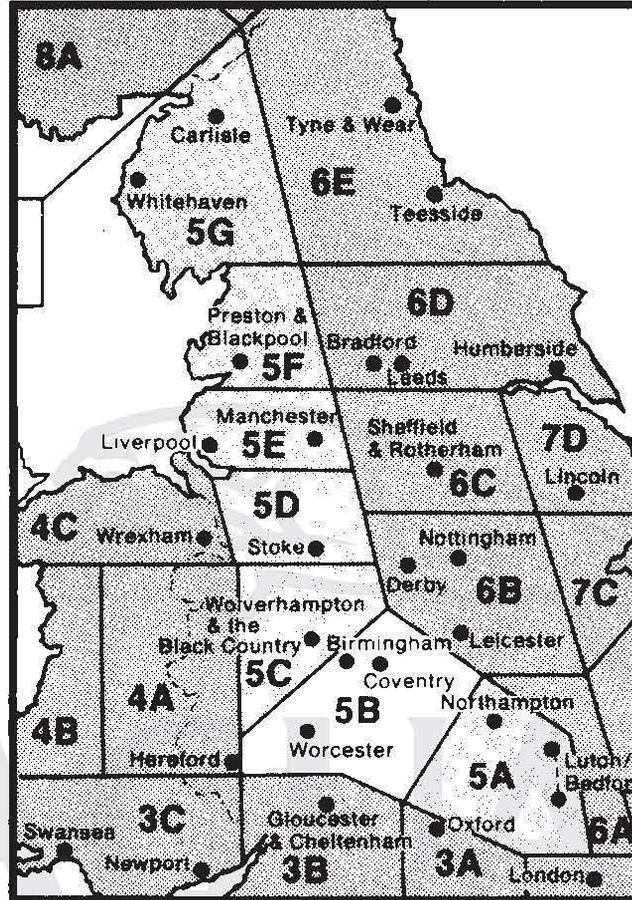
FIG 1.

To demonstrate frequency tuning, let us assume that the vehicle in question is to be based in the South-East Midlands area which is covered under area 5B, Page 26-27 (long-medium wave) and page 30 VHF (FM) of the "Clarion Radio on the Move" booklet.

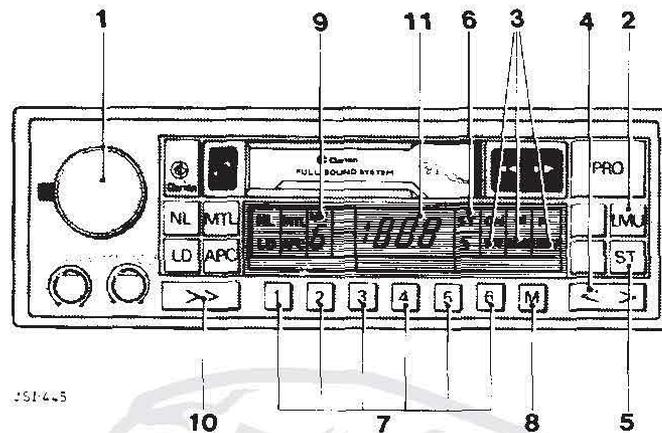
FIG 3

MODEL PU-9021A (DAC 3372/3716/4006)

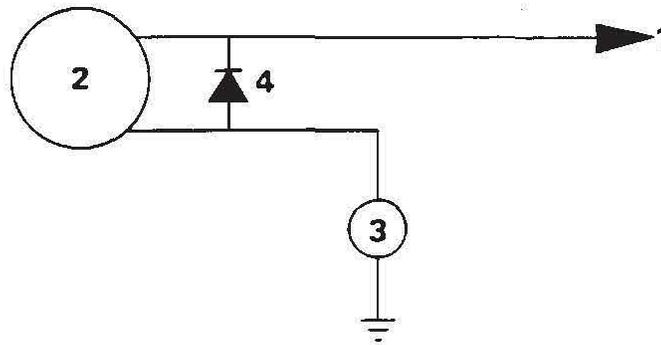
HSLP WIRING DIAGRAM

Dealers have experienced a problem in Service where in some instances a vehicle has been returned several times for the air conditioning thermal fuse to be replaced, although at the time the air conditioning system appeared to be fault free.

The HSLP switch is designed to monitor pressure drop on the high side of the system. At a low pressure condition of 25 psi \pm 5 psi, the HSLP switch contacts, which are normally closed, open circuit, thus breaking the earth circuit to the compressor clutch coil resulting in the clutch drive disengaging.

The thermal fuse and superheat switch system has now been deleted and replaced by a high side low pressure switch (HSLP) from Vins:

Following rectification and recharging of the system, the HSLP switch will return to a closed state, once again completing the clutch circuit.
