Service Bulletin

DATE: OCTOBER 1991

REF: JD 08/91

XJS

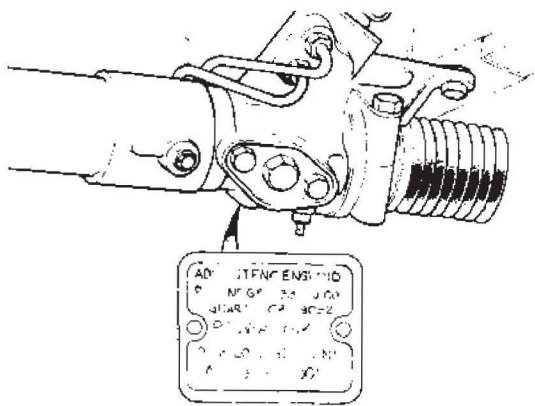
FIG 1

Note: Energised pinion seals should only be fitted to steering racks with plated pinion bores. Plated bore racks were fitted from VIN 597940. The plated racks are also identified by the part number stamped on the plate on the underside of the rack (Fig. 1). Part No. CBC 9052 – Right-hand drive vehicles. Part No. CBC 9053 – Left-hand drive vehicles. Energised seals were introduced from Part No. CCC 5650, XJ6 and Part No. CCC 5660, XJS.

A set of Service Tools has been developed (JD 184, JD 185, JD 186 and JD 187) to assist in renewing the steering pinion valve energised seals; Service Tool JD 120, steering rack centralising pin, is also needed to carry out the operation.
 As a general guide, if lack of steering assistance from cold is experienced, renew the seals. A seal kit is available, Part No. JLM 10839.
 To renew the seals, proceed as follows:

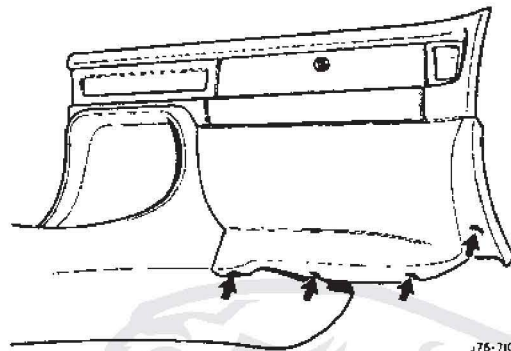
FIG 1

A quantity of dash liners has been replaced due to damage caused by their removal. A Service Tool (JD 188) has now been developed to assist with this procedure. To remove a dash liner, driver's or passenger's side of vehicle, proceed as follows:

Open the appropriate door to gain access to the dash liner.
Undo and remove the dash liner securing screws (Fig.1).

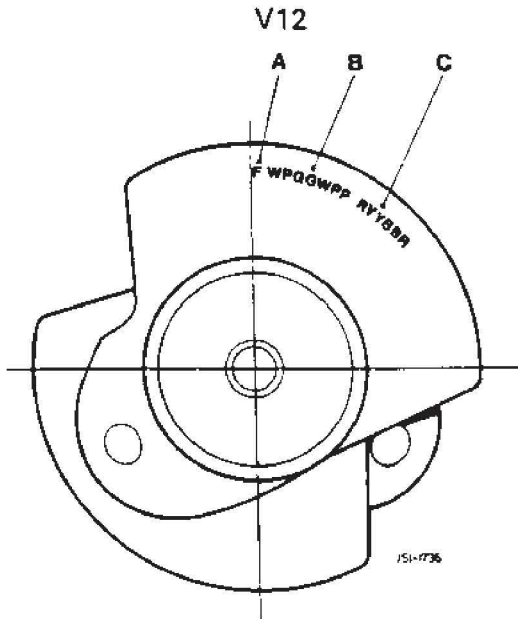
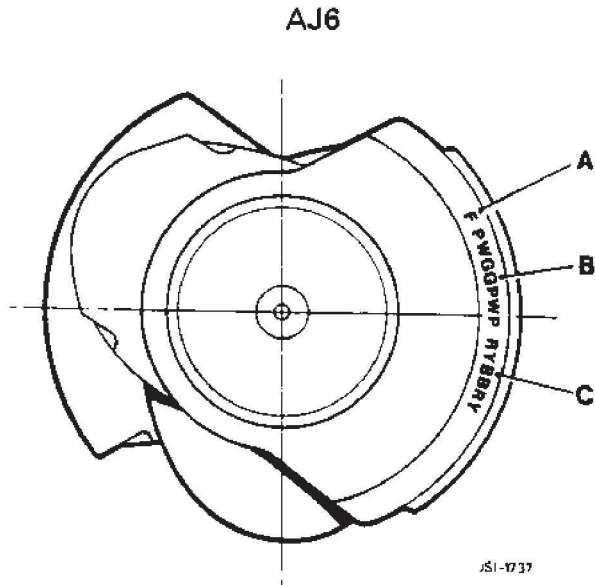
The three different grade diameters of the journals and pins are represented by a letter which corresponds to a colour, i.e. "P" equals Pink, "R" equals Red, etc. The grade of each individual journal and pin on each crankshaft is identified by having the grading diameter colour stamped on the No 1 balance weight, indicating the grade of shell to be fitted, as follows:

A: F Indicates front
 B: Journals 1 to 7
 C: Pins 1 to 6

If the bearing shells only have to be replaced, the relevant shells, as noted on the No. 1 balance weight (see above), should be ordered.
