Service Bulletin

REF: JD 03/92

REF: JD 14/92

REF: JD 16/92

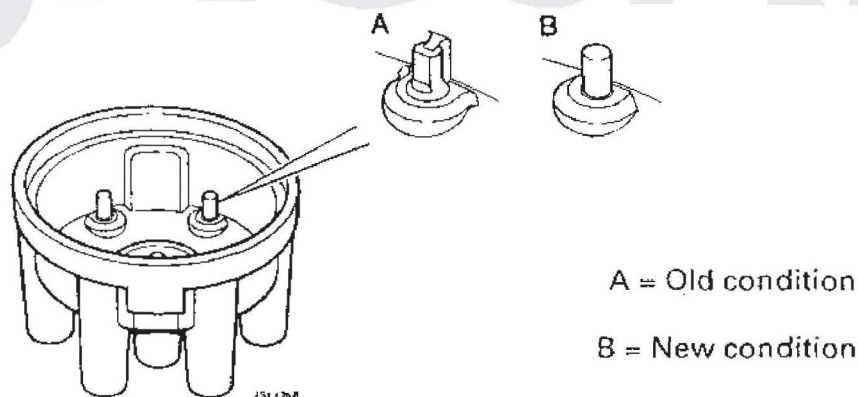
FIG 1

ENGINE NO		VIN
XJ40	-	(4.0)	=	9EPCNA	160563	663458
"	-	(3.2)	=	9BPMNA	109324	663448
XJS	-	(4.0)	=	9EPCNA	160566	184714

Please note that the part number for the distributor cap, JLM 150, remains unchanged and is fully interchangeable on vehicles with engine numbers prior to those listed above.

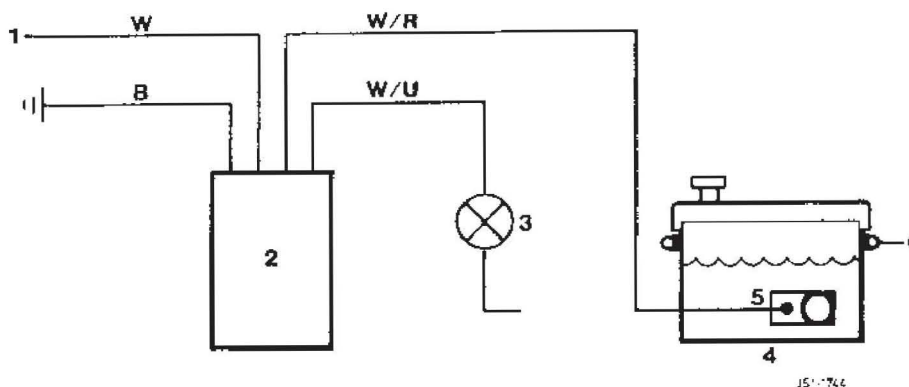
The system operates by measuring the resistance of the coolant. With resistance below 5,000 Ohm, the warning light is off. The light will illuminate with the resistance

- 1 – Ignition (IGN) supply
- 2 – Low coolant control unit
- 3 – Warning light (W/L)
- 4 – Header tank
- 5 – Low coolant probe
- 6 – Header tank earth via fixing bolts
