Service Bulletin

ISSUE NO: JD 04/92

- MODEL : XJ6 / XJS / S.III V12 (AIR CONDITIONED MODELS)
- SUBJECT : BLOWER MOTOR ASSEMBLIES
- CUSTOMER CONCERN : Brush gear noisy operation, ie: low speed ticking / squeak.

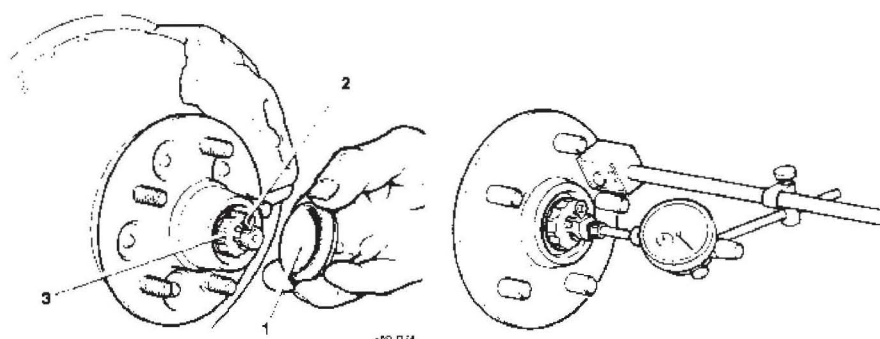
Note: For identification purposes only,
 Fig. 1 shows XJS, S III & Limo. type hub.
 Fig. 2 shows XJ6 hub.

Fit a Dial Test Indicator (DTI) to the hub (Fig. 2).

Grasp the hub unit. Firmly pull and push the unit, oscillating at the same time, to determine the DTI end float reading.

If the reading is within the specification quoted there is no need to carry out the adjustment. If not, remove the hub nut split pin and cover (2, 3 Fig. 1).

When the new split pin is fitted, ensure the end float is re-checked using the DTI gauge (Fig. 2).

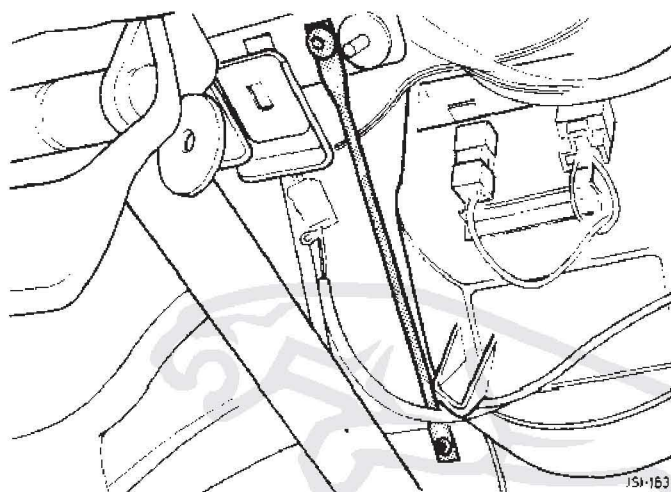
Fig. 1

The repair operation time for renewing the driver's side blower motor assembly has changed on all XJ6 Vehicles from VIN 629286.

Open the bonnet and disconnect the battery earth lead.
Remove the driver's side dash liner.
Remove the retaining clip from the air conditioning unit's pliable trunking.
Displace the pliable trunking from the air conditioning unit.
Displace the relay bases from their mounting brackets.
Cut and remove the ratchet straps securing the brake switch harness.
Disconnect the vacuum hose from the blower motor assembly servo unit.
Disconnect the blower motor multi-way connectors.
Undo and remove the steering column lower mounting securing nuts.
Undo and remove the steering column upper mounting securing nuts.
Lower the steering column assembly.
Retrieve the column upper packing shims.
Remove the washer bracket from the column.
Manoeuvre the steering column towards the centre of the vehicle for access.
Undo and remove the steering column outer stabilizer bar's upper and lower securing nuts.
Displace and remove the steering column stabilizer bar (Fig. 1).

Fit and align trunking to the new blower motor assembly.
Secure the trunking to the assembly with tape.
Smear the new intake gasket with a suitable adhesive.
Fit the gasket to the blower motor assembly intake.
Fit and align the blower motor assembly into its mounting position.
Connect the pliable trunking to the air conditioning unit.
Refit and tighten the blower motor assembly securing bolts.
Fit and align the trunking retaining clip.
Connect the blower motor multi-way connectors.
Connect the vacuum hose to the blower motor assembly servo unit.

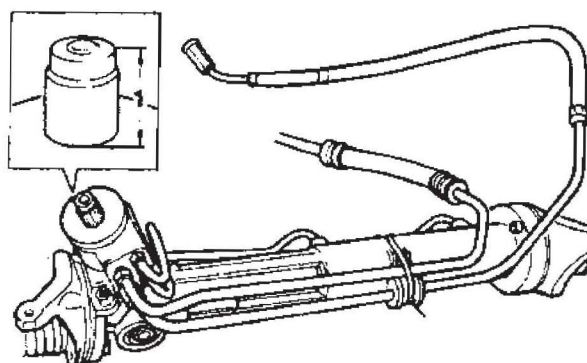
FIG. 1

INTRODUCTION OF THE ZF PHASE 2 STEERING RACK
