Service Bulletin

DATE: OCTOBER 1991

REF: JD 08/91

XJS

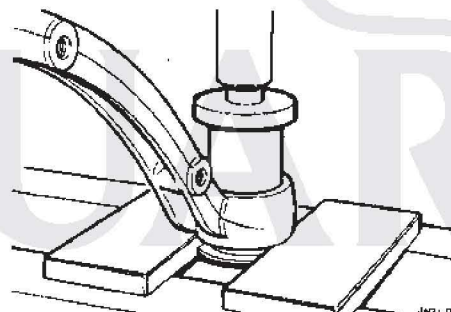
FIG 4

Fit and align bush removal tool JD 143-4 to the bush (Fig. 4).

Place tool JD 143 to the press.

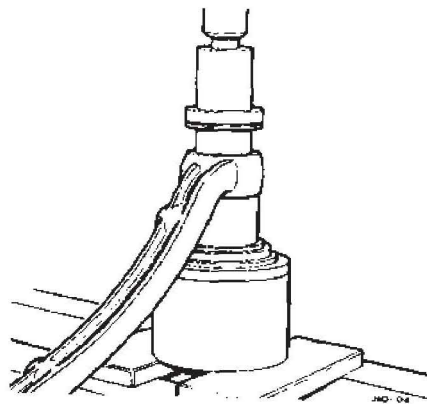
FIG 5

Align the large diameter of the bush replacer tool JD 143-3 to the bush (Fig. 5).

Remove the wishbone front arm and bush replacer tool from the press.

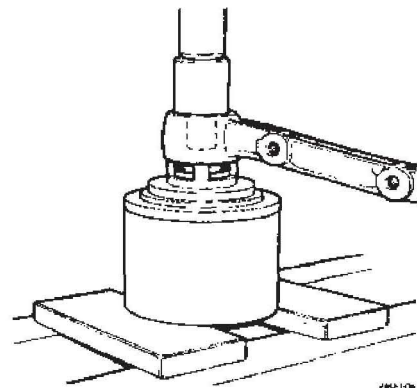
FIG 6

Align removal tool JD 143-3/1 to the bush (Fig. 6).

Using the press, carefully displace and remove the bush.

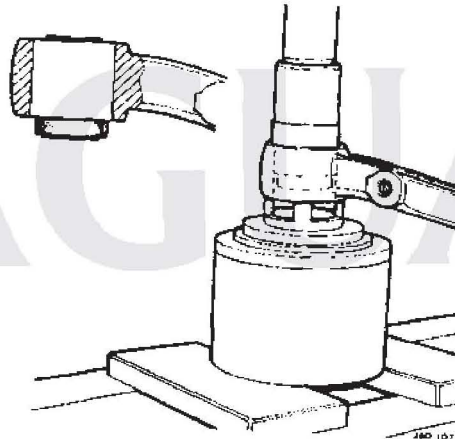
FIG 7

Align bush replacer tool JD 143-3/1 to the bush (Fig. 7).

Using the press, fully seat the bush into the wishbone arm until the upper face of the bush is level with the upper face of the wishbone (see detail in Fig. 7).

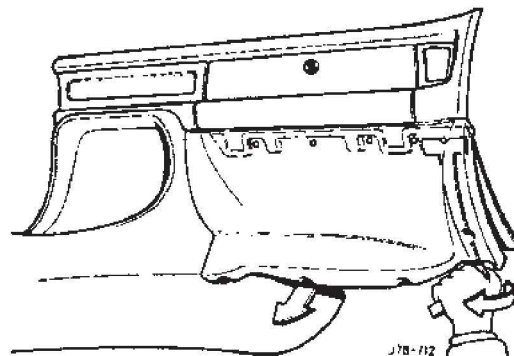
FIG 3

A quantity of dash liners has been replaced due to damage caused by their removal. A Service Tool (JD 188) has now been developed to assist with this procedure. To remove a dash liner, driver's or passenger's side of vehicle, proceed as follows:

Note: On vehicles fitted with a steel armature, the tool **must** be inserted between the dash liner and the steel armature (Fig. 3).

The number of dash liner retainers is different between Federal and U.K. vehicles. To avoid any damage to the dash liner, always ensure all retainers have been carefully displaced before removal.

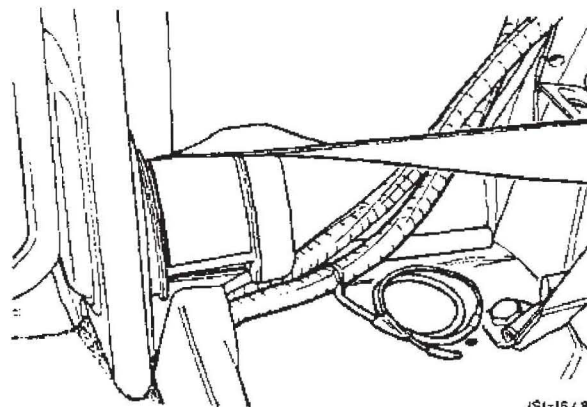
FIG 1

Investigation into Dealer reports of poor operation of the alarm system on XJ-S 92 MY vehicles has shown that a final operation has been omitted from the supplied installation instructions. Therefore, where customer complaints are received, the following action should be taken.

1. Remove the right-hand rear quarter lower trim pad assembly.
2. Identify the alarm antenna coiled in the harness (refer to Fig 1).

3. Remove the adhesive tape from the antenna, uncoil and straighten.
4. Position the rear quarter trim panel assembly to the vehicle.
5. Attach the straightened antenna to the rear of the trim panel in vertical attitude, using suitable adhesive tape (refer to Fig 2).
